Power operation with reduced heat transmitting tiles at Tore Supra

R. Mitteau, J. Schlosser, M. Lipa, A. Durocher. Power operation with reduced heat transmitting tiles at Tore Supra. *Journal of Nuclear Materials*, 2009, 386-388, pp.844 - 846. 10.1016/j.jnucmat.2008.12.260 . cea-02942091

POWER OPERATION WITH REDUCED HEAT TRANSMITTING TILES AT TORE SUPRA

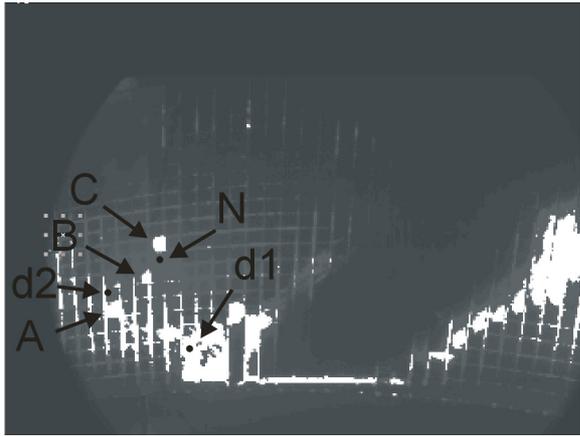
The three defects are observed on a section of 20° of 1000 tiles, which makes a defect rate of 0.3%. Considering that no lagging tile has been monitored on Q6B and Q3B lines of sight (2 x 60°, that is 6000 tiles), the defect rate for the entire limiter decreases to 0.05%. The three defectives tiles are called in the following A, B and C. The initial IR image suggests that A and B are corner defects, whereas C is a band defect in the radial direction. The IR image allows to determine the precise location of the lagging tiles (Fig. 2). The tile position on the element starts at 1 on the leading edge. Mechanically tile A is on the Q6A sector and B&C on Q5B.

Figure 1 : Infrared image of the section PJ6 during cool down after #37047. White areas are hot (1190 K), and black is cold (400 K).

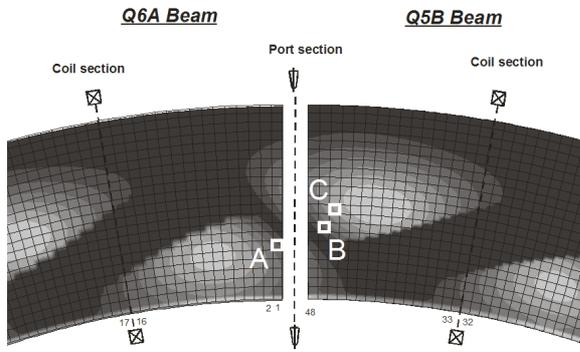
The positions are transferred on a heat flux map in Fig. 2. All 3 tiles are localized in a high heat load area, between the two heat flux concentrations. This area is also the one where the cross field heat flux is at its maximum, and is also the location where the ion ripple losses impinge. This can be considered an area where the heat flux is close to the TPL maximum. Investigation in the records of the non destructive examination of the finger elements prior to installation showed that the tiles were defectless at the origin, with a thermal lag ΔT smaller than the acceptance criterion of 3° (first line of table 1).

Figure 2 : Location of the defective tiles on the toroidal pump limiter

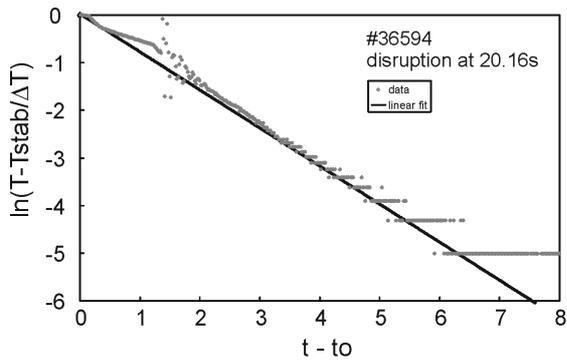
Figure 3 : Plot of the relative temperature variation versus time for the extraction of the thermal time constant for defect A (#36594).

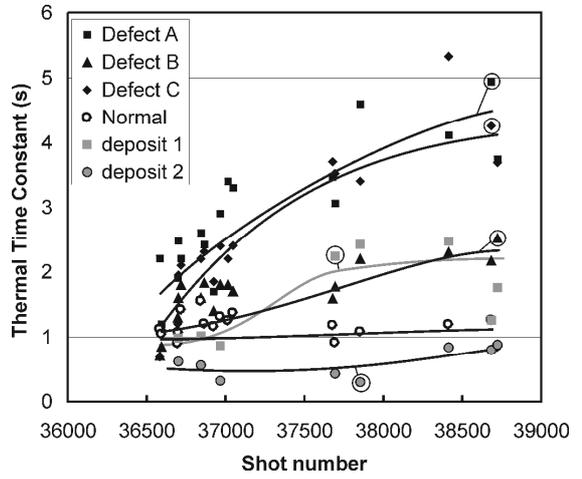
The time constant is plotted against the shot number in Fig. 5. Tile A passes from 1.7 s to 4.4 s, a four fold increase. Tile B increases somewhat less from 1 s to 2.4 s, and tile C from 1 s to 4 s. For the same discharge series, the normal tile undergoes no significant variation. Deposited tiles demonstrate a slow increase, from 0.5 to 0.8 s for the first pick-up point and from 1 to 2 s for the second one. These increases are attributed to deposit growth, and are still a factor of 2 smaller than the one apparently caused by bond deterioration. The error margin

Figure 5 : Evolution of the thermal time constants of defective tiles and reference pick-up points during 2006.

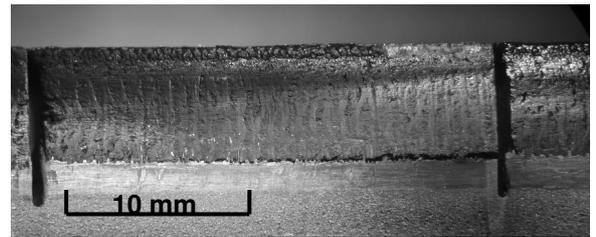
During the summer of 2007, Q6A was temporarily removed from the torus, in order to draw 9 element samples (DITS project, aiming at deuterium trapping investigations). The occasion is used to remove the first element of the sector, containing the defect A. Once examined by the side, a crack of 75% of the bond is evidenced (Fig 6). The crack is seen on both sides, to about the same length. It indicates that the defect is certainly continuous throughout the bond. It is now a transverse band defect, and it is an evolution from the initial estimate that it was a corner defect. A thermal non destructive test is done, using the SATIR test bed (Table 1). The ΔT_{SATIR} is measured to 21.8°. This is an increase by a factor 15 compared to the initial value, stressing how much the heat transfer has been degraded. It is remarkable to experience that the element is still functional at half its design heat flux with a so large defect : with a 75% defect, the cooling by the heat sink is still highly efficient as the tile is cooled in less than 15 seconds.

Figure 6 : Photo of the damaged bond (side view of the flat tile bond). The copper heat sink is on the bottom, the carbon tile above it. The heat flux comes on the top of the tile.

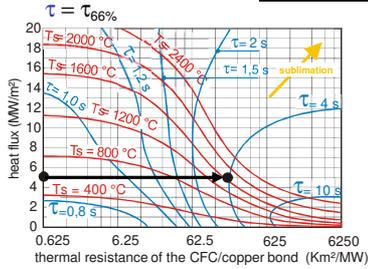
Abacus of defective bonds

Defects \Rightarrow longer time constant
Black shift (arrow) is tile A&C evolution in 2006

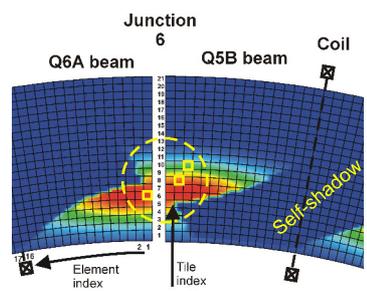
Location of the defective tiles on a calculated heat flux map (scale : blue is no heat flux, red is peak)
