POWER OPERATION WITH REDUCED HEAT TRANSMITTING TILES AT TORE SUPRA

R. Mitteau¹, J. Schlosser¹, M Lipa¹, A. Durocher¹

¹*Association Euratom-CEA, CEA/DSM/DRFC, Centre de Cadarache, 13108 Saint-Paul-Lez-Durance, France*

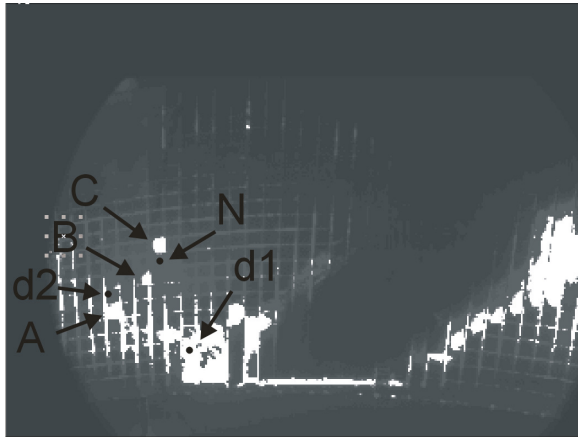
Figure 1 : Infrared image of the section PJ6 during cool down after #37047. White areas are hot (1190 K), and black is cold (400 K).

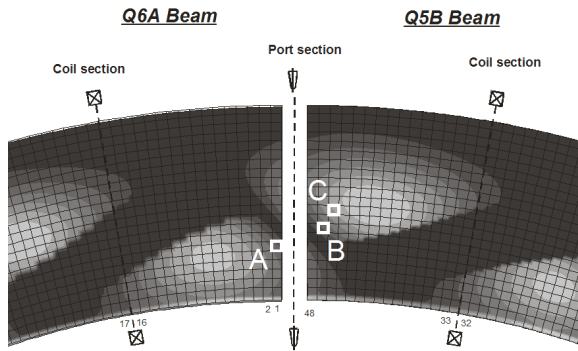
The positions are transferred on a heat flux map in Fig. 2. All 3 tiles are localized in a high heat load area, between the two heat flux concentrations. This area is also the one where the cross field heat flux is at its maximum, and is also the location where the ion ripple losses impinge. This can be considered an area where the heat flux is close to the TPL maximum. Investigation in the records of the non destructive examination of the finger elements prior to installation showed that the tiles were defectless at the origin, with a thermal lag ΔT smaller than the acceptance criterion of 3° (first line of table 1).

Figure 2 : Location of the defective tiles on the toroidal pump limiter

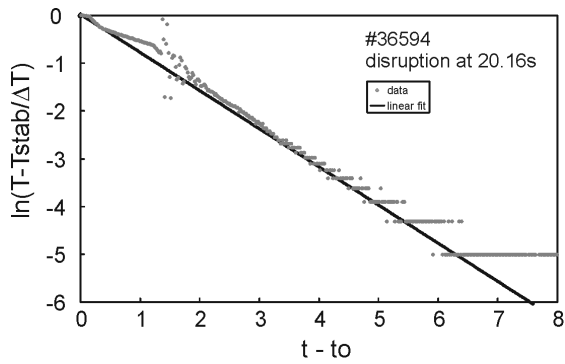
Figure 3 : Plot of the relative temperature variation versus time for the extraction of the thermal time constant for defect A (#36594).

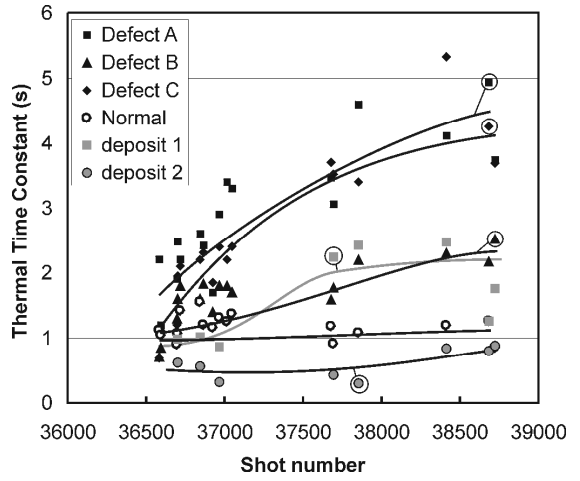
The time constant is plotted against the shot number in Fig. 5. Tile A passes from 1.7 s to 4.4 s, a four fold increase. Tile B increases somewhat less from 1 s to 2.4 s, and tile C from 1 s to 4 s. For the same discharge series, the normal tile undergoes no significant variation. Deposited tiles demonstrate a slow increase, from 0.5 to 0.8 s for the first pick-up point and from 1 to 2 s for the second one. These increases are attributed to deposit growth, and are still a factor of 2 smaller than the one apparently caused by bond deterioration. The error margin

on τ is difficult to establish, still a 20 to 30% error (the one of the IR measure) is probable. This error bar is also comparable to the reproducibility of the evaluations (Fig. 5). As a result, the τ increases are significant and can not be attributed to something else but crack propagation. The slope of the increase is steady, and does not shows sign of saturation : the tiles thermal behaviour is expected to tend to the one of a radiation cooled tile. The defects are less apparent on temperature maps. Even though their stabilized temperature is up to three time hotter than regular tiles, the hot area pattern is so much dominated by the very hot carbon redeposited material that the hotter tiles do not attract attention. It should be mentioned that the defects are located in a deposition area, where the stabilized temperature is influenced by the material deposit. The time constant is less sensitive to material deposits, especially when it is evaluated with a focus on the time scale of the seconds. A comparison can still be attempted : previous modeling during the TPL design indicated that a tile with a 3 time longer τ is 2 time hotter than normal tiles at 5MW/m² (1470 K instead of 870 K). This is indeed what is observed, within the IR accuracy of 20%.

Figure 5 : Evolution of the thermal time constants of defective tiles and reference pick-up points during 2006.

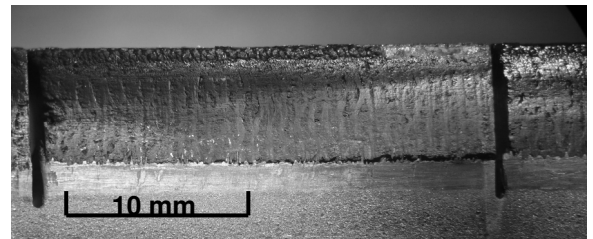
During the summer of 2007, Q6A was temporarily removed from the torus, in order to draw 9 element samples (DITS project, aiming at deuterium trapping investigations). The occasion is used to remove the first element of the sector, containing the defect A. Once examined by the side, a crack of 75% of the bond is evidenced (Fig 6). The crack is seen on both sides, to about the same length. It indicates that the defect is certainly continuous throughout the bond. It is now a transverse band defect, and it is an evolution from the initial estimate that it was a corner defect. A thermal non destructive test is done, using the SATIR test bed (Table 1). The ΔT_{SATIR} is measured to 21.8°. This is an increase by a factor 15 compared to the initial value, stressing how much the heat transfer has been degraded. It is remarkable to experience that the element is still functional at half its design heat flux with a so large defect : with a 75% defect, the cooling by the heat sink is still highly efficient as the tile is cooled in less than 15 seconds.

Figure 6 : Photo of the damaged bond (side view of the flat tile bond). The copper heat sink is on the bottom, the carbon tile above it. The heat flux comes on the top of the tile.

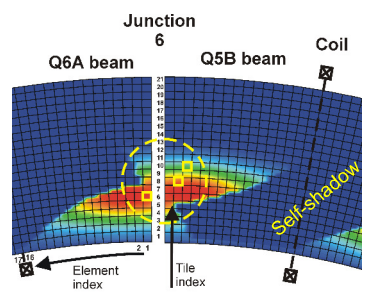
Location of the defective tiles on a calculated heat flux map (scale : blue is no heat flux, red is peak)

Assessment of critical heat flux risk :
 2D calculations ($v = 9$ m/s, $P_{out} = 2.4$ MPa, $T_{out} = 135$ °C)
 Tile / copper interface defect of 80 % @ 5 MW/m²,
 safety factor of wall critical heat flux is 2.8
 For 10 MW/m², tile surface sublimates,
 the critical heat flux safety factor remains around 1.8

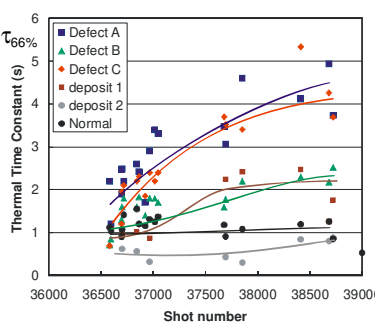
Thermal time constant is evaluated during the rapid cool down following a disruption.

- Normal is constant
- Deposit : small or no increase
- Defects : increase of 300%
