Thermal loads in gaps between ITER divertor monoblocks: first lessons learnt from WEST

J.P. Gunn, J. Bucalossi, Y. Corre, M. Diez, E. Delmas, N. Fedorczak, A. Grosjean, M. Firdaouss, J. Gaspar, T. Loarer, et al.

J.P. Gunn, J. Bucalossi, Y. Corre, M. Diez, E. Delmas, et al.. Thermal loads in gaps between ITER divertor monoblocks: first lessons learnt from WEST. Nuclear Materials and Energy, 2021, 27, pp.100920. cea-03202595

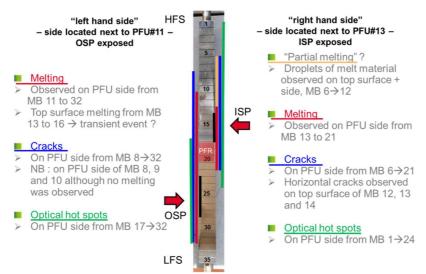
A detailed survey of the damage to PFU#12 is compiled in Figure 3. During the flat top phase, and depending on the X-point height, the outer strike point (OSP) can impinge on the left hand side of MBs 23 to 28, and the inner strike point on the right hand side of MBs 14 to 17. Despite being on the trailing edges of MBs 13 to 16, a significant amount of melting was observed there half way through the C3 campaign by the robotic articulated inspection arm that can penetrate into the tokamak and take photos under vacuum [10]. Melt layer motion and splashing of liquid W were clearly observable. Similar localized damage was not observed on any other PFUs. Furthermore, at the end of the campaign (Figure 4), the zone showed no evidence of evolution, leading us to believe that it was induced by a single event. The impact on the trailing edge of the MBs suggests that perhaps a disruption or even an impact of runaway electrons was responsible during the final instants when the magnetic equilibrium was collapsing. There was no evidence that the presence of this damage hindered the experimental campaign. Indeed, we were unable to find any precise data that would indicate when it occurred.

Figure 3. Summary of observed damage on misaligned PFU#12. The zones where the strike points impacted the divertor are indicated by black bars. Red bars indicate MBs on which leading edge melting occured. Blue bars indicate the presence of cracks (mostly vertical but some horizontal). Green bars indicate clear evidence for optical hot spots.

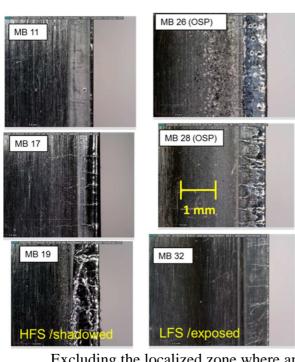
Figure 5. Images of MBs on the left hand side of PFU#12. The discoloured band is 0.8 mm wide and corresponds to the misalignment of the PFU with respect to its neighbour, PFU#11. Cracks (mostly vertical) and deformation (or perhaps fine scale melting, to be confirmed) are observed. The crack density and the severity of the deformation/melting decrease towards the extremities of the affected zone, and seem to be the most severe at the location of the OSP. See Figure 1 for the locations of the MBs on the PFU.

Excluding the localized zone where an exceptional melting event occurred, the leading edges from MB#8 to MB#32 on the left hand side of the PFU show a number of interesting features (Figure 5). On the front faces of the MBs, a discoloured band ~0.8 mm high is visible. This corresponds exactly to the misalignment of PFU#12 with respect to its neighbour, PFU#11. There are a number of vertical cracks that often extend to the bottom of the plasma-wetted surface, but sometimes penetrating deeper into the shadowed area. The cracks are separated typically by 0.2 to 1.0 mm in the poloidal direction. The crack density is lower at the poloidal extremities of the affected area, and higher around the OSP location. Small scale melting is observed from MB#11 to MB#32 (again, excluding MB#13-16 where the severe melting event occurred). At the poloidal extremities of the damaged region the melting seems to be limited to the sharp leading edge, whereas towards the center of the

region, both on HFS and LFS MBs, the melting can occur over the entire depth of the exposed surface, notably along the edges of the cracks. It seems that the damage is maximal at the leading edges around the OSP, but it exists even on the trailing edges of MBs at the ISP (both being on the left hand side of the PFU). During start-up and ramp-down, and during disruptions, the strike points sweep poloidally and can lead to heat flux transiently striking the MB trailing edges. That is, during transient movements of the strike points, trailing edges that are nominally shadowed during the flat top phase can briefly become leading edges with respect to the heat flow.

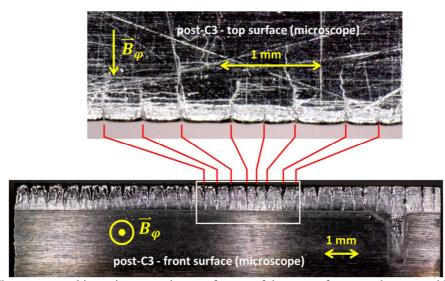
At the top surface the same cracks that are observed on the front surfaces of the MB leading edges are observed to propagate up to ~0.5-1 mm in the toroidal direction (Figure 6). The geometry of the loaded leading edges has changed. It is not possible to conclude whether the volume of metal between the cracks has migrated in the toroidal and poloidal directions, forming a pattern of corrugation, or whether material at the crack locations has gone missing. The poloidal separation between the cracks is very regular, about 0.4 mm on average (there are 31 columnar structures over the 12 mm poloidal MB width). The PFUs were again exposed during the C4 experimental campaign in 2019 and shall be inspected to see how the cracks evolved.

Figure 6. The upper panel is a microscope image of a part of the top surface near the exposed leading edge of MB#29 (left hand side, near OSP). An image of the full poloidal width of the leading edge is shown on the lower panel. Both images were taken after the 2018 (C3) experimental campaign.

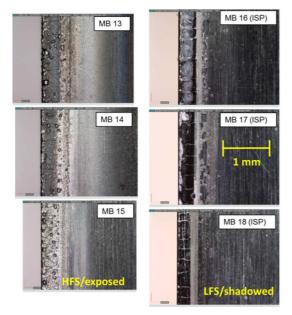
At the right hand side of the PFU around the ISP location (Figure 7), there is also cracking and what appears to be fine scale melting, although the crack density and deformation of the surface are qualitatively less important than at the OSP location (Figure 5). At the leading edges of the MBs that were impacted by the exceptional melting event on their trailing edges, there appear to be metal droplets sticking to the plasma-wetted area.

Figure 7. Side images of MBs on the right hand side of PFU#12, at the ISP. The discoloured band corresponds to the misalignment of the PFU with respect to its neighbour, PFU#13. Vertical cracks and fine scale melting are observed. On the leading edges of MBs#13-15, that were severely melted at their trailing edges, there appear to be droplets of liquid metal that stuck to the plasma-wetted area. See Figure 1 for the locations of the MBs on the PFU.
