# Thermal loads in gaps between ITER divertor monoblocks: first lessons learnt from WEST

#### Abstract

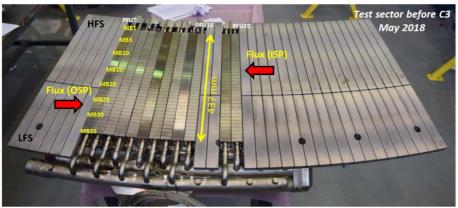
Figure 1. Photograph of the WEST lower divertor sector that was equipped with 12 ITER-like PFUs for the C3 experimental campaign. PFUs are numbered from 1 to 38 running in the toroidal direction (from left to right on the image), and the MBs are numbered from 1 to 35 running in the poloidal direction from the HFS to the LFS. The poloidal length of the ITER-like PFUs (437 mm) is indicated. The remaining PFUs are made of graphite with a 15  $\mu$ m coating of W. The direction of the parallel heat flux is indicated at the inner and outer strike points (ISP and OSP).

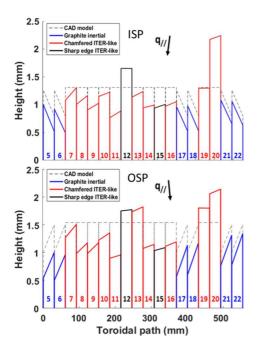
During the third WEST experimental campaign in the second half of 2018 (referred to as the C3 campaign), one of the lower divertor sectors was partially equipped with 12 actively cooled ITER-like PFUs provided by three different suppliers (3 from China, 3 from Japan, and 6 from Europe), each of which has 35 MBs (Figure 1) of 12 mm poloidal width separated by 0.5 mm toroidal gaps. They were monitored by a very-high-resolution infrared camera ( $3.9\mu$ m wavelength, minimum temperature threshold ~ $300^{\circ}$ C, 0.1 mm/pixel) [7]. The ITER-like PFUs were not beveled; some of them had 1 mm chamfers at both leading and trailing edges, while others had sharp edges. While most of the PFUs were aligned within the ITER tolerances (at most ±0.3 mm perpendicular steps between neighbouring PFUs), three of them were not: for example, at the outer strike point (OSP) PFU#7, PFU#12, and PFU#19 were measured to protrude respectively +0.31 mm, +0.79 mm, and +0.63 mm above their neighbours (Figure 2).

Figure 2. Representation of the results of a metrology study before the C3 experimental campaign illustrating the misalignments of the PFUs with respect to their nominal positions (dashed lines). The beveled graphite PFUs are shown in blue, the chamfered W PFUs are in red (the chamfers are not shown here because the exaggerated vertical scale does not yield a useful image), and the W PFUs with sharp edges are in black. These toroidal profiles are centered on MB#17 at the ISP (upper panel), and on MB#25 at the OSP (lower panel). Note that the vertical scale is greatly exaggerated in order to clearly show the misalignments.

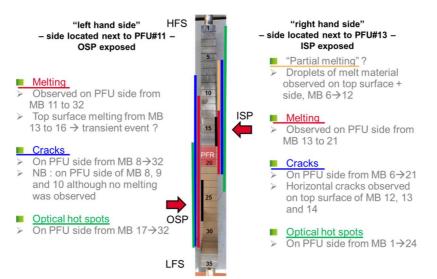
A detailed survey of the damage to PFU#12 is compiled in Figure 3. During the flat top phase, and depending on the X-point height, the outer strike point (OSP) can impinge on the left hand side of MBs 23 to 28, and the inner strike point on the right hand side of MBs 14 to 17. Despite being on the trailing edges of MBs 13 to 16, a significant amount of melting was observed there half way through the C3 campaign by the robotic articulated inspection arm that can penetrate into the tokamak and take photos under vacuum [10]. Melt layer motion and splashing of liquid W were clearly observable. Similar localized damage was not observed on any other PFUs. Furthermore, at the end of the campaign (Figure 4), the zone showed no evidence of evolution, leading us to believe that it was induced by a single event. The impact on the trailing edge of the MBs suggests that perhaps a disruption or even an impact of runaway electrons was responsible during the final instants when the magnetic equilibrium was collapsing. There was no evidence that the presence of this damage hindered the experimental campaign. Indeed, we were unable to find any precise data that would indicate when it occurred.

Figure 3. Summary of observed damage on misaligned PFU#12. The zones where the strike points impacted the divertor are indicated by black bars. Red bars indicate MBs on which leading edge melting occured. Blue bars indicate the presence of cracks (mostly vertical but some horizontal). Green bars indicate clear evidence for optical hot spots.

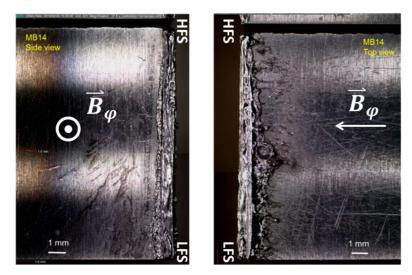
Figure 4. Side (left panel) and top (right panel) views of the trailing edge of MB#14. The images were taken after dismounting PFU#12 following the C3 experimental campaign. Melting of the leading edge to a depth about 1 mm and splashing of the melt layer over a few mm on the top surface are observed.

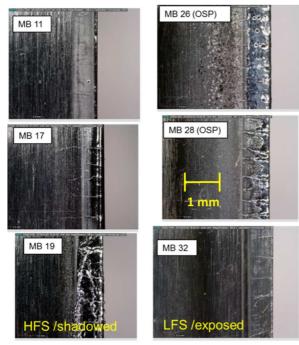
Figure 5. Images of MBs on the left hand side of PFU#12. The discoloured band is 0.8 mm wide and corresponds to the misalignment of the PFU with respect to its neighbour, PFU#11. Cracks (mostly vertical) and deformation (or perhaps fine scale melting, to be confirmed) are observed. The crack density and the severity of the deformation/melting decrease towards the extremities of the affected zone, and seem to be the most severe at the location of the OSP. See Figure 1 for the locations of the MBs on the PFU.

Excluding the localized zone where an exceptional melting event occurred, the leading edges from MB#8 to MB#32 on the left hand side of the PFU show a number of interesting features (Figure 5). On the front faces of the MBs, a discoloured band ~0.8 mm high is visible. This corresponds exactly to the misalignment of PFU#12 with respect to its neighbour, PFU#11. There are a number of vertical cracks that often extend to the bottom of the plasma-wetted surface, but sometimes penetrating deeper into the shadowed area. The cracks are separated typically by 0.2 to 1.0 mm in the poloidal direction. The crack density is lower at the poloidal extremities of the affected area, and higher around the OSP location. Small scale melting is observed from MB#11 to MB#32 (again, excluding MB#13-16 where the severe melting event occurred). At the poloidal extremities of the damaged region the melting seems to be limited to the sharp leading edge, whereas towards the center of the

region, both on HFS and LFS MBs, the melting can occur over the entire depth of the exposed surface, notably along the edges of the cracks. It seems that the damage is maximal at the leading edges around the OSP, but it exists even on the trailing edges of MBs at the ISP (both being on the left hand side of the PFU). During start-up and ramp-down, and during disruptions, the strike points sweep poloidally and can lead to heat flux transiently striking the MB trailing edges. That is, during transient movements of the strike points, trailing edges that are nominally shadowed during the flat top phase can briefly become leading edges with respect to the heat flow.

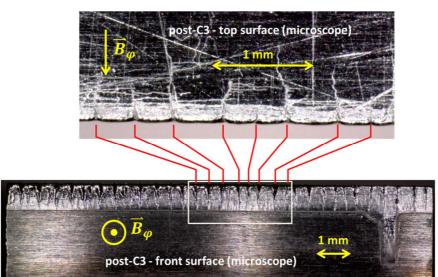
At the top surface the same cracks that are observed on the front surfaces of the MB leading edges are observed to propagate up to ~0.5-1 mm in the toroidal direction (Figure 6). The geometry of the loaded leading edges has changed. It is not possible to conclude whether the volume of metal between the cracks has migrated in the toroidal and poloidal directions, forming a pattern of corrugation, or whether material at the crack locations has gone missing. The poloidal separation between the cracks is very regular, about 0.4 mm on average (there are 31 columnar structures over the 12 mm poloidal MB width). The PFUs were again exposed during the C4 experimental campaign in 2019 and shall be inspected to see how the cracks evolved.

Figure 6. The upper panel is a microscope image of a part of the top surface near the exposed leading edge of MB#29 (left hand side, near OSP). An image of the full poloidal width of the leading edge is shown on the lower panel. Both images were taken after the 2018 (C3) experimental campaign.
