# ANALYSIS OF AN IN-SERVICE RUPTURE OF THE INNER FIRST WALL OF TORE SUPRA

R Mitteau, P Chappuis, G Martin, S Rosanvallon

R Mitteau, P Chappuis, G Martin, S Rosanvallon. ANALYSIS OF AN IN-SERVICE RUPTURE OF THE INNER FIRST WALL OF TORE SUPRA. Fusion Engineering and Design, 2001, 56-57, pp.445-449. 10.1016/S0920-3796(01)00321-0 . cea-03261826

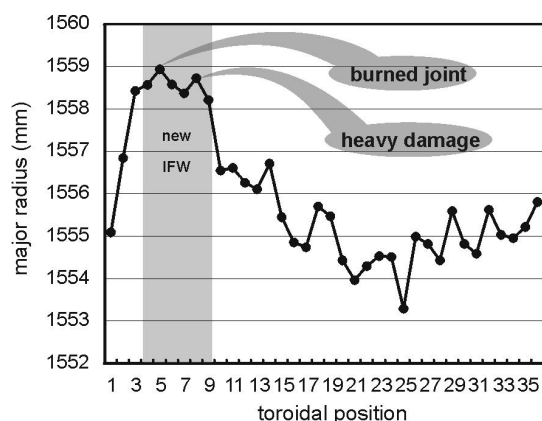
fig. 1 : toroidal profile of the Inner First Wall

The failure occurred  $10^\circ$  under the equatorial plane. The IFW is not perfectly toroidal, and the new panels were installed a few millimetres forward to be tested more thoroughly. The failure is located on the most advanced panel (see Fig. 1), and the second most advanced is also strongly damaged. It is stunning to see that tiles recessed from only 5 tenth of millimetres are untouched. This give hints of the narrowness of the phenomenon involved. The location of the accident indicates that it is bound to be related to the plasma, the failed tile being the one defining the last closed flux surface. In a poloidal section, the contact should be in the equatorial plane, but slight deformations of the plasma frontier may locate the contact point on the lower row of tiles that was actually touched

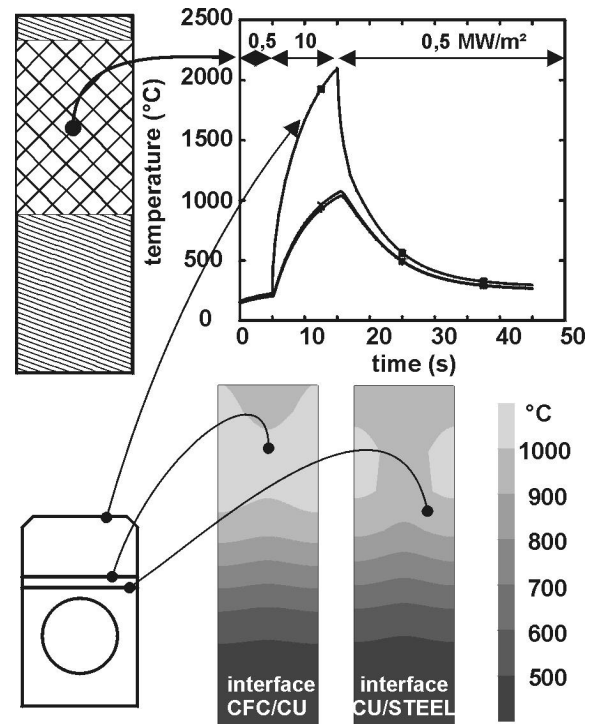
Fig. 2 : time - evolution of the temperature and temperature of brazed bonds at  $t = 15$  s

A thermal transient calculation (Fig. 2) shows that this condition is obtained for a mean incident heat flux of  $10 \text{ MW/m}^2$  over half the surface of the tile. This is ten times more than the nominal value of the structure (which was designed for  $1 \text{ MW/m}^2$ ) and five time more than the toughest test realised on it ( $2 \text{ MW/m}^2$  on the EB200 facility). Under these conditions, the interface between copper and the steel tube reaches the copper melting temperature of  $1083^\circ\text{C}$  in 10 seconds, necessary to explain the ejection of the copper. At the same time, the copper plate under the normal heat flux of  $0.5 \text{ MW/m}^2$  is still under  $500^\circ\text{C}$ . This is the reason why the tile can have stayed well bonded to the heat sink, the interfaces still holding strongly in this area. With this combination of events, the flux incoming on the heavily loaded part of the tile is still passed on to the copper and to the stainless steel, increasing the power load on it and leading ultimately to the

failure of the inner tube before complete detachment of the tile.

Two mechanisms are possible for the rupture of the stainless steel tube : firstly an overheating of the tube, leading to a cracking of the stainless steel, and secondly a critical heat flux in the water of the cooling circuit, which occur at 6 MW/m<sup>2</sup> incident for the hydraulic conditions of that shot. At that stage, it is not possible to distinguish between the two (see section 5 for further investigations about this.).

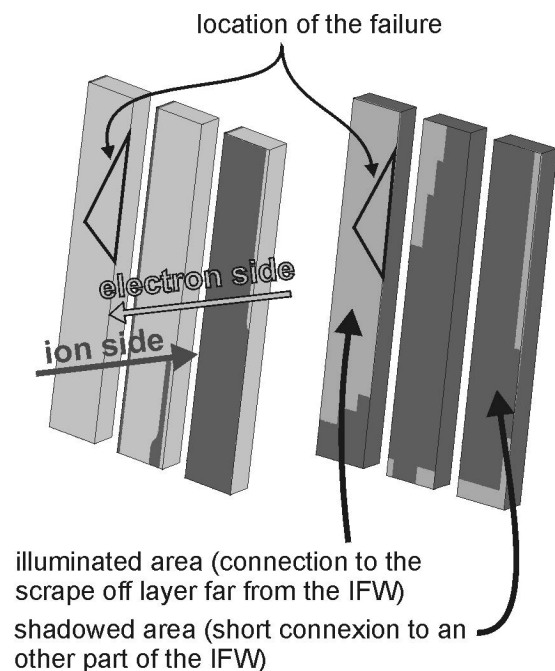
Fig. 3 : particle deposition on the IFW

The simulation gives some hints on the heat flux reaching the tile (Fig. 3). The tile is connected to the electron side, thus enabling the hypothesis of supra thermal electrons [5]. The eroded location is actually wetted by the heat flux, not being shadowed by the IFW itself as other tiles (Fig 3.b). A precise value of e-folding length can however hardly be given, because it would be a result of the adjustment of the simulation to the observation of the surface temperature field. As the parameter has an order of magnitude smaller than a millimetre, the correlation would require to know the geometry of the wall and the plasma frontier with an accuracy smaller than that, which is not the case.

3.a : drift sides 3.b : IFW-shadowed areas

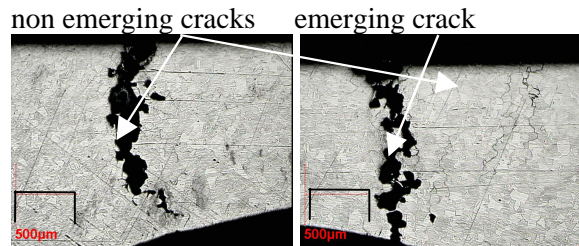
Fig. 4 : microstructure of the failed structure

The damaged structure was investigated by metallography. The copper has indeed been blown-up, possibly by water vapour coming with the 2.8 MPa pressure from the inside of the tube. A crater is observed where the copper once stood. The tile and the square tube have retained their external shape and are covered by a thin copper layer. Many cracks are found in the stainless steel tube, where the wall thickness is the smallest. Some of these cracks are emerging, which was the cause for the water leak. Non - emerging cracks show all stages of the formation. The cracks are initiated on the copper side and progress towards the inside, speaking for a rupture caused by excessive heat flux rather than by critical heat flux. The cracks are intergranular, reminiscent of a slow crack progression. This speaks also in favour of a progressive damaging of the structure, well compatible to the flux excess, whereas a critical heat flux is a faster event. Copper is present as dendrites in the cracks. Cracking may have be facilitated

by the presence of liquid copper, which penetrates the grain boundaries of the stainless steel, causing their embrittlement.

A pattern of corrosion is observed in the tube around the crack, indicating the steel has heated up to around 600°C. There is however no loss of material and the corrosion is more likely to be a consequence of the accident than its cause. No changes in the structure of the carbon fibre reinforced carbon of the tile are observed.
