ANALYSIS OF AN IN-SERVICE RUPTURE OF THE INNER FIRST WALL OF TORE SUPRA

R Mitteau, P Chappuis, G Martin, S Rosanvallon

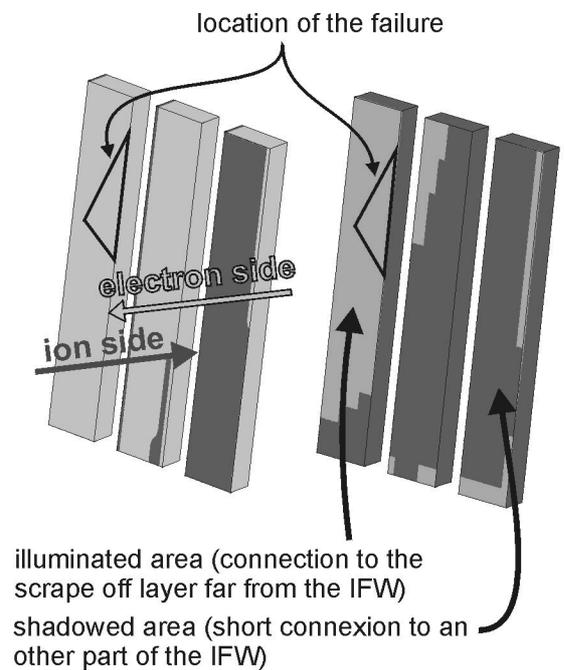
3.a : drift sides 3.b : IFW-shadowed areas

Fig. 3 : particle deposition on the IFW

The simulation gives some hints on the heat flux reaching the tile (Fig. 3). The tile is connected to the electron side, thus enabling the hypothesis of supra thermal electrons [5]. The eroded location is actually wetted by the heat flux, not being shadowed by the IFW itself as other tiles (Fig 3.b). A precise value of e-folding length can however hardly be given, because it would be a result of the adjustment of the simulation to the observation of the surface temperature field. As the parameter has an order of magnitude smaller than a millimetre, the correlation would require to know the geometry of the wall and the plasma frontier with an accuracy smaller than that, which is not the case.
