Insight on High Temperature Hydrogen Attack initiation and morphology on case studies - 3D FIB-SEM and TEM analyses for fine microstructural characterization of attacked low carbon steels

Camille Flament^{1*}, Olivier Gillia¹, Thomas David¹, Romain Soulas¹, Laure Guetaz¹, Charles Le Nevé², Raphaël Goti²

¹. Université Grenoble Alpes, CEA - LITEN, Grenoble, France

². TotalEnergies, Total Research and Technology Gonfreville, Harfleur, France

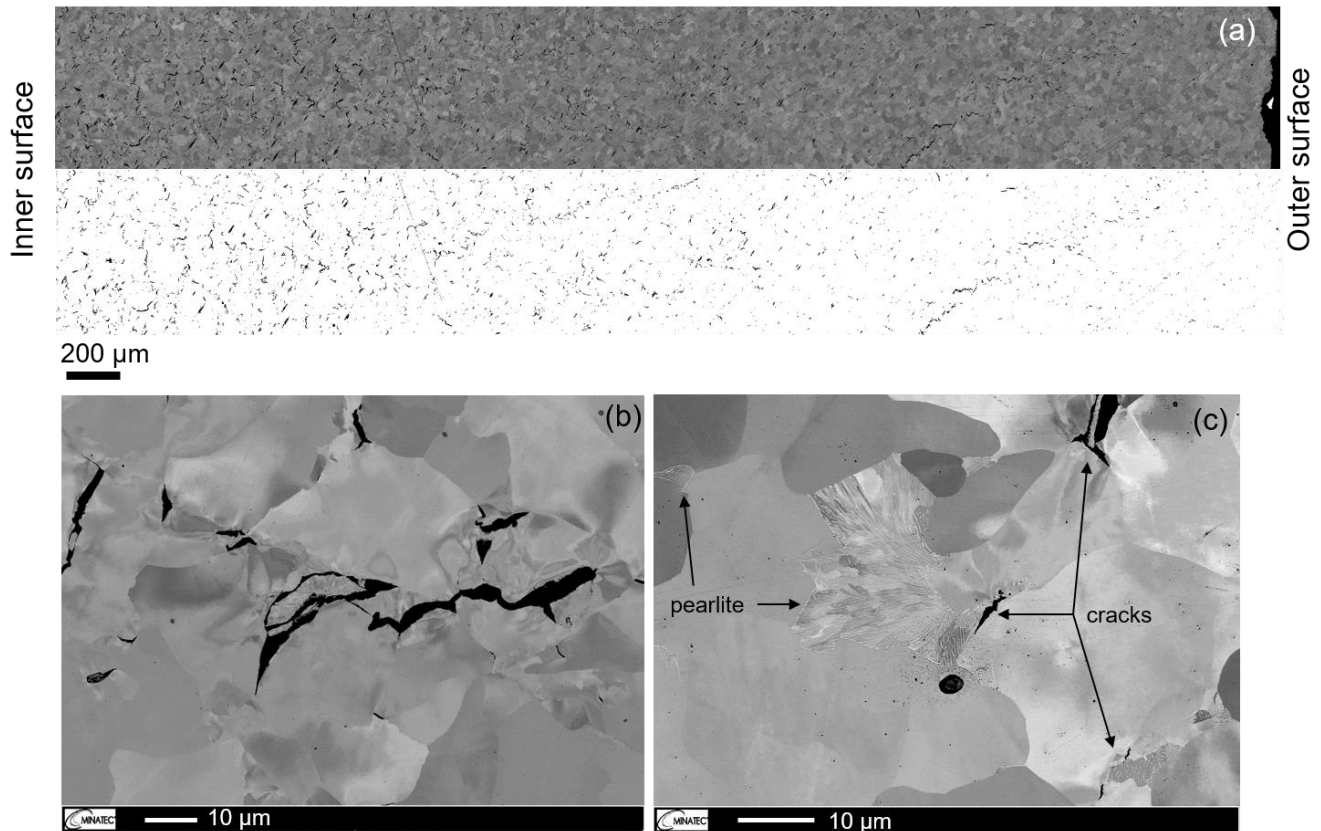
A careful attention has been paid to the location of initiation and the morphology evolution of defects (bubbles/voids, cracks) on the different case studies of this work. On a much-attacked C-steel vessel coming from a CO-methanation tube, observations at micron scale by optical microscopy and SEM reveal a particular attack profile with orthoradial intergranular cracks near the inner surface submitted to hydrogen atmosphere and radial near the outer surface. Pearlite grains, which are constituted of packets of cementite carbides plates distributed in a same ferrite grain, are preferentially attacked since their amount decreases approaching inner surface (Figure 1). This induces a surface decarburization and a weakening of the steel from the inner surface. On a much less attacked vessel coming from a hydrofinishing reactor, SEM observations from inner surface show that voids decorate some pearlite grains. They are located at the interface between cementite and ferrite as well as at grain boundaries. No crack has been noted for this stage of attack in this microstructure. 3D FIB-SEM technique has allowed to visualize in three dimensions the link between voids, carbon phases and inclusions distributed along particular planes which can cross several ferrite and pearlite grains (Figure 2). When a plane rich in inclusions intercepts a grain of pearlite or a grain boundary, voids are detected. Associated to TEM

Figure 1. Characterization of much-attacked steel microstructure. (a) SEM observations from the inner (left) to the outer (right) surface of a piece of attacked tube as well as the image analysis by Image J showing cracks in black. (c,d) SEM observations of intergranular cracks at different magnifications showing their relation with pearlite grains.

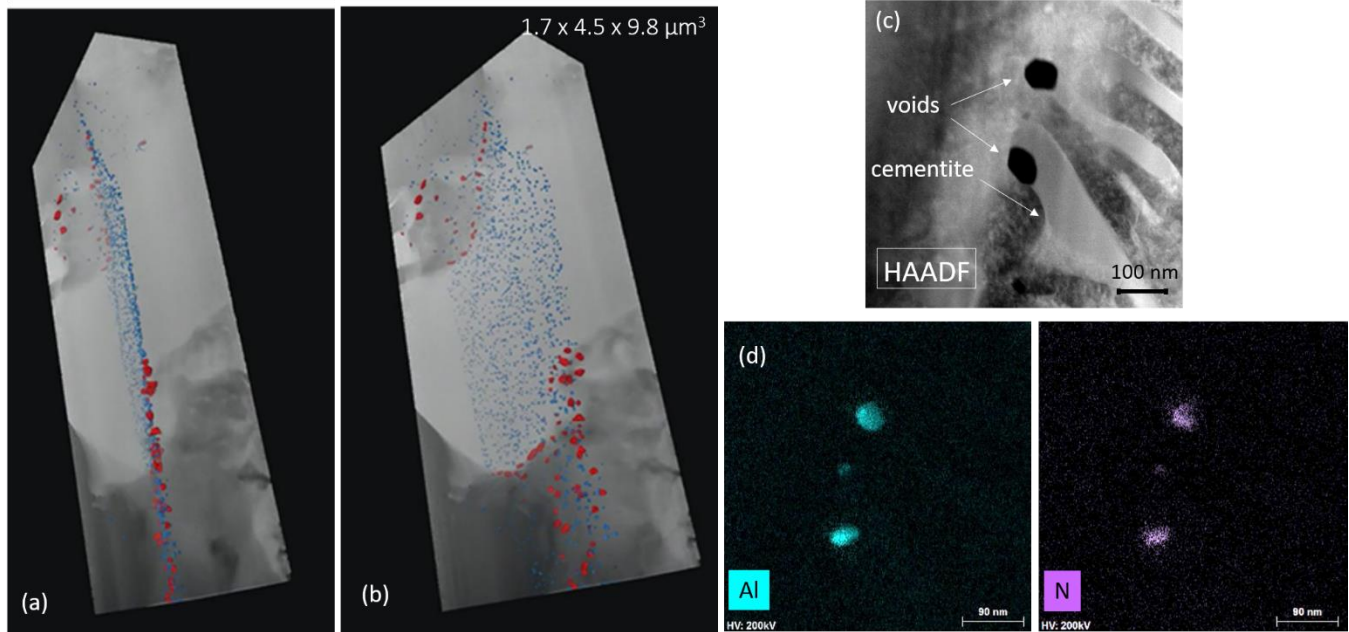
observations, it has been shown that the small inclusions observed both close to voids and carbon phases are mainly nanometric AlN precipitates. They could be a catalyst of voids nucleation. It shows that the advanced characterization techniques used in this study are very powerful for understanding the early hydrogen attack stage and as far as our knowledge, only very few articles [4] describe such combination of fine characterizations in order to highlight the trigger of HTHA.

Figure 2. Characterization of less-attacked steel microstructure. (a,b) 3D view of an alignment of small inclusions (blue objects) in ferrite (light grey) linked to voids nucleation (red objects) when the inclusion plane interferes with the carbon phase - cementite (dark grey) (volume dimension : $1.7 \times 4.5 \times 9.8 \mu\text{m}^3$). (c) STEM-HAADF (high angle annular dark field) image showing voids at carbides interface with the matrix. (d) Al and N EDX maps suggesting inclusions in voids can be AlN precipitates.
