Insight on High Temperature Hydrogen Attack initiation and morphology on case studies - 3D FIB-SEM and TEM analyses for fine microstructural characterization of attacked low carbon steels

Camille Flament^{1*}, Olivier Gillia¹, Thomas David¹, Romain Soulas¹, Laure Guetaz¹, Charles Le Nevé², Raphaël Goti²

^{1.} Université Grenoble Alpes, CEA - LITEN, Grenoble, France

^{2.} TotalEnergies, Total Research and Technology Gonfreville, Harfleur, France

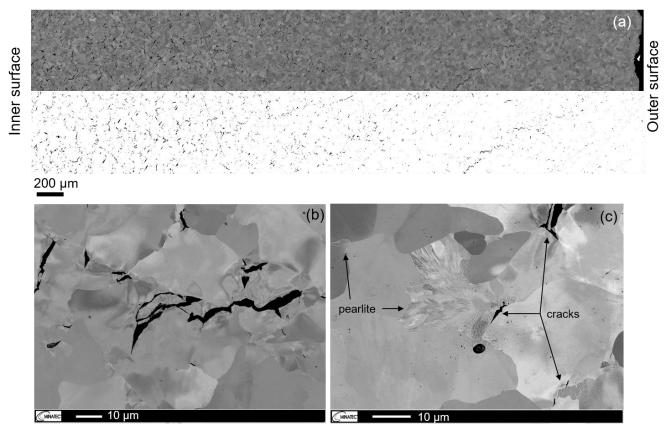
A careful attention has been paid to the location of initiation and the morphology evolution of defects (bubbles/voids, cracks) on the different case studies of this work. On a much-attacked C-steel vessel coming from a CO-methanation tube, observations at micron scale by optical microscopy and SEM reveal a particular attack profile with orthoradial intergranular cracks near the inner surface submitted to hydrogen atmosphere and radial near the outer surface. Pearlite grains, which are constituted of packets of cementite carbides plates distributed in a same ferrite grain, are preferentially attacked since their amount decreases approaching inner surface. On a much less attacked vessel coming from a hydrofinishing reactor, SEM observations from inner surface show that voids decorate some pearlite grains. They are located at the interface between cementite and ferrite as well as at grain boundaries. No crack has been noted for this stage of attack in this microstructure. 3D FIB-SEM technique has allowed to visualize in three dimensions the link between voids, carbon phases and inclusions distributed along particular planes which can cross several ferrite and pearlite grains (Figure 2). When a plane rich in inclusions intercepts a grain of pearlite or a grain boundary, voids are detected. Associated to TEM

Figure 1. Characterization of much-attacked steel microstructure. (a) SEM observations from the inner (left) to the outer (right) surface of a piece of attacked tube as well as the image analysis by Image J showing cracks in black. (c,d) SEM observations of intergranular cracks at different magnifications showing their relation with pearlite grains.

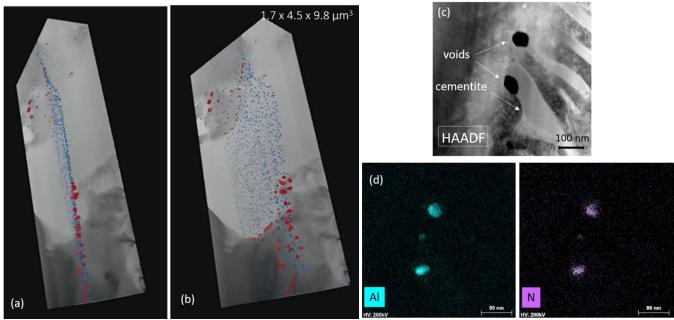
observations, it has been shown that the small inclusions observed both close to voids and carbon phases are mainly nanometric AlN precipitates. They could be a catalyst of voids nucleation. It shows that the advanced characterization techniques used in this study are very powerful for understanding the early hydrogen attack stage and as far as our knowledge, only very few articles [4] describe such combination of fine characterizations in order to highlight the trigger of HTHA.

Figure 2. Characterization of less-attacked steel microstructure. (a,b) 3D view of an alignment of small inclusions (blue objects) in ferrite (light grey) linked to voids nucleation (red objects) when the inclusion plane interferes with the carbon phase - cementite (dark grey) (volume dimension : $1.7 \times 4.5 \times 9.8 \mu m^3$). (c) STEM-HAADF (high angle annular dark field) image showing voids at carbides interface with the matrix. (d) Al and N EDX maps suggesting inclusions in voids can be AlN precipitates.
