Insight on High Temperature Hydrogen Attack initiation and morphology on case studies - 3D FIB-SEM and TEM analyses for fine microstructural characterization of attacked low carbon steels

Camille Flament^{1*}, Olivier Gillia¹, Thomas David¹, Romain Soulas¹, Laure Guetaz¹, Charles Le Nevé², Raphaël Goti²

- ^{1.} Université Grenoble Alpes, CEA LITEN, Grenoble, France
- ² TotalEnergies, Total Research and Technology Gonfreville, Harfleur, France
- * Corresponding author: camille.flament@cea.fr

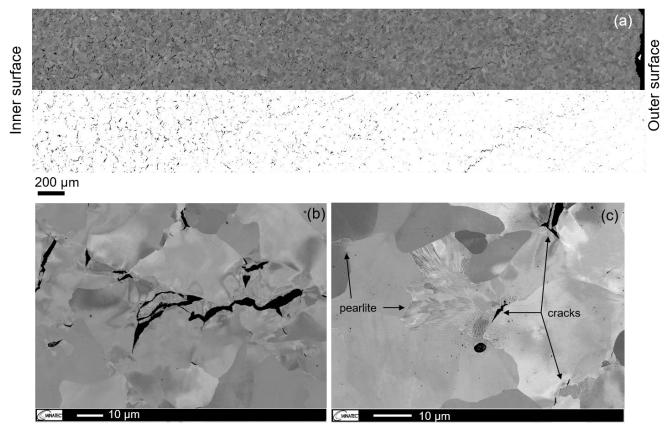
A careful attention has been paid to the location of initiation and the morphology evolution of defects (bubbles/voids, cracks) on the different case studies of this work. On a much-attacked C-steel vessel coming from a CO-methanation tube, observations at micron scale by optical microscopy and SEM reveal a particular attack profile with orthoradial intergranular cracks near the inner surface submitted to hydrogen atmosphere and radial near the outer surface. Pearlite grains, which are constituted of packets of cementite carbides plates distributed in a same ferrite grain, are preferentially attacked since their amount decreases approaching inner surface (Figure 1). This induces a surface decarburization and a weakening of the steel from the inner surface. On a much less attacked vessel coming from a hydrofinishing reactor, SEM observations from inner surface show that voids decorate some pearlite grains. They are located at the interface between cementite and ferrite as well as at grain boundaries. No crack has been noted for this stage of attack in this microstructure. 3D FIB-SEM technique has allowed to visualize in three dimensions the link between voids, carbon phases and inclusions distributed along particular planes which can cross several ferrite and pearlite grains (Figure 2). When a plane rich in inclusions intercepts a grain of pearlite or a grain boundary, voids are detected. Associated to TEM

Figure 1. Characterization of much-attacked steel microstructure. (a) SEM observations from the inner (left) to the outer (right) surface of a piece of attacked tube as well as the image analysis by Image J showing cracks in black. (c,d) SEM observations of intergranular cracks at different magnifications showing their relation with pearlite grains.

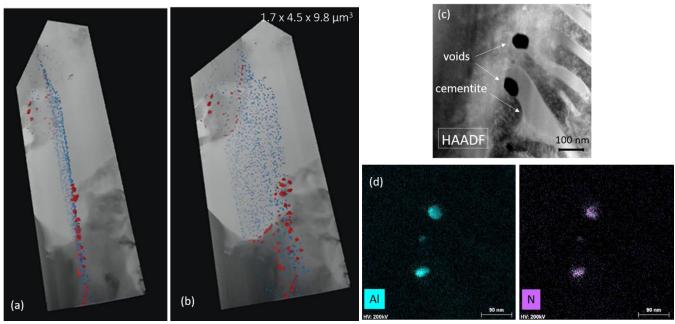
observations, it has been shown that the small inclusions observed both close to voids and carbon phases are mainly nanometric AlN precipitates. They could be a catalyst of voids nucleation. It shows that the advanced characterization techniques used in this study are very powerful for understanding the early hydrogen attack stage and as far as our knowledge, only very few articles [4] describe such combination of fine characterizations in order to highlight the trigger of HTHA.

Figure 2. Characterization of less-attacked steel microstructure. (a,b) 3D view of an alignment of small inclusions (blue objects) in ferrite (light grey) linked to voids nucleation (red objects) when the inclusion plane interferes with the carbon phase - cementite (dark grey) (volume dimension : 1.7 x 4.5 x 9.8 μm³). (c) STEM-HAADF (high angle annular dark field) image showing voids at carbides interface with the matrix. (d) Al and N EDX maps suggesting inclusions in voids can be AlN precipitates.
