Experimental characterization of leading edge cracking on bulk tungsten divertor components during 2017–2019 WEST operation

M. Diez^a, J. Demiane^a, P. Reilhac^a, D. Dorow-Gerspach^b, M. Lemetais^c, J. Gerardin^a, J. Gaspar^d, C. Martin^e, A. Durif^a, M. Wirtz^b, T. Loewenhoff^b, the WEST team¹

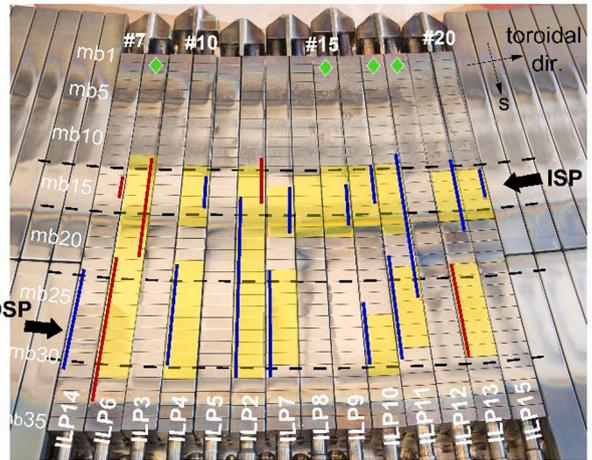
Fig. 2. Photograph of the lower divertor sector after the 2019 campaign (c4) showing the location and the number of monoblocks with cracks on their leading edges.

Fig. 2 shows the configuration of the test divertor sector during the C4 campaign (2019). The 14 ITER-like PFUs installed in toroidal position from 7 to 20 are visible with their ILPi identification. Unchamfered PFUs are indicated by green diamonds, while the location of the inner striking point (ISP) and the outer striking point (OSP) is indicated by black dotted lines.

Microscope observations at the end of C4 revealed that 10 out of the 14 PFUs had cracks on their poloidal edges. Cracks on ILP14 (ISP), ILP6, ILP2 (ISP), ILP13 (OSP) were observed during the shutdown following the C3 campaign and are therefore attributed to C3. On the other hand, cracks on ILP14 (OSP), ILP4, ILP2 (OSP), ILP7, ILP9, ILP10, ILP11, ILP13 (ISP) and ILP15 are believed to have formed during C4. ILP3, ILP5 and ILP8 did not reveal cracks at the end of C4 because their leading edges were not exposed to the plasma (negative vertical misalignment). Similarly, ILP9 and ILP15 had no cracks in the OSP because their leading edges were negatively misaligned (shadowed by their upstream neighbors). There are no data associated with unchamfered ILP12 because it was not available for the characterization program.

In total, it represents 133 monoblocks with cracks, or 27 % of the monoblocks. The cracks are located on the leading edges of the monoblocks, mainly around the inner and outer strike point areas where plasma heat load is the highest.

Some cracks are also visible on the private flux region (MB19-23) and sometimes on the trailing edges. Unchamfered PFUs show the same behavior in terms of number and location of damaged monoblocks as the chamfered PFUs.

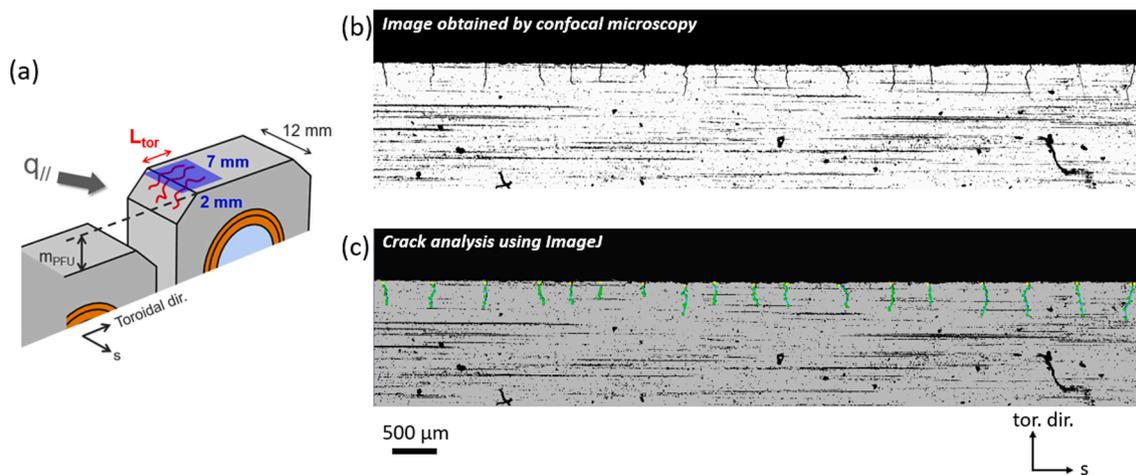
Fig. 1. (a) schematic illustration showing the $7 \times 2\text{ mm}^2$ area on the leading edge where the crack analysis was performed. (b) image obtained by confocal microscopy, here in the case of MB16 ILP4. (c) This image is then analyzed by ImageJ which identifies each crack and calculates its length and density. Here the average crack length was $231\text{ }\mu\text{m}$ and the crack density was $2.71\text{ }\mu\text{m}$ for MB16 ILP4.

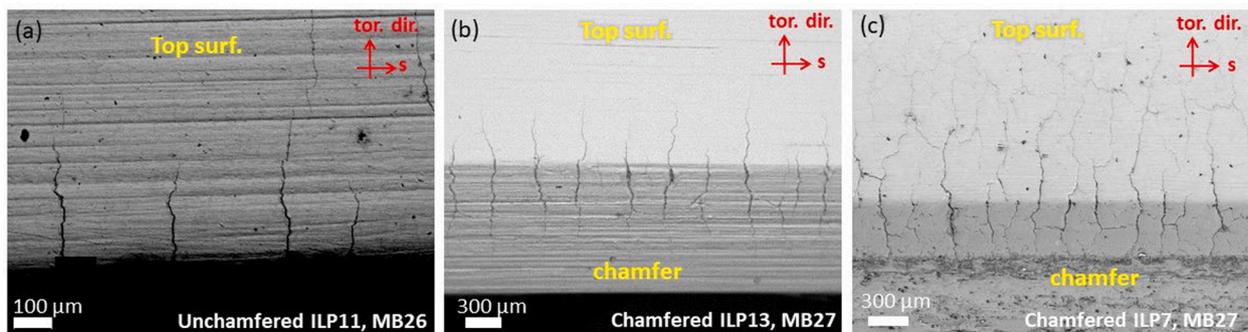
Fig. 3 shows the topography of the leading edge of 3 cracked MBs located in the OSP region, coming from unchamfered ILP11, chamfered ILP13 and chamfered ILP7. The cracks are visible on the top surface of the MBs propagating in the toroidal direction as well as on their poloidal side surfaces. On ILP11 and ILP13, the cracks are neat and quite regularly spaced in the 's' direction. The cracks therefore appear identical on components provided by 2 different manufacturers, independently of the presence or absence of a 1mmx1mm chamfer on the leading edges. Sometimes, but not all the time, there is an alternation of long crack, then short, then long, reminiscent of EAST's proposal for the crack formation process (primary/secondary crack) [8], though never clearly established in WEST.

other components. Numerous interconnected cracks resembling a crack network are visible on the chamfer and top surface, extending several mm in the toroidal direction. To verify this result, MB35 of the same PFU was also observed. A network of micro-cracks was observed on the top surface, despite the fact that this monoblock does not see plasma in the WEST configuration. This suggests that micro-cracks were initiated during the fabrication of the component and then developed during plasma exposure. A comparative metallographic analysis should be carried out on components from different manufacturers to confirm this result.

The photos in Fig. 3 are from observations made after the C4 campaign, but it should be noted that several components were observed after C3 and again after C4, when possible. The PFUs with cracks after C3 and still misaligned during C4 do not show any crack propagation or additional cracks (see Fig. 9 of [9]), suggesting that the cracks are quite stable once they formed.

Fig. 3. SEM images revealing the topography of cracked monoblocks observed on the leading edge in the OSP region (a) MB26 unchamfered ILP11 (b) MB27 chamfered ILP13, (c) MB27 chamfered ILP7.

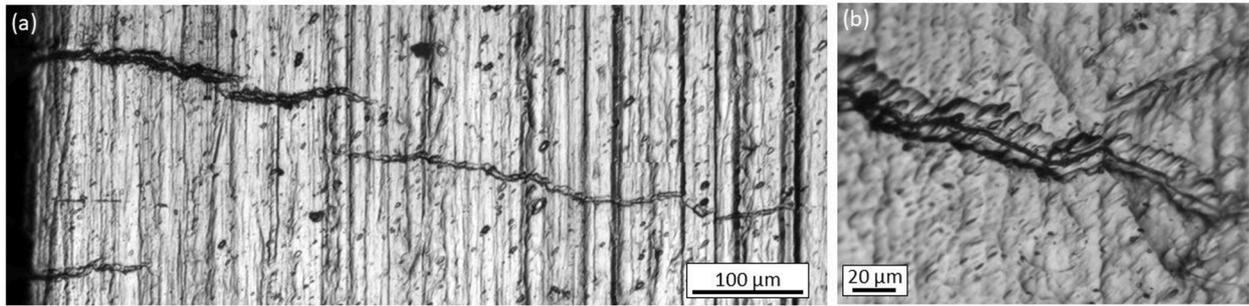
At higher magnification the cracks appear to be discontinuous as illustrated on Fig. 4a. The long cracks observed at low magnification are sometimes the alignment of several small cracks, which do not seem to be connected to each other. At the leading edge, where the crack is most open, crack width was measured around 5–15 μm . Another interesting feature of these cracks is the presence of beads of material on both sides of the crack groove (Fig. 4b). These bumps are observed for almost all cracks, in the OSP region but also in the ISP region, for both unchamfered and chamfered PFUs. No further characterization has been carried out to understand the formation of these material's beads (molten edges? material deformation during crack opening?). They therefore remain an open question today.

Fig. 4. Optical microscope images showing the cracks features on the top surface of unchamfered (a) ilp11, mb27 and (b) ilp13 mb27.

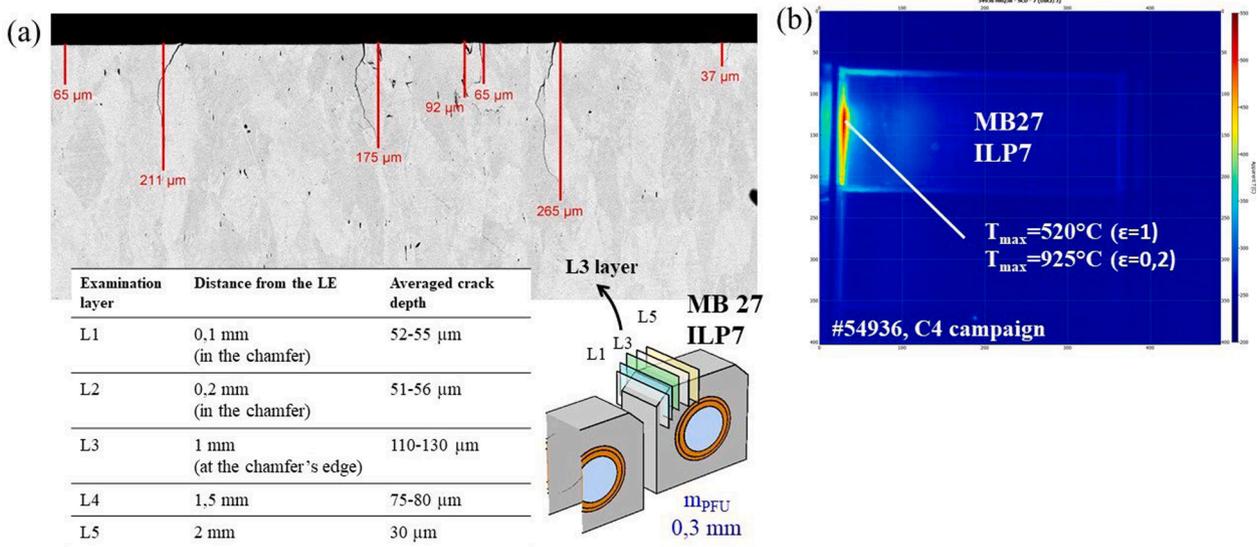
Fig. 5a shows the results obtained for chamfered ILP7 on MB27, which was vertically misaligned by 0.3 mm with respect to its upstream neighbour during C4. The leading edge was progressively grinded and polished up to 2 mm in 5 examination steps, corresponding to examination layers L1 to L5. The crack depth distribution is quite broad, ranging from practically zero to the deepest of around 350 μm on this monoblock. Inside the chamfer, an average crack depth of about 50 μm was measured. Cracks are deepest at the edge of the chamfer, averaging up to 130 μm . Then, as going deeper into the material, the cracks become shallower and shallower, with an average of about 30 μm at 2 mm from the leading edge.

Fig. 5. (a) optical microscopy image showing the crack depth at the edge of the chamfer (examination layer L3) of MB27 ILP7. The table shows the averaged crack depth measured for each examination plan. (b) IR image of the same MB during shot#54936 at t = 12 s when thermal equilibrium is reached.

Although it is difficult to link post-mortem observations to a specific plasma event, infrared cameras can be a good tool when discussing damage to monoblock surfaces [10]. An IR image taken during the C4 campaign (Fig. 5b) (shot#54936, $P_{inj} = 3.5-4.0$ MW, stationary heat flux for at least 6 s, estimated parallel heat flux $70-90$ MW/m²) shows that the monoblock surface can reach $500-900$ °C (depending on emissivity), above the ductile-to-brittle transition temperature.

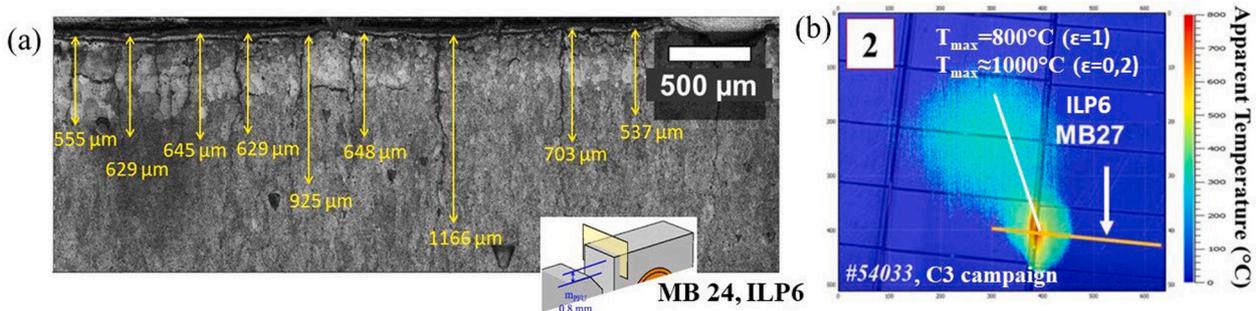
The other component is ILP6, for which cracks were observed after C3 both in the ISP and OSP areas [2]. During C3 this component was highly misaligned (+0.8 mm) and an IR image taken during C3 (Fig. 6b) indicate that the surface temperature of MB27 reached $800-1000$ °C (depending on emissivity) in steady state. A modest parallel heat flux

was estimated at $40-50$ MW/m², which is unlikely to have generated cracks. At that stage, no microstructure observation could be made. The only metallographic analysis was performed after C4 on MB24 (see Fig. 6a). It can be seen that damage is more severe than for the previous MB. A different crack structure is observed, with the presence of cracks parallel to the surface and much longer cracks, measured up to about 1.1 mm. It is also clear that recrystallization of tungsten occurred near the surface. Independently of the cause of recrystallization, the damage is more severe. This difference in damage could be the direct consequences of W recrystallization (degradation in materials properties such as a loss of mechanical strength, fracture toughness and embrittlement) or could be the result of a different initial microstructure of W.

Fig. 6. (a) Optical microscopy image showing the state of damage of the leading edge of MB24 ILP6 after C4 (surface polished over 300 μm). (b) IR image of ILP6 MB27 during shot#54033. The image is taken from [11].

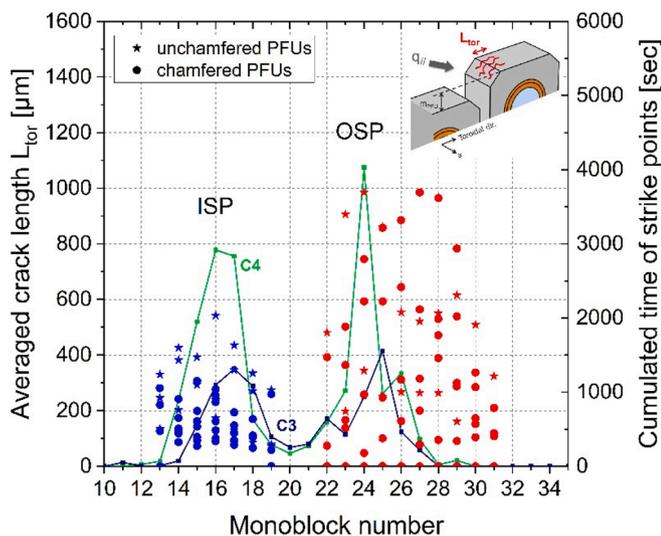
An extensive characterization of all 133 cracked monoblocks enabled us to determine the average length and linear density (number of cracks / mm) of the cracks on each monoblock. Fig. 7 shows that cracks in the OSP region are twice as long as those in the ISP region, with lengths ranging from 0 to 1000 μm in the OSP region and 0 to 500 μm in the ISP region. It should be noted that these values are averages, meaning that cracks can be longer than 1000 μm in some cases. Furthermore, as mentioned in the previous paragraph, cracks are discontinuous and length measurement can therefore be tricky, but this does not change the trend for longer cracks in OSP than in ISP. No difference is observed between chamfered MBs (circular markers) and unchamfered MBs (star markers). As damage is generally related to heat flux, the fact that cracks are more severe in the OSP than in the ISP seems unsurprising due to the in/out asymmetry observed in many tokamaks, which gives rise to higher heat fluxes in the OSP than in the ISP.

The figure also shows the positions of the strike points (SP) during C3 and C4. In the OSP region, the strike point was often positioned very locally on MB24, or even MB25, where the heat flux is supposed to be higher. However, cracks are present over a very wide area from MB22 to MB31. For example, MB30 exhibits cracks up to 300 μm long, despite being located far from the SP zone, where intense steady state heat loads are not expected. Even with the assumption that the peak heat flux shifts 1 or 2 MBs away from the SP, the figure shows that cracking occurred in regions where it was not expected. Such significant damage far from the strike point region reinforces the hypothesis of previous research that disruptions could have a big role to play in cracking mechanisms [2,3,12].

Fig. 7. Average crack length in the toroidal direction, combined with the position of the strike points during the c3/2018 (blue line) and c4/2019 (green line) campaigns. (For interpretation of the references to colour in this figure legend, the reader is referred to the web version of this article.)

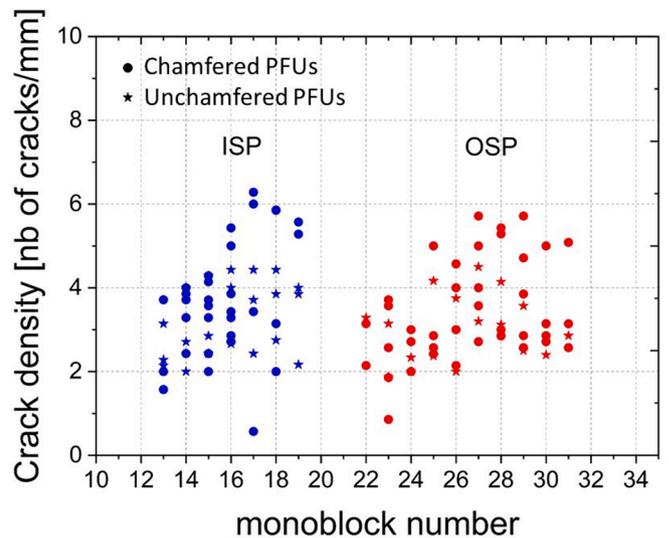
Fig. 8 shows the crack density for each monoblock, i.e. the number of cracks per mm. It is between 2 and 6, i.e. each crack is separated by 0.15 to 0.5 mm in the poloidal direction, whether the monoblock is chamfered or not. It therefore appears that once formed and stable, the cracks have a regular spacing which seems to be an intrinsic behavior of W.

Fig. 8. Crack density for each of the cracked monoblock.

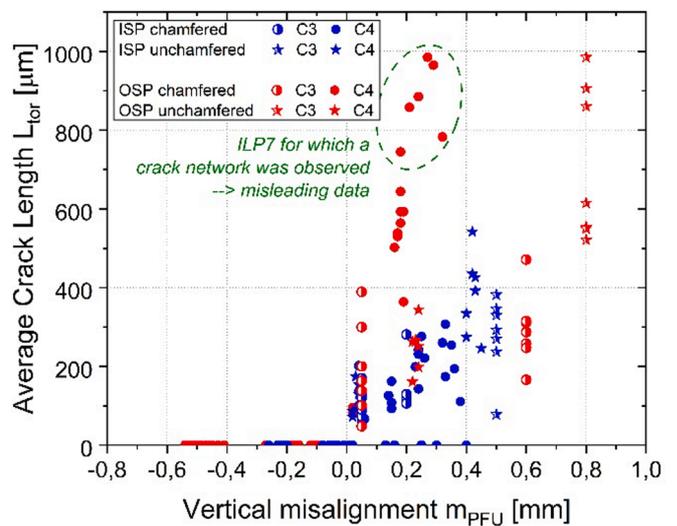
Fig. 9. Measured average crack length versus relative vertical misalignment.

pertains to the C4 campaign. The data points circled in green belong to ILP7, for which a crack network was observed on the leading edge. Compared to the other PFUs with neat cracks (see 3.2), the measurement of the crack length is therefore much more difficult for this PFU and might be inaccurate.

The figure clearly shows that positive misalignment necessarily leads to cracking, as all non-cracked MBs are associated with negative misalignment. With the non-beveled geometry of the MB, the leading edges are not protected, so vertical misalignment plays an important role. Today, there are no alignment tolerances for these non-beveled components (existing tolerances only apply to beveled PFUs), but it can be seen that a misalignment of 0.1–0.2 mm can already result in cracks > 200 μm . The higher the misalignment the longer the cracks.

Although further studies would be needed to better understand the mechanisms behind crack formation, it is evident that a toroidal bevel should be applied to the monoblocks to avoid any risk of damage on the LE during operation. This design is foreseen in ITER and is currently being tested with the lower divertor targets installed in WEST since 2021. So far, no cracks on the LE have been observed.
