# Experimental characterization of leading edge cracking on bulk tungsten divertor components during 2017–2019 WEST operation

## Experimental characterization of leading edge cracking on bulk tungsten divertor components during 2017–2019 WEST operation

During the 2017–2019 WEST operation, a set of ITER-like plasma-facing units consisting of tungsten monoblocks was installed on the lower divertor. Despite modest heating power, 27 % of these monoblocks had cracks on their poloidal leading edges, which were not protected by a toroidal bevel. A comprehensive experimental characterization of the 133 cracked monoblocks indicates that damage occurs near the plasma strike point areas where neat cracks separated by 0.15–0.5 mm in the poloidal direction were observed. Cracks are up to 1 mm long and 1 mm deep and did not affect the lower divertor ability to sustain long pulses. The most important parameter affecting crack formation is the relative vertical misalignment between components.

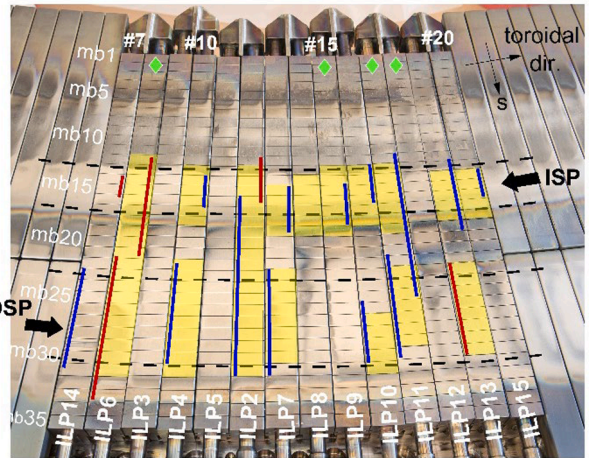
**Fig. 2.** Photograph of the lower divertor sector after the 2019 campaign (c4) showing the location and the number of monoblocks with cracks on their leading edges.

Fig. 2 shows the configuration of the test divertor sector during the C4 campaign (2019). The 14 ITER-like PFUs installed in toroidal position from 7 to 20 are visible with their ILPi identification. Unchamfered PFUs are indicated by green diamonds, while the location of the inner striking point (ISP) and the outer striking point (OSP) is indicated by black dotted lines.

Microscope observations at the end of C4 revealed that 10 out of the 14 PFUs had cracks on their poloidal edges. Cracks on ILP14 (ISP), ILP6, ILP2 (ISP), ILP13 (OSP) were observed during the shutdown following the C3 campaign and are therefore attributed to C3. On the other hand, cracks on ILP14 (OSP), ILP4, ILP2 (OSP), ILP7, ILP9, ILP10, ILP11, ILP13 (ISP) and ILP15 are believed to have formed during C4. ILP3, ILP5 and ILP8 did not reveal cracks at the end of C4 because their leading edges were not exposed to the plasma (negative vertical misalignment). Similarly, ILP9 and ILP15 had no cracks in the OSP because their leading edges were negatively misaligned (shadowed by their upstream neighbors). There are no data associated with unchamfered ILP12 because it was not available for the characterization program.

In total, it represents 133 monoblocks with cracks, or 27 % of the monoblocks. The cracks are located on the leading edges of the monoblocks, mainly around the inner and outer strike point areas where plasma heat load is the highest.

Some cracks are also visible on the private flux region (MB19-23) and sometimes on the trailing edges. Unchamfered PFUs show the same behavior in terms of number and location of damaged monoblocks as the chamfered PFUs.

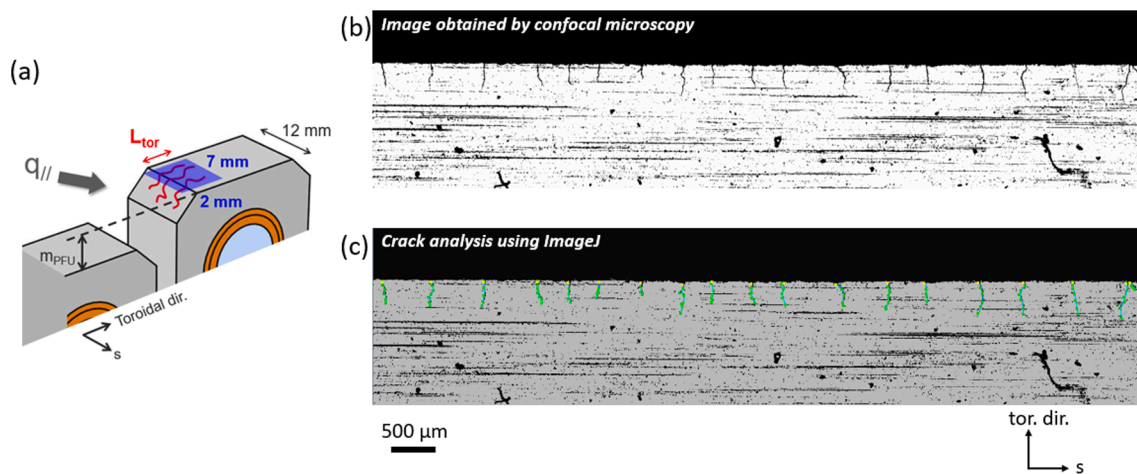
number of pixel and a calibrated scale, the software calculates the length of each crack and thus an average crack length can be given for each monoblock. The crack density was determined by calculating the number of identified cracks and dividing it by the scanned length along the 's' coordinate. This allowed to express the crack density as cracks per millimetre. An example describing the data analysis process for ILP4 MB16 is given in Fig. 1b,c.

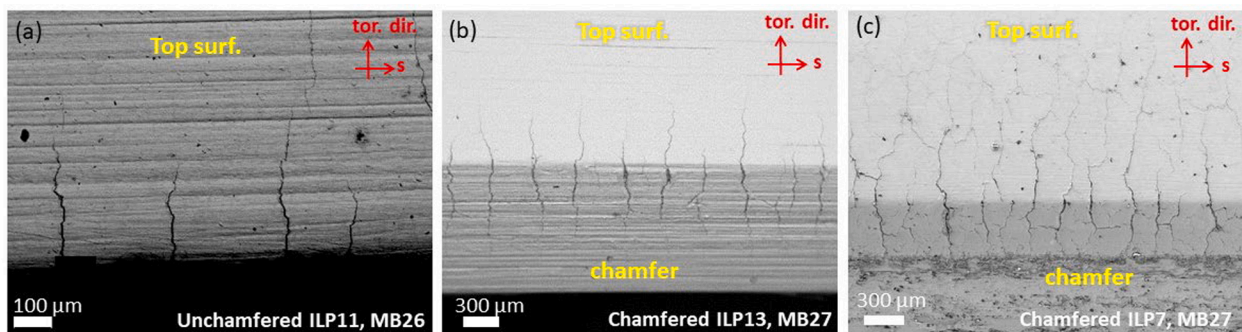
Fig. 3. SEM images revealing the topography of cracked monoblocks observed on the leading edge in the OSP region (a) MB26 unchamfered ILP11 (b) MB27 chamfered ILP13, (c) MB27 chamfered ILP7.

Fig. 3 shows the topography of the leading edge of 3 cracked MBs located in the OSP region, coming from unchamfered ILP11, chamfered ILP13 and chamfered ILP7. The cracks are visible on the top surface of the MBs propagating in the toroidal direction as well as on their poloidal side surfaces. On ILP11 and ILP13, the cracks are neat and quite regularly spaced in the 's' direction. The cracks therefore appear identical on components provided by 2 different manufacturers, independently of the presence or absence of a 1mmx1mm chamfer on the leading edges. Sometimes, but not all the time, there is an alternation of long crack, then short, then long, reminiscent of EAST's proposal for the crack formation process (primary/secondary crack) [8], though never clearly established in WEST.

other components. Numerous interconnected cracks resembling a crack network are visible on the chamfer and top surface, extending several mm in the toroidal direction. To verify this result, MB35 of the same PFU was also observed. A network of micro-cracks was observed on the top surface, despite the fact that this monoblock does not see plasma in the WEST configuration. This suggests that micro-cracks were initiated during the fabrication of the component and then developed during plasma exposure. A comparative metallographic analysis should be carried out on components from different manufacturers to confirm this result.

The photos in Fig. 3 are from observations made after the C4 campaign, but it should be noted that several components were observed after C3 and again after C4, when possible. The PFUs with cracks after C3 and still misaligned during C4 do not show any crack propagation or additional cracks (see Fig. 9 of [9]), suggesting that the cracks are quite stable once they formed.

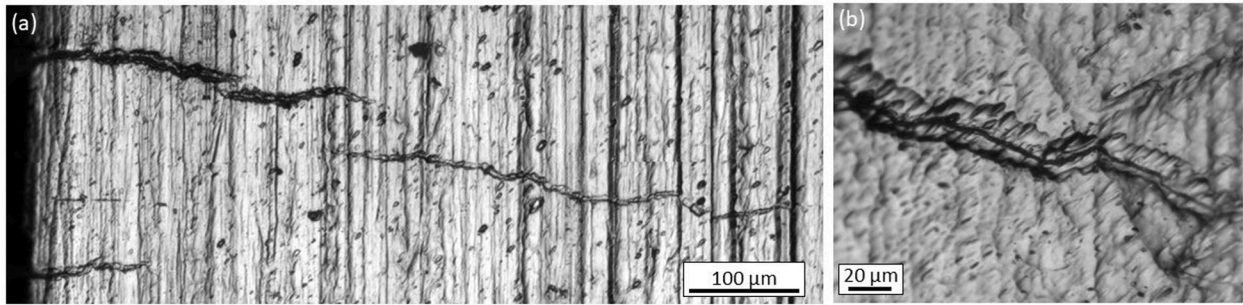
Fig. 4. Optical microscope images showing the cracks features on the top surface of unchamfered (a) ilp11, mb27 and (b) ilp13 mb27.

At higher magnification the cracks appear to be discontinuous as illustrated on Fig. 4a. The long cracks observed at low magnification are sometimes the alignment of several small cracks, which do not seem to be connected to each other. At the leading edge, where the crack is most open, crack width was measured around 5–15  $\mu\text{m}$ . Another interesting feature of these cracks is the presence of beads of material on both sides of the crack groove (Fig. 4b). These bumps are observed for almost all cracks, in the OSP region but also in the ISP region, for both unchamfered and chamfered PFUs. No further characterization has been carried out to understand the formation of these material's beads (molten edges? material deformation during crack opening?). They therefore remain an open question today.

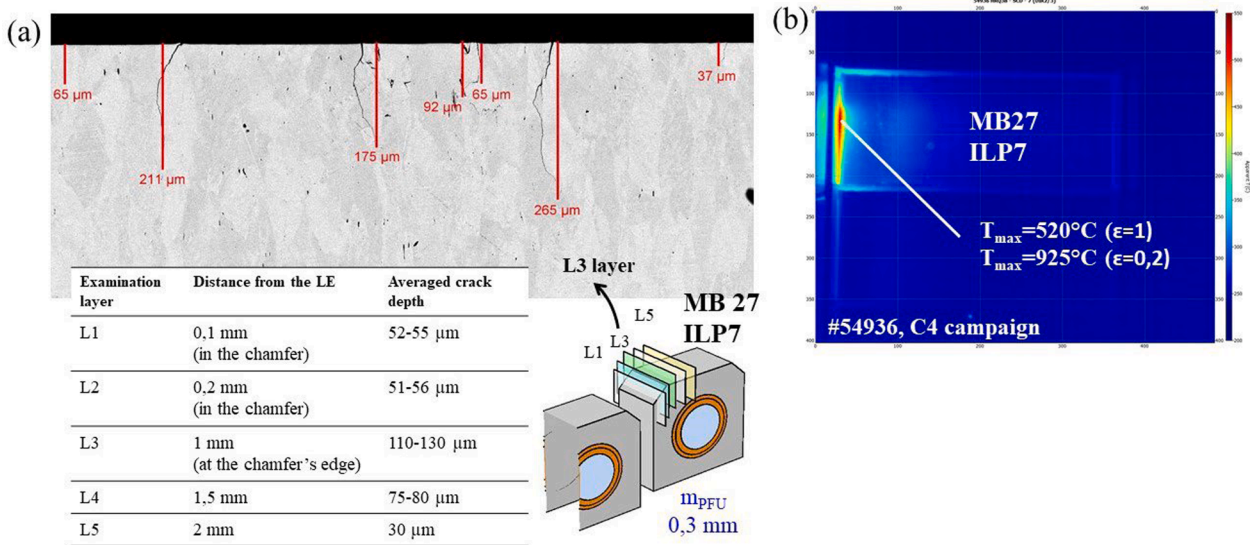
Fig. 5. (a) optical microscopy image showing the crack depth at the edge of the chamfer (examination layer L3) of MB27 ILP7. The table shows the averaged crack depth measured for each examination plan. (b) IR image of the same MB during shot#54936 at  $t = 12$  s when thermal equilibrium is reached.

Fig. 5a shows the results obtained for chamfered ILP7 on MB27, which was vertically misaligned by 0.3 mm with respect to its upstream neighbour during C4. The leading edge was progressively grinded and polished up to 2 mm in 5 examination steps, corresponding to examination layers L1 to L5. The crack depth distribution is quite broad, ranging from practically zero to the deepest of around 350  $\mu\text{m}$  on this monoblock. Inside the chamfer, an average crack depth of about 50  $\mu\text{m}$  was measured. Cracks are deepest at the edge of the chamfer, averaging up to 130  $\mu\text{m}$ . Then, as going deeper into the material, the cracks become shallower and shallower, with an average of about 30  $\mu\text{m}$  at 2 mm from the leading edge.

Although it is difficult to link post-mortem observations to a specific plasma event, infrared cameras can be a good tool when discussing damage to monoblock surfaces [10]. An IR image taken during the C4 campaign (Fig. 5b) (shot#54936,  $P_{inj} = 3.5-4.0$  MW, stationary heat flux for at least 6 s, estimated parallel heat flux  $70-90$  MW/m<sup>2</sup>) shows that the monoblock surface can reach  $500-900$  °C (depending on emissivity), above the ductile-to-brittle transition temperature.

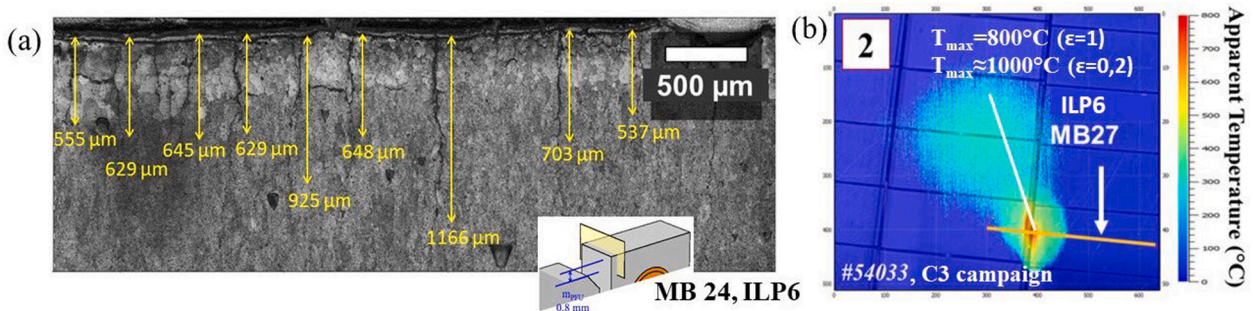
Fig. 6. (a) Optical microscopy image showing the state of damage of the leading edge of MB24 ILP6 after C4 (surface polished over  $300$  μm). (b) IR image of ILP6 MB27 during shot#54033. The image is taken from [11].

The other component is ILP6, for which cracks were observed after C3 both in the ISP and OSP areas [2]. During C3 this component was highly misaligned (+0.8 mm) and an IR image taken during C3 (Fig. 6b) indicate that the surface temperature of MB27 reached  $800-1000$  °C (depending on emissivity) in steady state. A modest parallel heat flux

was estimated at  $40-50$  MW/m<sup>2</sup>, which is unlikely to have generated cracks. At that stage, no microstructure observation could be made. The only metallographic analysis was performed after C4 on MB24 (see Fig. 6a). It can be seen that damage is more severe than for the previous MB. A different crack structure is observed, with the presence of cracks parallel to the surface and much longer cracks, measured up to about 1.1 mm. It is also clear that recrystallization of tungsten occurred near the surface. Independently of the cause of recrystallization, the damage is more severe. This difference in damage could be the direct consequences of W recrystallization (degradation in materials properties such as a loss of mechanical strength, fracture toughness and embrittlement) or could be the result of a different initial microstructure of W.

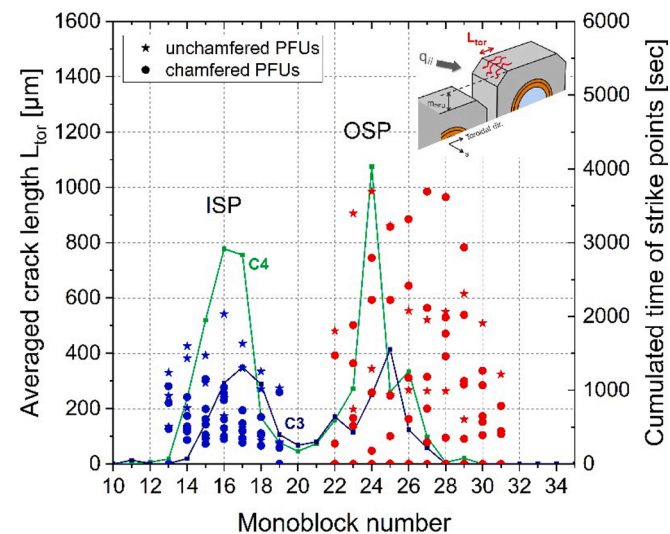
An extensive characterization of all 133 cracked monoblocks enabled us to determine the average length and linear density (number of cracks / mm) of the cracks on each monoblock. Fig. 7 shows that cracks in the OSP region are twice as long as those in the ISP region, with lengths ranging from 0 to 1000  $\mu\text{m}$  in the OSP region and 0 to 500  $\mu\text{m}$  in the ISP region. It should be noted that these values are averages, meaning that cracks can be longer than 1000  $\mu\text{m}$  in some cases. Furthermore, as mentioned in the previous paragraph, cracks are discontinuous and length measurement can therefore be tricky, but this does not change the trend for longer cracks in OSP than in ISP. No difference is observed between chamfered MBs (circular markers) and unchamfered MBs (star markers). As damage is generally related to heat flux, the fact that cracks are more severe in the OSP than in the ISP seems unsurprising due to the in/out asymmetry observed in many tokamaks, which gives rise to higher heat fluxes in the OSP than in the ISP.

The figure also shows the positions of the strike points (SP) during C3 and C4. In the OSP region, the strike point was often positioned very locally on MB24, or even MB25, where the heat flux is supposed to be higher. However, cracks are present over a very wide area from MB22 to MB31. For example, MB30 exhibits cracks up to 300  $\mu\text{m}$  long, despite being located far from the SP zone, where intense steady state heat loads are not expected. Even with the assumption that the peak heat flux shifts 1 or 2 MBs away from the SP, the figure shows that cracking occurred in regions where it was not expected. Such significant damage far from the strike point region reinforces the hypothesis of previous research that disruptions could have a big role to play in cracking mechanisms [2,3,12].

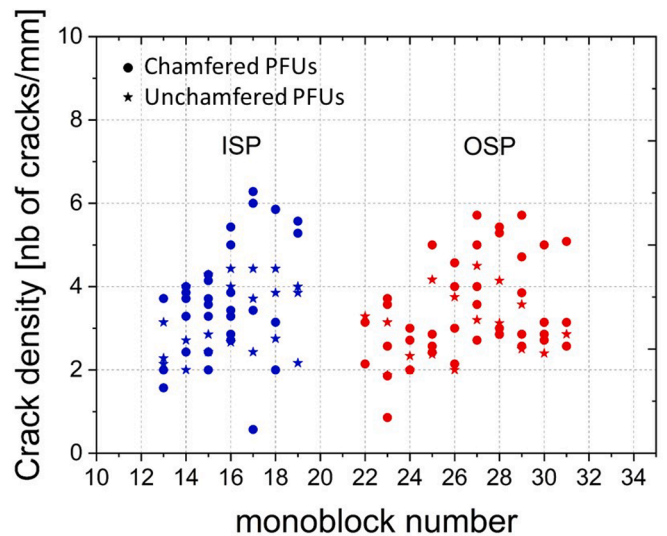
Fig. 8. Crack density for each of the cracked monoblock.

Fig. 8 shows the crack density for each monoblock, i.e. the number of cracks per mm. It is between 2 and 6, i.e. each crack is separated by 0.15 to 0.5 mm in the poloidal direction, whether the monoblock is chamfered or not. It therefore appears that once formed and stable, the cracks have a regular spacing which seems to be an intrinsic behavior of W.

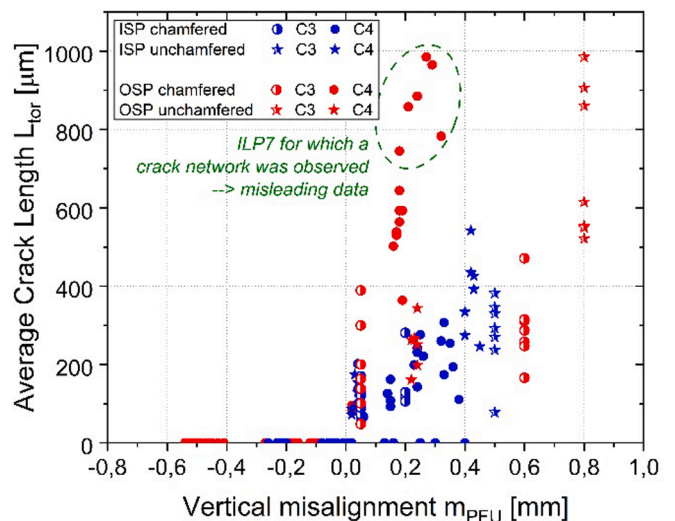
Fig. 9. Measured average crack length versus relative vertical misalignment.

It was then intended to see the variation of the average crack length with respect to the vertical misalignment of the PFUs (Fig. 9). For the cracks believed to have formed during C3, the value of the misalignment of the PFUs during C3 was taken. Otherwise, the misalignment data

pertains to the C4 campaign. The data points circled in green belong to ILP7, for which a crack network was observed on the leading edge. Compared to the other PFUs with neat cracks (see 3.2), the measurement of the crack length is therefore much more difficult for this PFU and might be inaccurate.

The figure clearly shows that positive misalignment necessarily leads to cracking, as all non-cracked MBs are associated with negative misalignment. With the non-beveled geometry of the MB, the leading edges are not protected, so vertical misalignment plays an important role. Today, there are no alignment tolerances for these non-beveled components (existing tolerances only apply to beveled PFUs), but it can be seen that a misalignment of 0.1–0.2 mm can already result in cracks > 200  $\mu\text{m}$ . The higher the misalignment the longer the cracks.

Although further studies would be needed to better understand the mechanisms behind crack formation, it is evident that a toroidal bevel should be applied to the monoblocks to avoid any risk of damage on the LE during operation. This design is foreseen in ITER and is currently being tested with the lower divertor targets installed in WEST since 2021. So far, no cracks on the LE have been observed.
