Experimental characterization of leading edge cracking on bulk tungsten divertor components during 2017–2019 WEST operation

M. Diez^a, J. Demiane^a, P. Reilhac^a, D. Dorow-Gerspach^b, M. Lemetais^c, J. Gerardin^a, J. Gaspar^d, C. Martin^e, A. Durif^a, M. Wirtz^b, T. Loewenhoff^b, the WEST team¹

ABSTRACT

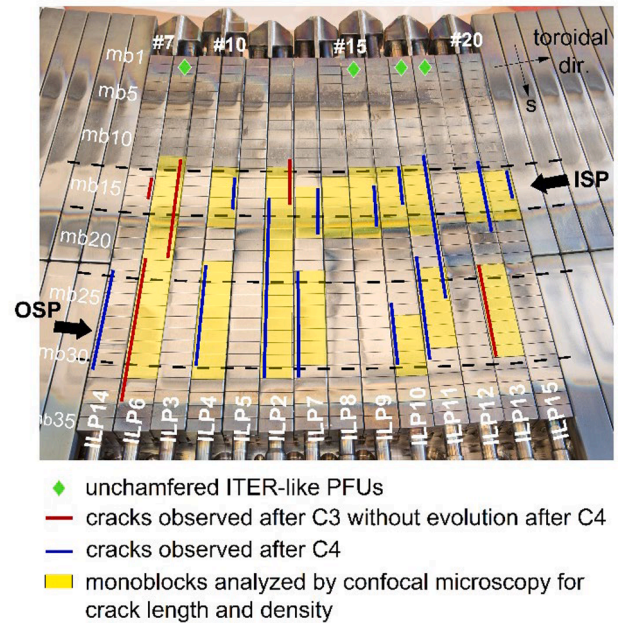
Fig. 2. Photograph of the lower divertor sector after the 2019 campaign (c4) showing the location and the number of monoblocks with cracks on their leading edges.

Fig. 2 shows the configuration of the test divertor sector during the C4 campaign (2019). The 14 ITER-like PFUs installed in toroidal position from 7 to 20 are visible with their ILPi identification. Unchamfered PFUs are indicated by green diamonds, while the location of the inner striking point (ISP) and the outer striking point (OSP) is indicated by black dotted lines.

Microscope observations at the end of C4 revealed that 10 out of the 14 PFUs had cracks on their poloidal edges. Cracks on ILP14 (ISP), ILP6, ILP2 (ISP), ILP13 (OSP) were observed during the shutdown following the C3 campaign and are therefore attributed to C3. On the other hand, cracks on ILP14 (OSP), ILP4, ILP2 (OSP), ILP7, ILP9, ILP10, ILP11, ILP13 (ISP) and ILP15 are believed to have formed during C4. ILP3, ILP5 and ILP8 did not reveal cracks at the end of C4 because their leading edges were not exposed to the plasma (negative vertical misalignment). Similarly, ILP9 and ILP15 had no cracks in the OSP because their leading edges were negatively misaligned (shadowed by their upstream neighbors). There are no data associated with unchamfered ILP12 because it was not available for the characterization program.

In total, it represents 133 monoblocks with cracks, or 27 % of the monoblocks. The cracks are located on the leading edges of the monoblocks, mainly around the inner and outer strike point areas where plasma heat load is the highest.

Some cracks are also visible on the private flux region (MB19-23) and sometimes on the trailing edges. Unchamfered PFUs show the same behavior in terms of number and location of damaged monoblocks as the chamfered PFUs.

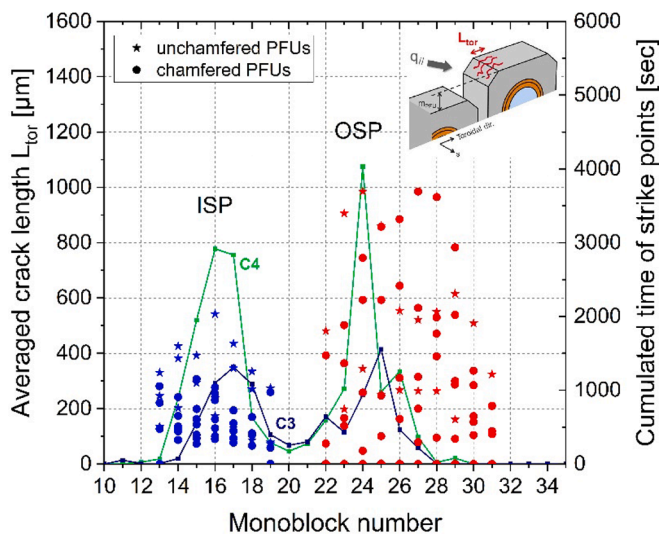
An extensive characterization of all 133 cracked monoblocks enabled us to determine the average length and linear density (number of cracks / mm) of the cracks on each monoblock. Fig. 7 shows that cracks in the OSP region are twice as long as those in the ISP region, with lengths ranging from 0 to 1000 μm in the OSP region and 0 to 500 μm in the ISP region. It should be noted that these values are averages, meaning that cracks can be longer than 1000 μm in some cases. Furthermore, as mentioned in the previous paragraph, cracks are discontinuous and length measurement can therefore be tricky, but this does not change the trend for longer cracks in OSP than in ISP. No difference is observed between chamfered MBs (circular markers) and unchamfered MBs (star markers). As damage is generally related to heat flux, the fact that cracks are more severe in the OSP than in the ISP seems unsurprising due to the in/out asymmetry observed in many tokamaks, which gives rise to higher heat fluxes in the OSP than in the ISP.

The figure also shows the positions of the strike points (SP) during C3 and C4. In the OSP region, the strike point was often positioned very locally on MB24, or even MB25, where the heat flux is supposed to be higher. However, cracks are present over a very wide area from MB22 to MB31. For example, MB30 exhibits cracks up to 300 μm long, despite being located far from the SP zone, where intense steady state heat loads are not expected. Even with the assumption that the peak heat flux shifts 1 or 2 MBs away from the SP, the figure shows that cracking occurred in regions where it was not expected. Such significant damage far from the strike point region reinforces the hypothesis of previous research that disruptions could have a big role to play in cracking mechanisms [2,3,12].

Fig. 7. Average crack length in the toroidal direction, combined with the position of the strike points during the c3/2018 (blue line) and c4/2019 (green line) campaigns. (For interpretation of the references to colour in this figure legend, the reader is referred to the web version of this article.)

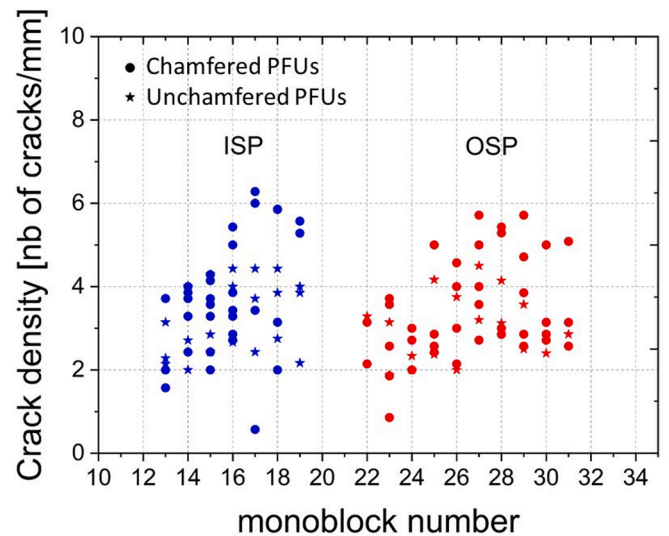
Fig. 8 shows the crack density for each monoblock, i.e. the number of cracks per mm. It is between 2 and 6, i.e. each crack is separated by 0.15 to 0.5 mm in the poloidal direction, whether the monoblock is chamfered or not. It therefore appears that once formed and stable, the cracks have a regular spacing which seems to be an intrinsic behavior of W.

Fig. 8. Crack density for each of the cracked monoblock.

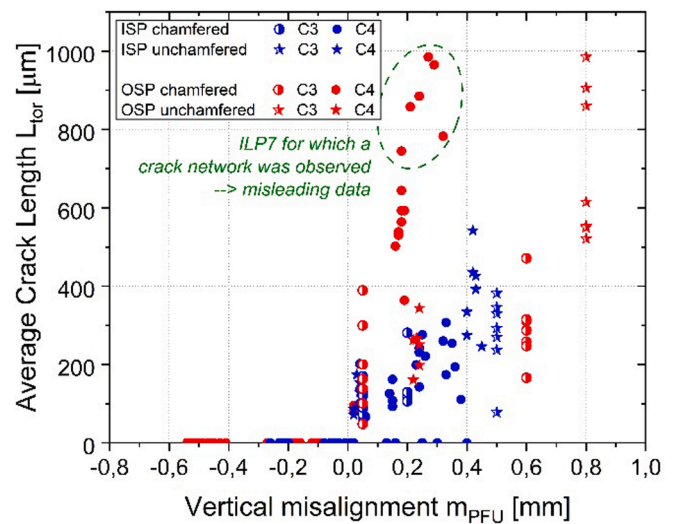
Fig. 9. Measured average crack length versus relative vertical misalignment.

pertains to the C4 campaign. The data points circled in green belong to ILP7, for which a crack network was observed on the leading edge. Compared to the other PFUs with neat cracks (see 3.2), the measurement of the crack length is therefore much more difficult for this PFU and might be inaccurate.

The figure clearly shows that positive misalignment necessarily leads to cracking, as all non-cracked MBs are associated with negative misalignment. With the non-beveled geometry of the MB, the leading edges are not protected, so vertical misalignment plays an important role. Today, there are no alignment tolerances for these non-beveled components (existing tolerances only apply to beveled PFUs), but it can be seen that a misalignment of 0.1–0.2 mm can already result in cracks > 200 μm . The higher the misalignment the longer the cracks.

Although further studies would be needed to better understand the mechanisms behind crack formation, it is evident that a toroidal bevel should be applied to the monoblocks to avoid any risk of damage on the LE during operation. This design is foreseen in ITER and is currently being tested with the lower divertor targets installed in WEST since 2021. So far, no cracks on the LE have been observed.
