Thermal loads in gaps between ITER divertor monoblocks: first lessons learnt from WEST

J. P. Gunn, J. Bucalossi, Y. Corre, M. Diez, E. Delmas, N. Fedorczak, A. Grosjean, M. Firdaouss, J. Gaspar,^a T. Loarer, M. Missirlian, P. Moreau, E. Nardon, C. Reux, M. Richou, E. Tsitrone, and the WEST team^b

Abstract

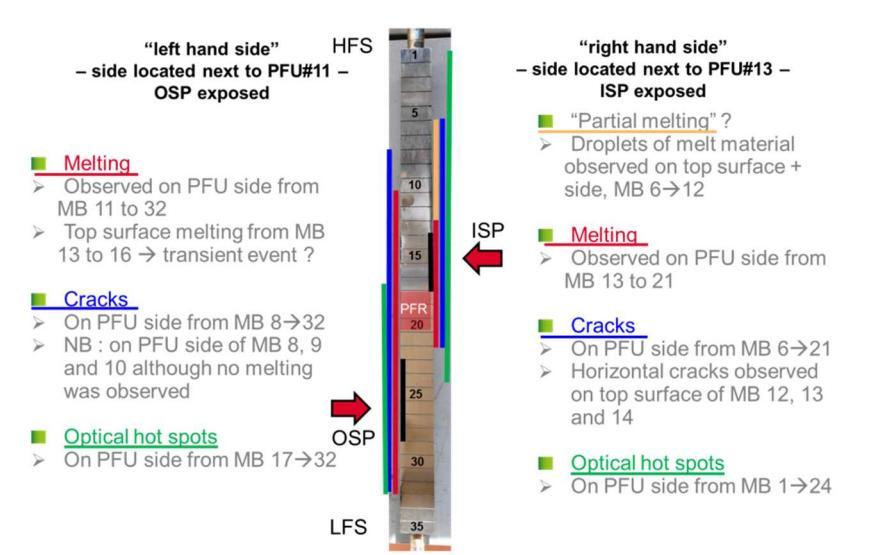
A detailed survey of the damage to PFU#12 is compiled in Figure 3. During the flat top phase, and depending on the X-point height, the outer strike point (OSP) can impinge on the left hand side of MBs 23 to 28, and the inner strike point on the right hand side of MBs 14 to 17. Despite being on the trailing edges of MBs 13 to 16, a significant amount of melting was observed there half way through the C3 campaign by the robotic articulated inspection arm that can penetrate into the tokamak and take photos under vacuum [10]. Melt layer motion and splashing of liquid W were clearly observable. Similar localized damage was not observed on any other PFUs. Furthermore, at the end of the campaign (Figure 4), the zone showed no evidence of evolution, leading us to believe that it was induced by a single event. The impact on the trailing edge of the MBs suggests that perhaps a disruption or even an impact of runaway electrons was responsible during the final instants when the magnetic equilibrium was collapsing. There was no evidence that the presence of this damage hindered the experimental campaign. Indeed, we were unable to find any precise data that would indicate when it occurred.

Figure 3. Summary of observed damage on misaligned PFU#12. The zones where the strike points impacted the divertor are indicated by black bars. Red bars indicate MBs on which leading edge melting occured. Blue bars indicate the presence of cracks (mostly vertical but some horizontal). Green bars indicate clear evidence for optical hot spots.

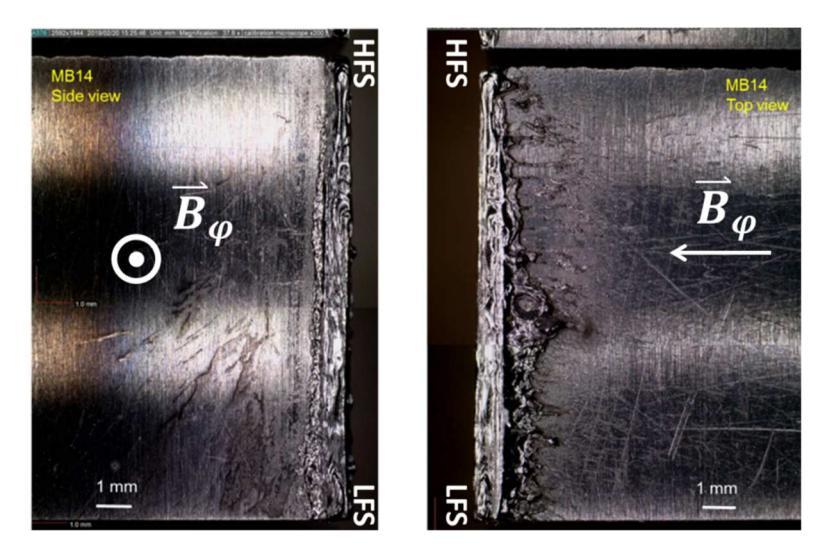
Figure 4. Side (left panel) and top (right panel) views of the trailing edge of MB#14. The images were taken after dismounting PFU#12 following the C3 experimental campaign. Melting of the leading edge to a depth about 1 mm and splashing of the melt layer over a few mm on the top surface are observed.

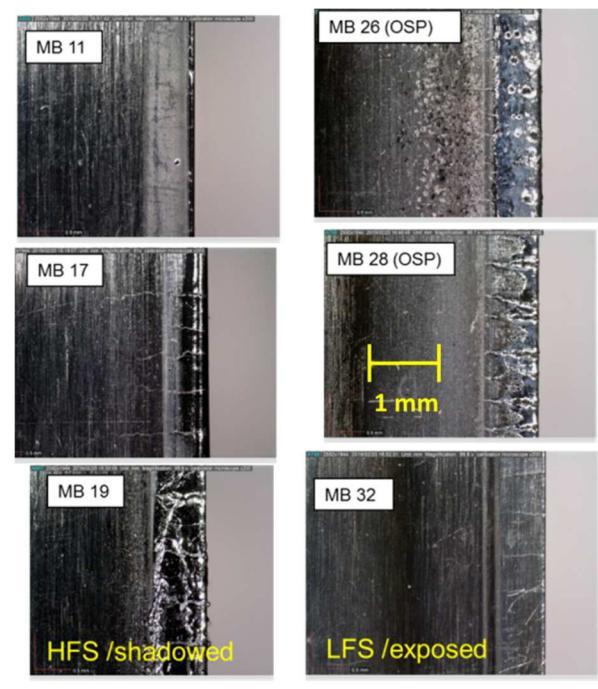
Figure 5. Images of MBs on the left hand side of PFU#12. The discoloured band is 0.8 mm wide and corresponds to the misalignment of the PFU with respect to its neighbour, PFU#11. Cracks (mostly vertical) and deformation (or perhaps fine scale melting, to be confirmed) are observed. The crack density and the severity of the deformation/melting decrease towards the extremities of the affected zone, and seem to be the most severe at the location of the OSP. See Figure 1 for the locations of the MBs on the PFU.

Excluding the localized zone where an exceptional melting event occurred, the leading edges from MB#8 to MB#32 on the left hand side of the PFU show a number of interesting features (Figure 5). On the front faces of the MBs, a discoloured band ~0.8 mm high is visible. This corresponds exactly to the misalignment of PFU#12 with respect to its neighbour, PFU#11. There are a number of vertical cracks that often extend to the bottom of the plasma-wetted surface, but sometimes penetrating deeper into the shadowed area. The cracks are separated typically by 0.2 to 1.0 mm in the poloidal direction. The crack density is lower at the poloidal extremities of the affected area, and higher around the OSP location. Small scale melting is observed from MB#11 to MB#32 (again, excluding MB#13-16 where the severe melting event occurred). At the poloidal extremities of the damaged region the melting seems to be limited to the sharp leading edge, whereas towards the center of the

region, both on HFS and LFS MBs, the melting can occur over the entire depth of the exposed surface, notably along the edges of the cracks. It seems that the damage is maximal at the leading edges around the OSP, but it exists even on the trailing edges of MBs at the ISP (both being on the left hand side of the PFU). During start-up and ramp-down, and during disruptions, the strike points sweep poloidally and can lead to heat flux transiently striking the MB trailing edges. That is, during transient movements of the strike points, trailing edges that are nominally shadowed during the flat top phase can briefly become leading edges with respect to the heat flow.

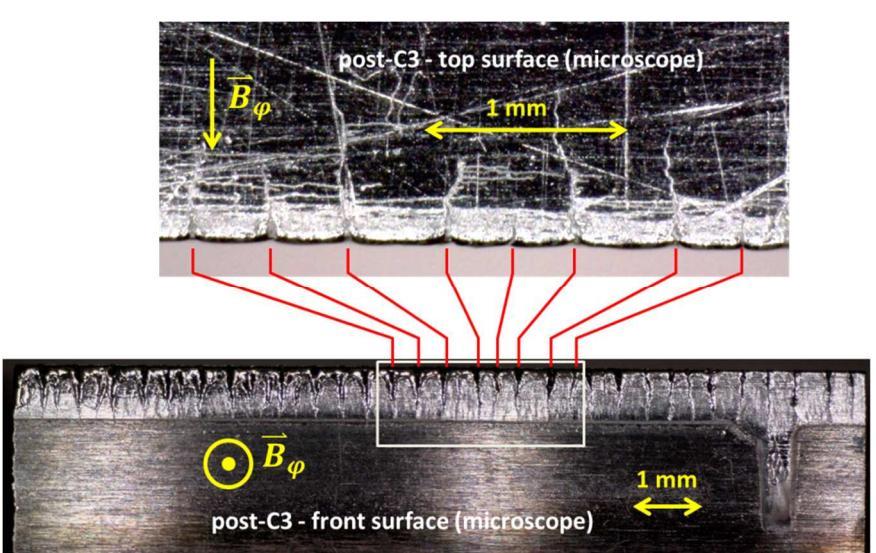
At the top surface the same cracks that are observed on the front surfaces of the MB leading edges are observed to propagate up to ~0.5-1 mm in the toroidal direction (Figure 6). The geometry of the loaded leading edges has changed. It is not possible to conclude whether the volume of metal between the cracks has migrated in the toroidal and poloidal directions, forming a pattern of corrugation, or whether material at the crack locations has gone missing. The poloidal separation between the cracks is very regular, about 0.4 mm on average (there are 31 columnar structures over the 12 mm poloidal MB width). The PFUs were again exposed during the C4 experimental campaign in 2019 and shall be inspected to see how the cracks evolved.

Figure 6. The upper panel is a microscope image of a part of the top surface near the exposed leading edge of MB#29 (left hand side, near OSP). An image of the full poloidal width of the leading edge is shown on the lower panel. Both images were taken after the 2018 (C3) experimental campaign.

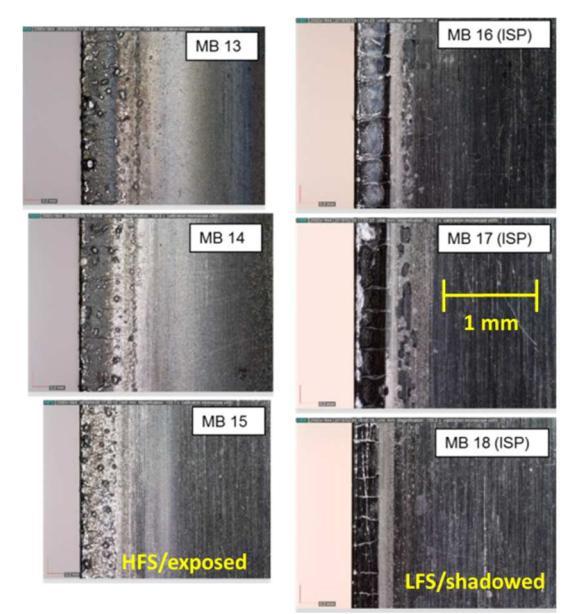
At the right hand side of the PFU around the ISP location (Figure 7), there is also cracking and what appears to be fine scale melting, although the crack density and deformation of the surface are qualitatively less important than at the OSP location (Figure 5). At the leading edges of the MBs that were impacted by the exceptional melting event on their trailing edges, there appear to be metal droplets sticking to the plasma-wetted area.

Figure 7. Side images of MBs on the right hand side of PFU#12, at the ISP. The discoloured band corresponds to the misalignment of the PFU with respect to its neighbour, PFU#13. Vertical cracks and fine scale melting are observed. On the leading edges of MBs#13-15, that were severely melted at their trailing edges, there appear to be droplets of liquid metal that stuck to the plasma-wetted area. See Figure 1 for the locations of the MBs on the PFU.

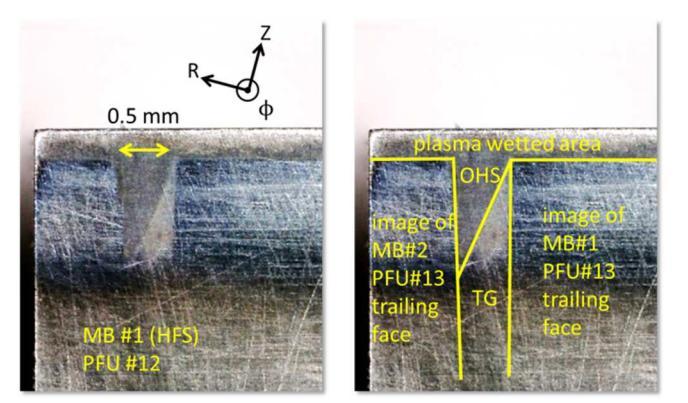
Figure 8 contains a remarkable image of the left-hand corner of MB#1 at the HFS extremity of PFU#12. A perfect image of its upstream neighbour, PFU#13, is visible, as if the image had been captured on an old-fashioned photographic plate from the nineteenth century. The gray band and the triangular protrusion at the top of the image represent surfaces to which magnetic field lines connect from the SOL, and along which plasma can arrive to impact the leading edge. In ITER, the upper band would not be visible due to the 0.5 mm toroidal bevel, but the triangular imprint, the OHS, will be [9,12]. The trailing faces of MB#1 and MB#2 of PFU#13 (dark bluish squares) as well as the interior of the toroidal gap (lighter gray) between them can be seen. The differences in aspect are likely related to the different origins of particles striking the surface (for example neutral particles reflecting from the trailing edges of the upstream MBs versus neutrals reflecting from inside the walls of the toroidal gap between the PFUs, and looking along the magnetic field lines from PFU#12 towards PFU#13. The view is similar to the photo a tourist might take looking down a city street between two skyscrapers.

Figure 8. Photograph of the leading edge of MB#1 (the first MB on the HFS of PFU#12). The plasma heat flux is directed into the page. The image is repeated on the right panel, with lines indicating the MB edges to guide the eye. This deposition pattern is akin to a true photograph, and shows an image of what a microscopic observer would see looking along the field lines through a toroidal gap between MBs. The OHS is the triangular region.

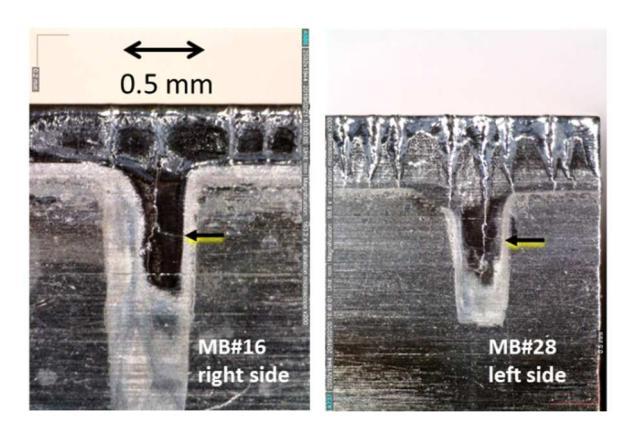
On most MBs the OHS is visible, even in regions such as MB#1 where very little plasma flux is expected. In regions nearer the strike points where cracks and fine scale melting were observed on the exposed leading edges, the OHSs in many cases are also damaged. Cracks often descend vertically through the full depth of the OHS (Figure 9), and horizontal cracks branch out from them in some cases.

Figure 9. Examples of optical hot spots on the leading edge of MB#16 (right hand side, near ISP) and MB#28 (left hand side, OSP). The plasma heat flux is directed into the page in each case. There appears to be deformation at the edges of cracks on the exposed leading edge. Cracks extend down into the OHSs , and branching horizontal cracks are also seen (indicated by arrows).

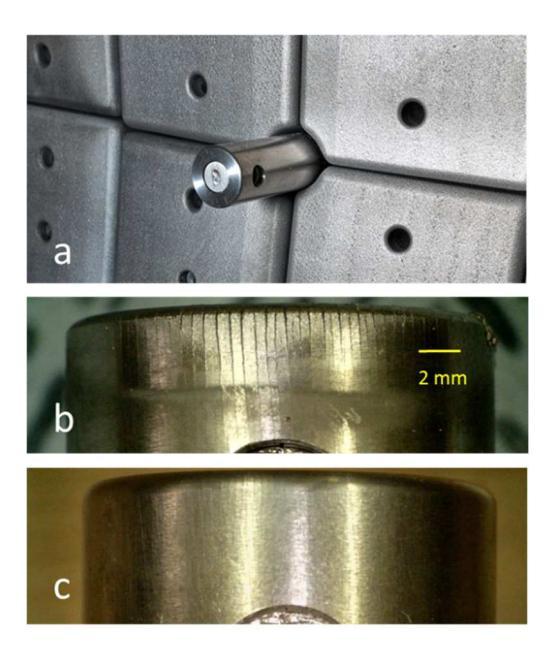
Most of the first year of WEST operation (C1 campaign, 2017) was spent trying to obtain a sustained plasma breakdown [36]. During that time the probes were not used. During the C2 campaign in the first half of 2018, diverted plasmas were obtained and the reciprocating probes were commissioned. They were exposed about 50 times to very tenuous and low temperature plasmas, with parallel heat flux less than 1 MW/m². They were impacted by 4 disruptions. Following the C2 campaign in mid 2018, the lower probe was removed to make room for another experiment, while the upper probe remained in operation for the C3 and C4 campaigns until the end of 2019. It made ~1000 reciprocations into the SOL, with heat fluxes reaching several 10s of MW/m² as plasma performance improved over time. It also experienced a number of disruptions. In 2020 the upper probe was removed for maintenance and that is when we learned that both probes had cracked in the same way as the divertor MBs.

On the lower probe (Figure 14c), the cracks are very thin and difficult to see even under a microscope. Assuming that the cracks on both probes developed in the same way during the C2 campaign, those on the upper probe, which was much more exposed to plasma, seem to have evolved (Figure 14b). Near the tip of the probe they have opened up and exhibit fine scale melting at their edges. The length of the cracks (~1 cm) corresponds roughly to the characteristic SOL decay length in WEST. The spacing between cracks (~0.5 mm) and their appearance are nearly identical to those observed on the exposed leading edges and OHS of the divertor MBs.

Figure 14. (a) Photograph of the lower reciprocating probe on the mobile outboard limiter before first plasma in WEST. The visible cylindrical part is a W-La(10%) heat shield. (b) The tip of the upper probe's heat shield after ~1000 reciprocations and a number of disruptions. (c) The tip of the lower probe's heat shield after only 50 reciprocations and 4 disruptions during the early phase of WEST operation (C2 campaign, 2018).

The remarkable similarity between the cracks on MBs and those on the probes suggests that they were formed the same way. The divertor's irradiation history folds in every plasma and transient event since the beginning of operation, making it impossible to draw conclusions about what caused the cracks to form. The observation of similar cracks on the lower probe that measured very weak plasma flux and experienced only 4 disruptions lends credence to the hypothesis that the cracks formed under a mode of brittle fracture. Exposure to a steady state SOL heat flux less than 1 MW/m^2 for a few tens of ms (the duration of the reciprocation) leads to a surface temperature increase of merely a few °C. The cracks, therefore, could only have been formed during the 4 disruptions. The observations of the upper probe show that once formed, and upon irradiation to higher steady state loads and increasing numbers of disruptions, the cracks evolve over time, opening up, with the appearance of localized edge melting. It is impossible to know whether the evolution is continuous, or saturates at some point. Both probes, with their respective surface states (the lower probe having barely visible cracks, and the upper probe having cracks visible to the naked eye), will be reinstalled for the next experimental campaign (C5, late 2020). The probes will be inspected between future experimental campaigns to see how the cracks on both probes evolve.
