Using STED and ELSM confocal microscopy for a better knowledge of fused silica polished glass interface

Abstract: Characteristics and nature of close surface defects existing in fused silica polished optical surfaces were explored. Samples were deliberately scratched using a modified polishing process in presence of different fluorescent dyes. Various techniques including Epi-fluorescence Laser Scanning Mode (ELSM) or STimulated Emission Depletion (STED) confocal microscopy were used to measure and quantify scratches that are sometimes embedded under the polished layer. We show using a non-destructive technique that depth of the modified region extends far below the surface. Moreover cracks of 120 nm width can be present ten micrometers below the surface.

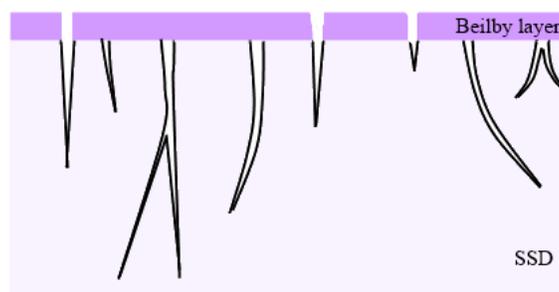
Fig. 1. Schematic structure of the fused silica interface after polishing.

Both SSD and process induce contamination can lead to laser damage at 351 nm. High concentration of ceria in the polished layer induces gray haze *e.g.* during damage testing [4, 5]. Damage density can thus be linked to pollutant concentration for high degrees of pollution [6]. As depicted in Fig. 1, residual SSD can also lead to laser damage [7, 8].

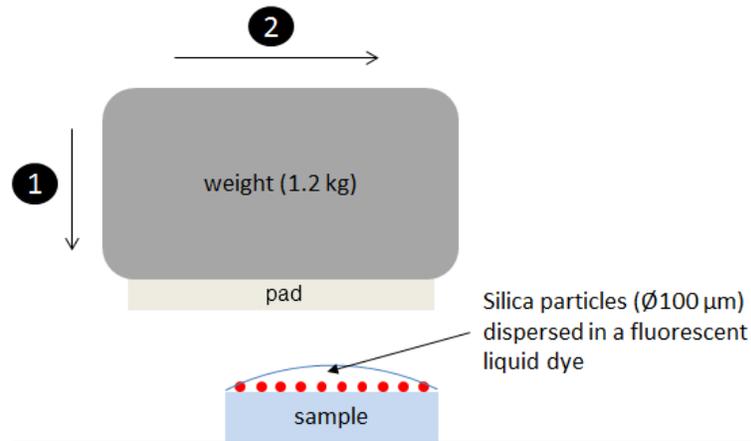
Fig. 2. Schematic representation of the experimental method used for the production of polishing-like scratches on sample surfaces.

Studying defects in polished fused silica glass interface is very difficult. In contrast with ground surfaces, subsurface defects density is rather weak. Moreover the width of fractures is less than a micrometer which is also beyond most of classic optical apparatus resolution. Consequently, groups working on this topic are used to create subsurface defects artificially in large quantity using a process which derives from polishing and uses polishing slurry polluted with large hard particles [11]. The morphology of such artificial imperfections matches well process-related polishing scratches that appear from the last grinding/polishing operations. We retained a similar approach to create subsurface defects on our polished samples. As shown in Fig. 2, an adhesive polishing pad was stuck on a 1.2 kg weight. A slurry containing silica particles of 100 μm diameter dispersed in a D.I. water was preliminary deposited on the sample surface. The weight is moved down to the clamped sample till contact (step 1 of Fig. 2) and is translated one time over the sample surface (step 2 in Fig. 2). Unidirectional scratches with controlled density and width are obtained on the

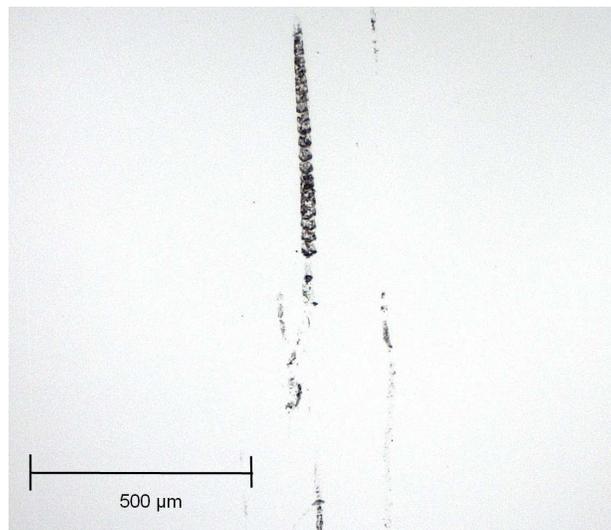
Typical scratches created by this process are shown on Fig. 3. Image was obtained using a bright field microscope in dark interference contrast mode and a 20x objective. Conchoidal shape, trailing indent fractures are created with morphology similar to polishing process induced scratches [13].

Fig. 3. Typical scratch created by the scratching process.

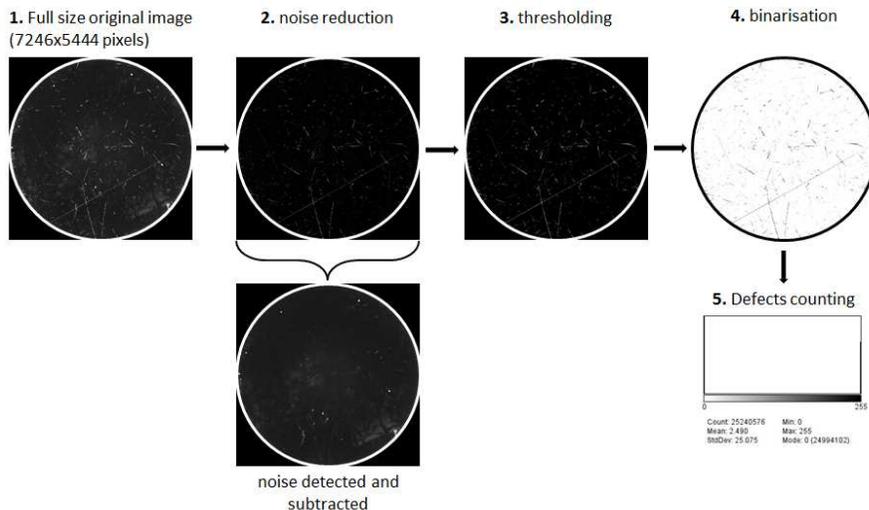
First of all a noise reduction (rolling-ball algorithm [15]) is applied to the images, followed by a thresholding and a binarisation (see Fig. 4). The amount of black pixels per square centimeter (black pixel density) is finally automatically counted in the selected area of the images.

Fig. 4. Description of the image post-treatment steps using ImageJ.

The images were then post-processed using a macro developed with ImageJ [14] in order to quantify the amount of defects. The image analysis process consists in counting the amount of black pixels per cm² (obscuration), directly related to the amount of defects like scratches.

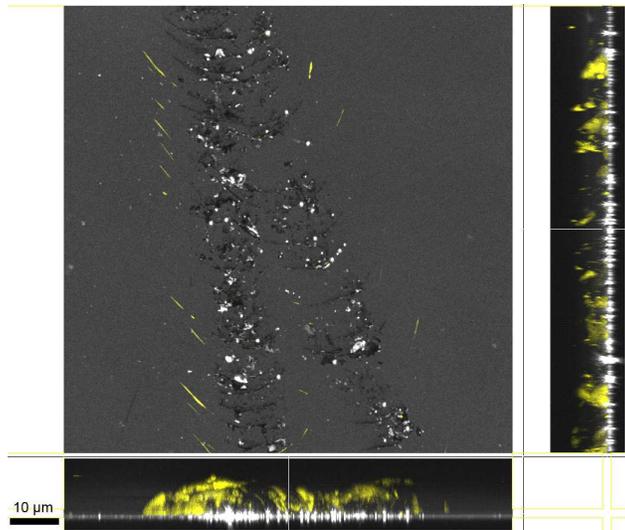
A first set of samples was scratched using the procedure detailed in section 2.1 using silica particles, D.I. water and Lucifer Yellow fluorescent dye for subsurface defects tagging. A typical image obtained in both ELSM mode and reflection mode is shown in Fig. 5. Central image is a top view and includes the entire stack of images. The right side image is a view looking from the left and includes the entire stack. The bottom side image is a side view looking from the top and including all the stacks. Reflection mode signal is represented in black and white, ELSM mode in Yellow. Analysis of top and sides views brings information on surface and subsurface defects. Two main surface scratches created by silica particles are visible. It can also be seen that Lucifer yellow tagging is efficient, allowing imaging of subsurface structures not observed in reflection mode.

Fig. 5. Scratch observed in reflection (black and white scale) and ELSM mode with Lucifer Yellow tagging (yellow scale). Top view (central), side view from left (right) and side view from top (bottom) – All stacks represented.

In the example of Fig. 5, the subsurface defect observed in ELSM mode is associated with a surface scratch. We presume that both scratch and subsurface cracks are created by the action of silica particles acting as indents sticking and slipping on the surface. But such a behavior is not always observed as shown in Fig. 6. In this later less frequent case, no surface defect is observed in reflection mode whereas ELSM signal is present, meaning the existence of subsurface defects. Subsurface defects are here embedded under the polished layer.

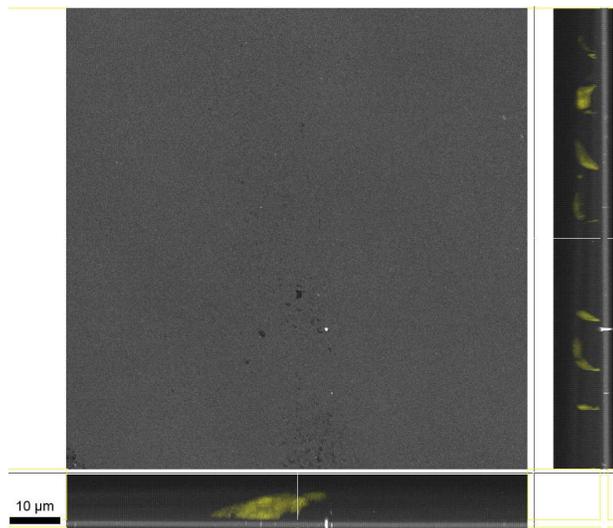
Fig. 6. Subsurface defect observed in reflection (black and white scale) and ELSM mode with Lucifer Yellow tagging (yellow scale). Top view (central), side view from left (right) and side view from top (bottom) – All stacks represented.

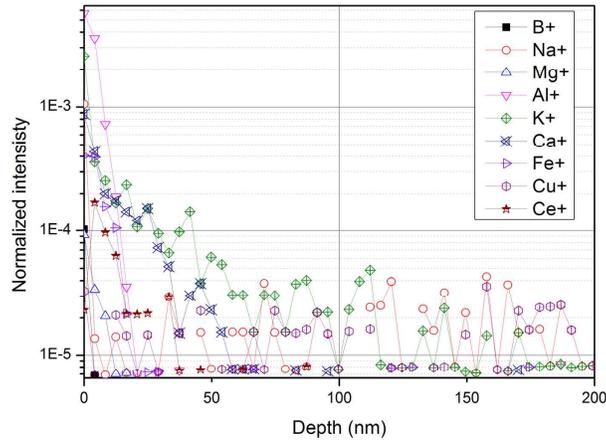
Fig. 7. ToF-SIMS profile obtained on a polished sample. A 50 to 75 nm polished layer is observed.

Process induced contamination of the fused silica glass close surface can be seen with traces of cerium, aluminum and iron (tooling, polishing slurries) but also calcium and potassium (water). Thickness of this contaminated layer is 50 to 75 nm.

To confirm this hypothesis, we analyzed a polished sample from the same polishing batch (prior scratching) using Time of Flight (ToF) SIMS. Measurement was performed using O_2^+ for erosion, analyze is carried out on a $60 \times 60 \mu m^2$ area. Intensity profiles were normalized by the secondary ion dose. The measurement was repeated at three different locations to

evaluate uniformity with no significant differences observed between profiles. An example of a ToF SIMS profile is given in Fig. 7.

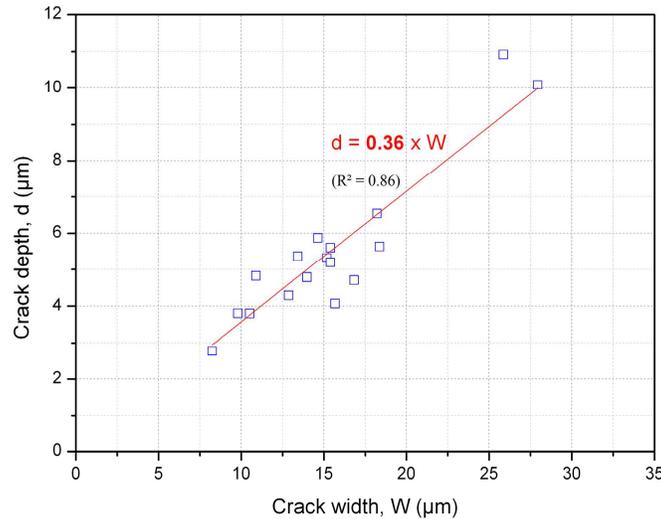
Firstly, we measured the crack width and depth of numerous scratches. Width is defined as the length across the crack on the surface as defined by Suratwala [19]; it was obtained from the reflection mode confocal image. Depth of each crack was measured by analyzing the ELSM mode image stacks. We were then able to represent in Fig. 8 the relation between crack depth (d) and crack width (W).

Fig. 8. Correlation between *mean* crack depth (d) and crack width (W). Best linear fit is shown in red.

Data linear fitting shows that *mean* crack depth is linked to width by a $d = 0.36 \times W$ relation. This result is in good agreement with the $d = 0.35 \times W$ relation established by Suratwala using a destructive method combining MRF wedge polishing to an automatic raster microscope imaging [19]. Consequently dye is likely to penetrate along the full subsurface fracture.

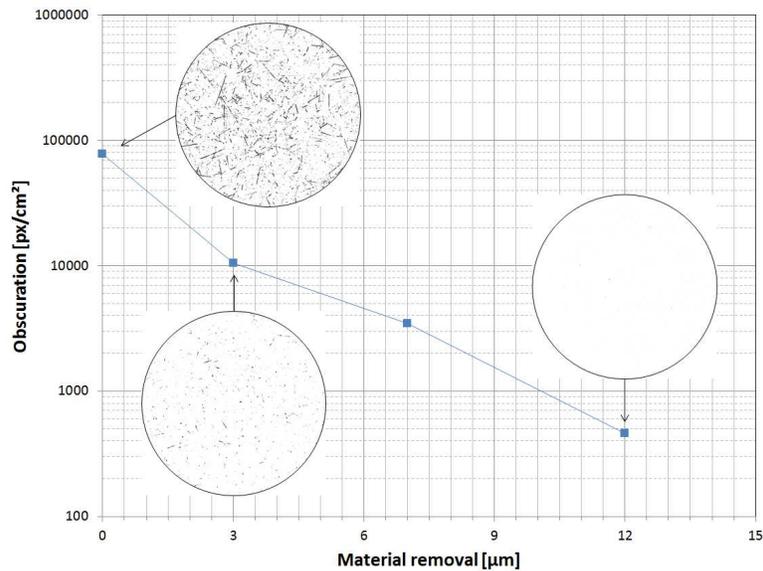
Fig. 9. Evolution of the crack obscuration during iterative material removal. The inserts correspond to DMS images of the initial state and after 3 μm and 12 μm material removal. Light HF wet etch was performed before DMS.

After 3 μm material removal, which approximately corresponds to the mean crack depth of scratches estimated thanks to the $d = 0.36 W$ relation, ImageJ post treatment shows a crack obscuration reduced by a decade. Almost no defects are seen on the DMS imaging thus confirming our depth estimation. DMS analysis using complete removal of any fracture is obtained with a 12 μm material removal which is approximately the crack width. This result is in good agreement with recent results demonstrating that a 90% probability of scratch removal is obtained when removing a depth equal to its width [13].

Secondly, a magneto-rheological fluid (MRF) finishing machine was used to suppress created defects from the scratched samples. MRF is a deterministic polishing method that permits local material removal by shear forces created by a fluid in contact with workpiece. It therefore induces very low to almost no SSD during polishing [20, 21]. MRF polishing was realized on a QED Q-22 XE machine using a standard fluid containing cerium oxide particles and a 50 mm diameter wheel. The following parameters were used: wheel speed of 600 rpm, pump speed of 80 rpm, spot depth of about 150 nm. A set of samples was scratched on a LOGITECH PM5 polishing machine using a cerium slurry polluted with 0.1 g/l of 9 μm alumina particles. We verified by confocal microscopy that using this other scratching process the $d = 0.36 \times W$ was fulfilled, meaning that similar subsurface defects were created. Iterative MRF uniform layer removals and DMS imaging (see section 2.2) were performed to track subsurface defect removal. Figure 9 shows the evolution of surface obscuration (step 5 of Fig. 4) after iterative material removals on a scratched sample with a mean crack width of 10 μm .

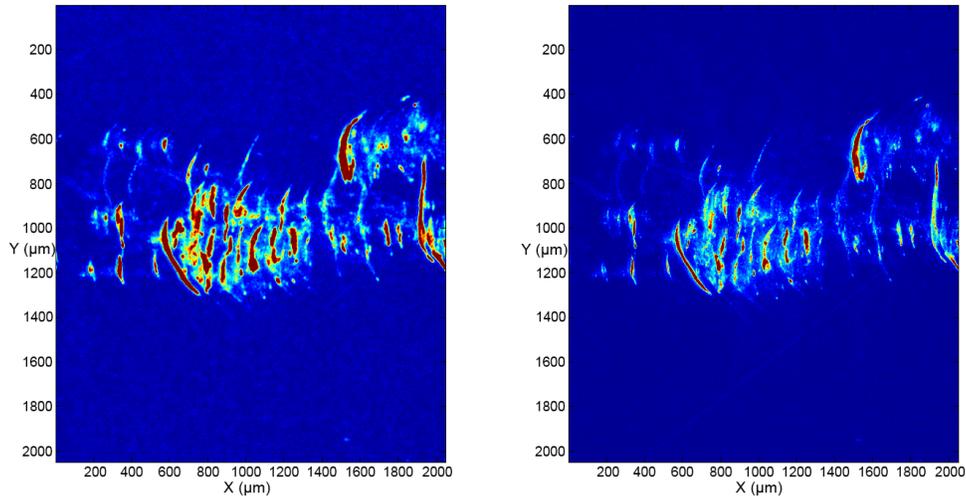
ATTO647N fluorescent dye for subsurface defects tagging. The interest of STED is to improve the resolution of the measurement and consequently gather finer details in the stack. This improvement can be seen in Fig. 10 which compares subsurface fractures evaluated 3 μm below a surface scratch.

Fig. 10. ELSM (left) and STED (right) mode confocal imaging of subsurface fractures, 3 μm below the surface.

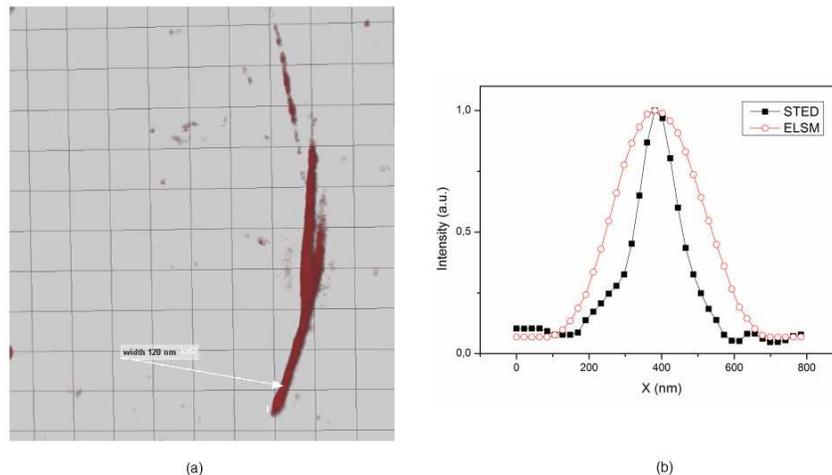
We also used STED stacks of different subsurface fractures to estimate crack width below the surface. An example is given on a single fracture extending about 2.5 μm below the surface and presented in Fig. 11 and in [Media 1](#). A width of 120 nm FWHM (Full Width at Half Maximum) is measured 2.5 μm below the surface in STED mode whereas it is given at 280 nm FWHM in ELSM mode (Fig. 11(b)). Similar sizes can be measured on Fig. 10 on fine details of subsurface fractures and equivalent width are found down to ten micrometers below the surface. This order of magnitude is in good agreement with width of subsurface cracks supposed to play a role in damage initiation at the wavelength of 351 nm [7, 22–24]. For example, Genin *et al.* demonstrated that 100 nm width and few micrometers depth cracks can induce light intensity enhancements of 10x to 100x depending on their orientation [7].

Fig. 11. Measurement of a subsurface fracture width on an isolated fracture ([Media 1](#)) at about 2.5 μm below the surface (a) – X-profile of crack width estimated in ELSM (red circles) and in STED mode (black rectangles) at the pointed location (arrow in (a)) (b).
