## Polishing-induced contamination of fused silica optics and laser induced damage density at 351 nm

**Abstract:** In this paper we study the effect of contamination induced by fabrication process on laser damage density of fused silica polished parts at 351 nm in nanosecond regime. We show, owing to recent developments of our raster scan metrology, that a good correlation exists between damage density and concentration of certain contaminants for the considered parts.

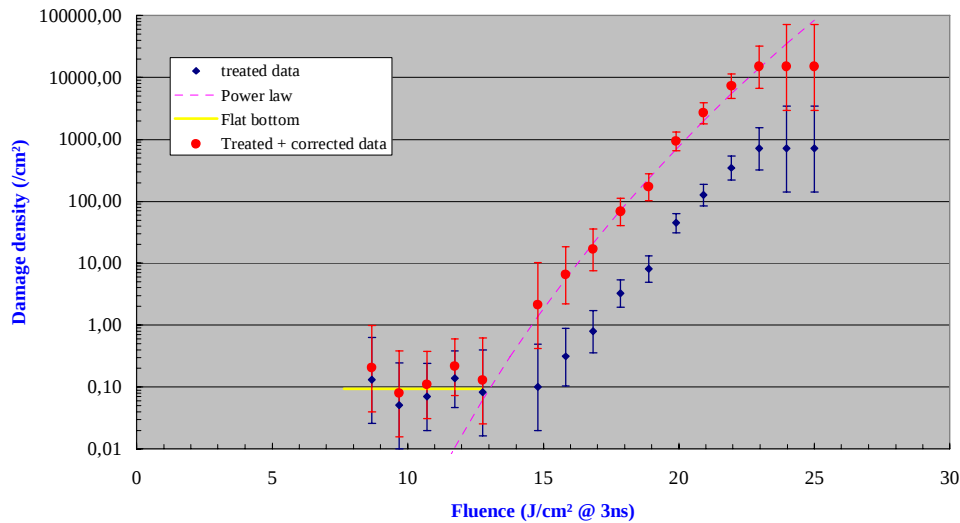
Fig. 1 : Damage density versus fluence. Sample B2. Blue and red points represent respectively treated and “treated + corrected” data. The corrective factors are 1.5 and 21 respectively for the flat bottom and the power law.

Figure 1 illustrates typical results obtained after complete analysis. Blue points correspond to the treatment described previously. Due to Gaussian beam profile and beam overlap between shots (about 66%), we have to take into account the beam shape to obtain an absolute result. On the graph, one can observe two behaviors. Below 15 J/cm<sup>2</sup>, damage density is roughly constant and damage is not fluence dependent but based only on the defect density; we simply have to take into account the total irradiated area. Above 15 J/cm<sup>2</sup>, damage density increases following a power law. In this domain, damage occurs at the beam maximum fluence and only the Gaussian top part of the profile is taken into account. In this

case, raw data are corrected by a factor that depends on the slope of the fluence law [17, 18]. Ultimately, red points represent the absolute result from the test.

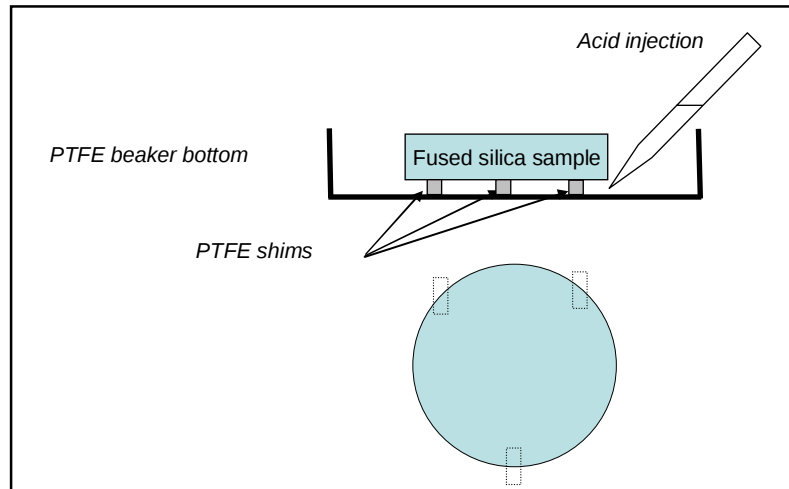
Fig. 2. Sample digestion scheme

After accurate weighing and thickness measurement, each fused silica sample was etched (see Fig. 2) during 10 minutes in a mixture of ultra pure grade concentrated HNO<sub>3</sub> and HF (90 %vol/10 %vol). Then the solution was sucked with a 3 mL tube as well as the de-ionized water used for washing. About 0.8  $\mu\text{m}$  of silica was digested during this preparation.

This  $\text{HNO}_3/\text{HF}$  cycle was repeated up to 8 times. This was generally enough to obtain asymptotic impurities concentrations. After this controlled sample digestion, suitable spectra can be obtained for the main impurities (Ce, La, Zr, Hf, Al, Fe, Cu). The wavelengths used for ICP measurements are summarized in Table 3.

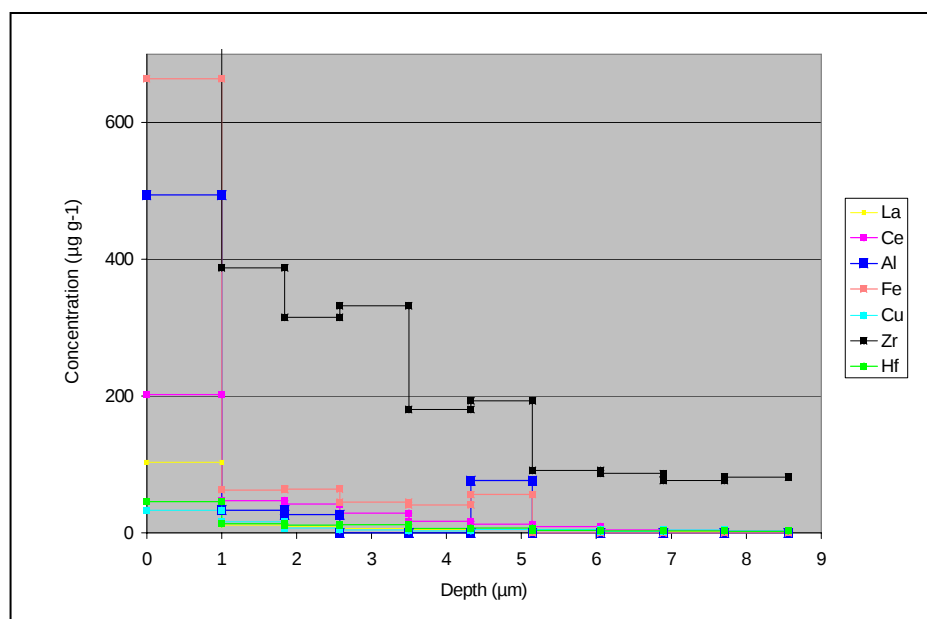
Fig. 3. Depth profiles of impurities concentrations for sample B2

This analytical procedure allows us to evaluate concentrations of impurities as a function of depth. Figure 3 illustrates the surface and sub-surface depth profiles of impurities that can be obtained with this analytical procedure and gives by the way an average value for maximum depth of sub-surface cracks. Results are given with a relative precision of 10%.

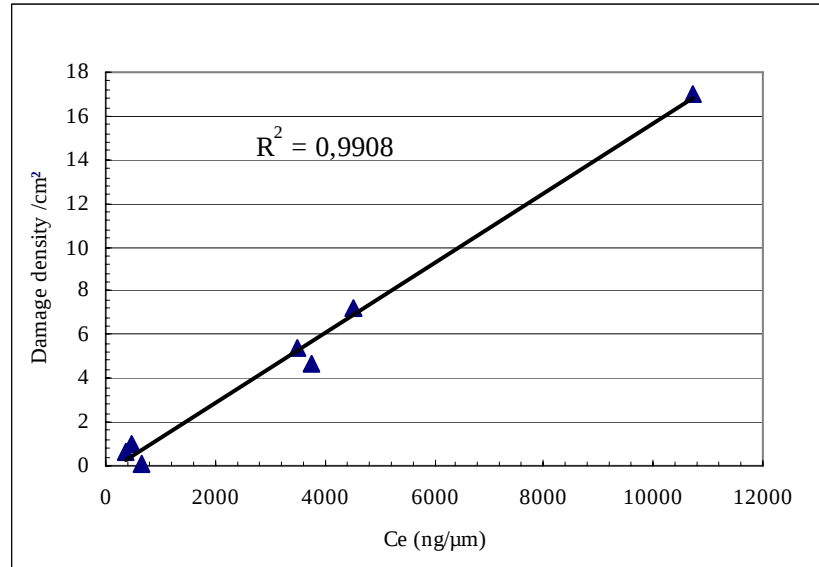
Fig. 4. Effect of cerium content on damage density.

machine before the manufacturing of our part. Insufficient cleaning of the polishing machine before the ZrO<sub>2</sub> polishing of samples B2 and B3 is therefore likely to be the cause of the cerium pollution of these parts. Moreover, it must be noticed that a high concentration of zirconium is compatible with low damage density such as seen on part B3. This last remark has already been made [16]. Figure 4 shows the correlation existing between cerium content in the interface and damage density at 14 J/cm<sup>2</sup>.

Data are fitted with a linear law with a correlation coefficient of 0.99 approximately. At the opposite, Figure 5 presents the data for Fe where correlation between damage density and Fe concentration is very weak.

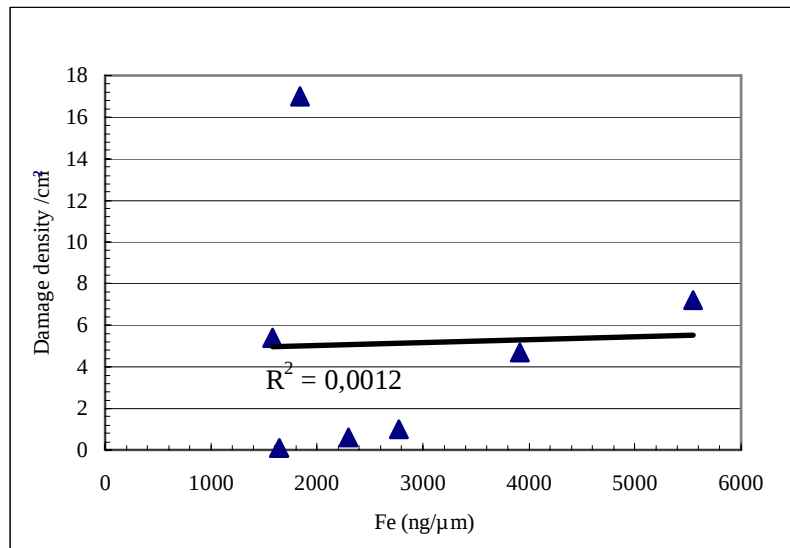
Fig. 5. Effect of Fe content on damage density.

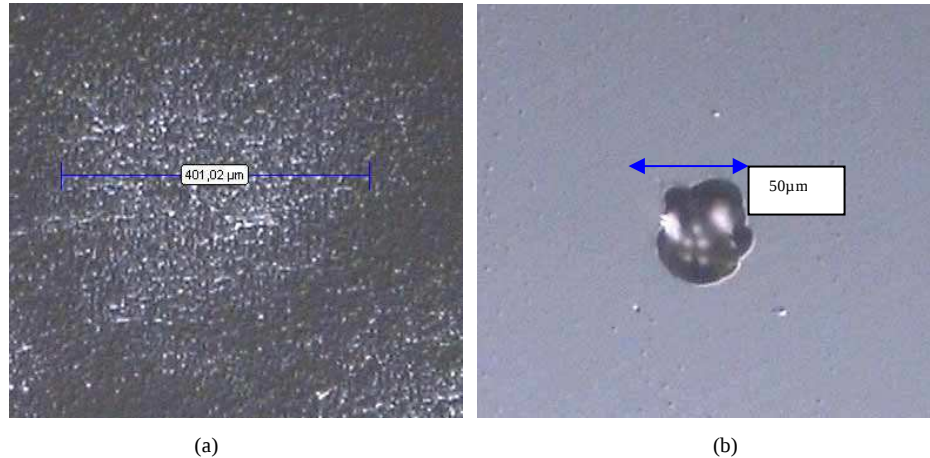
Fig. 6. (a) Gray haze damage, part B1 (b) typical damage morphology on part A4

We have also been trying to correlate the presence of cerium in the interface with damage morphology. On part B1 exhibiting very high cerium concentration in the interface, the "gray haze" damage morphology can be easily seen such as previously described by Kozłowski *et al.* [16]. Figure 6(a) shows such a gray haze damage like observed with a Nomarski microscope. When cerium content decreases, the gray haze morphology disappears to leave place to more classical small damage sites such as depicted in Figure 6(b). Some small damage clusters can be observed but no clear correlation has been seen between cerium concentration and quantities of these clusters like damage sites.
