Polishing-induced contamination of fused silica optics and laser induced damage density at 351 nm

Abstract: In this paper we study the effect of contamination induced by fabrication process on laser damage density of fused silica polished parts at 351 nm in nanosecond regime. We show, owing to recent developments of our raster scan metrology, that a good correlation exists between damage density and concentration of certain contaminants for the considered parts.

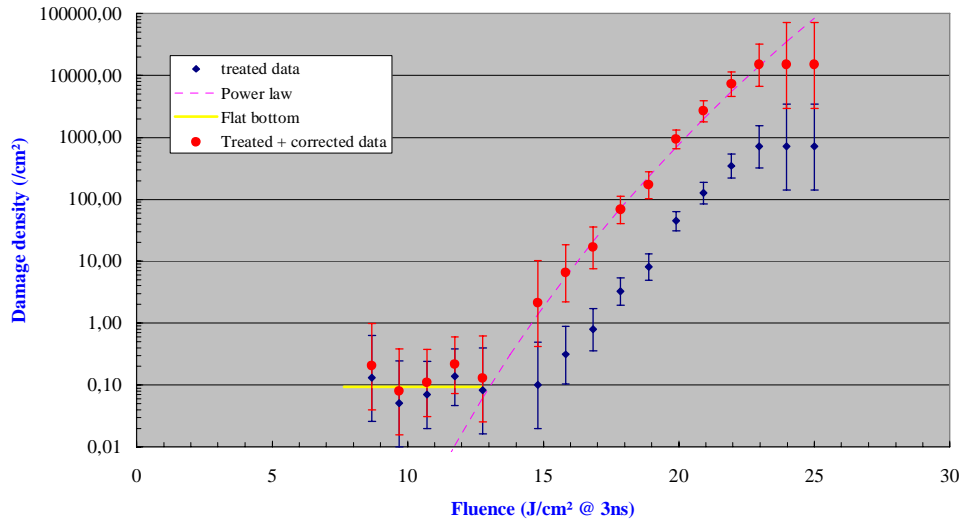
Fig. 1 : Damage density versus fluence. Sample B2. Blue and red points represent respectively treated and “treated + corrected” data. The corrective factors are 1.5 and 21 respectively for the flat bottom and the power law.

Figure 1 illustrates typical results obtained after complete analysis. Blue points correspond to the treatment described previously. Due to Gaussian beam profile and beam overlap between shots (about 66%), we have to take into account the beam shape to obtain an absolute result. On the graph, one can observe two behaviors. Below 15 J/cm², damage density is roughly constant and damage is not fluence dependent but based only on the defect density; we simply have to take into account the total irradiated area. Above 15 J/cm², damage density increases following a power law. In this domain, damage occurs at the beam maximum fluence and only the Gaussian top part of the profile is taken into account. In this

case, raw data are corrected by a factor that depends on the slope of the fluence law [17, 18]. Ultimately, red points represent the absolute result from the test.

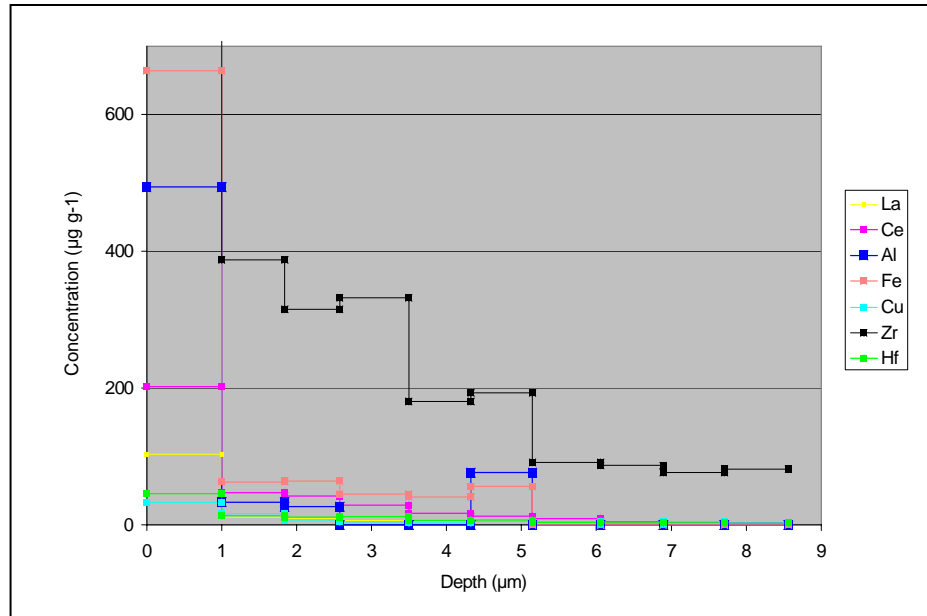
Fig. 3. Depth profiles of impurities concentrations for sample B2

This analytical procedure allows us to evaluate concentrations of impurities as a function of depth. Figure 3 illustrates the surface and sub-surface depth profiles of impurities that can be obtained with this analytical procedure and gives by the way an average value for maximum depth of sub-surface cracks. Results are given with a relative precision of 10%.
