Polishing-induced contamination of fused silica optics and laser induced damage density at 351 nm

Jerome Neauport, L. Lamaignere, H. Bercegol, F. Pilon, J.-C. Birolleau

Abstract: In this paper we study the effect of contamination induced by fabrication process on laser damage density of fused silica polished parts at 351 nm in nanosecond regime. We show, owing to recent developments of our raster scan metrology, that a good correlation exists between damage density and concentration of certain contaminants for the considered parts.

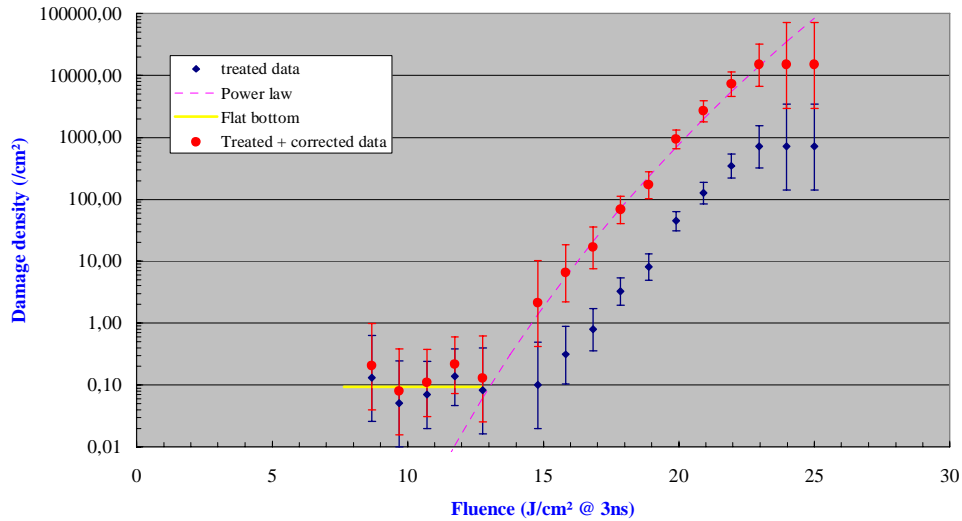
Fig. 1 : Damage density versus fluence. Sample B2. Blue and red points represent respectively treated and “treated + corrected” data. The corrective factors are 1.5 and 21 respectively for the flat bottom and the power law.

Figure 1 illustrates typical results obtained after complete analysis. Blue points correspond to the treatment described previously. Due to Gaussian beam profile and beam overlap between shots (about 66%), we have to take into account the beam shape to obtain an absolute result. On the graph, one can observe two behaviors. Below 15 J/cm², damage density is roughly constant and damage is not fluence dependent but based only on the defect density; we simply have to take into account the total irradiated area. Above 15 J/cm², damage density increases following a power law. In this domain, damage occurs at the beam maximum fluence and only the Gaussian top part of the profile is taken into account. In this

case, raw data are corrected by a factor that depends on the slope of the fluence law [17, 18]. Ultimately, red points represent the absolute result from the test.

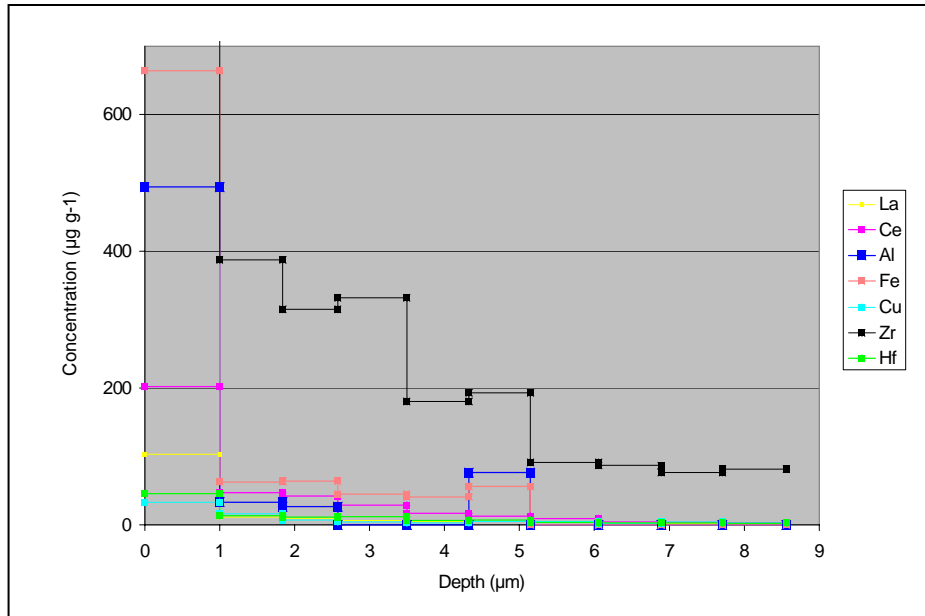
Fig. 3. Depth profiles of impurities concentrations for sample B2

This analytical procedure allows us to evaluate concentrations of impurities as a function of depth. Figure 3 illustrates the surface and sub-surface depth profiles of impurities that can be obtained with this analytical procedure and gives by the way an average value for maximum depth of sub-surface cracks. Results are given with a relative precision of 10%.

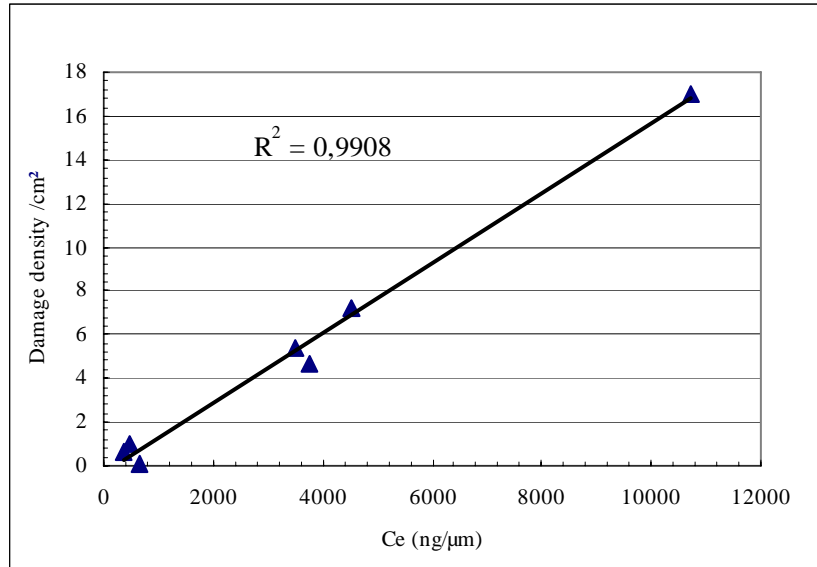
Fig. 4. Effect of cerium content on damage density.

machine before the manufacturing of our part. Insufficient cleaning of the polishing machine before the ZrO₂ polishing of samples B2 and B3 is therefore likely to be the cause of the cerium pollution of these parts. Moreover, it must be noticed that a high concentration of zirconium is compatible with low damage density such as seen on part B3. This last remark has already been made [16]. Figure 4 shows the correlation existing between cerium content in the interface and damage density at 14 J/cm².

Data are fitted with a linear law with a correlation coefficient of 0.99 approximately. At the opposite, Figure 5 presents the data for Fe where correlation between damage density and Fe concentration is very weak.

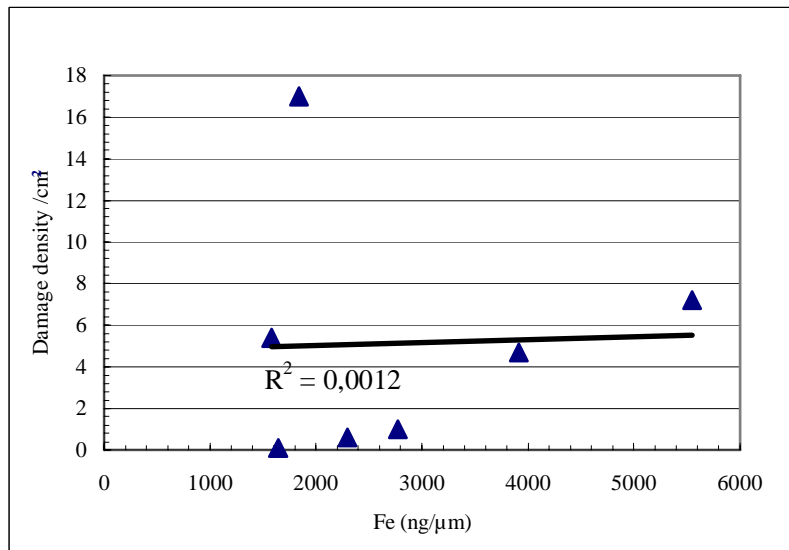
Fig. 5. Effect of Fe content on damage density.

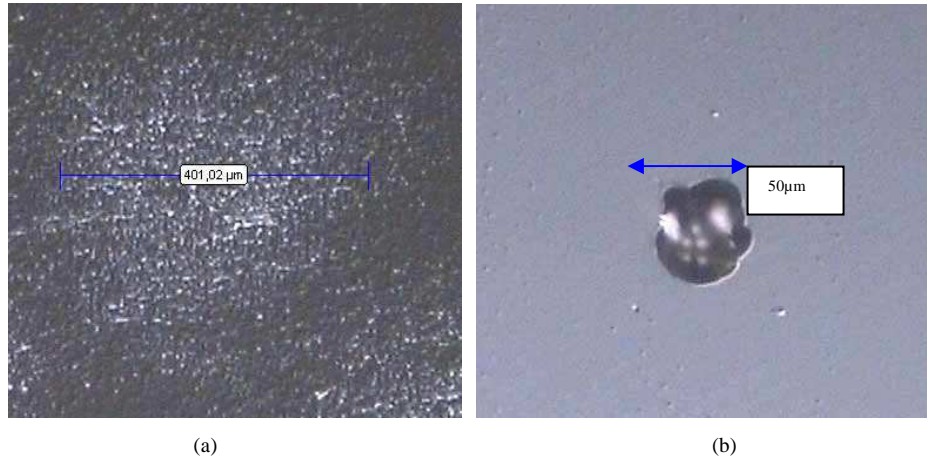
Fig. 6. (a) Gray haze damage, part B1 (b) typical damage morphology on part A4

We have also been trying to correlate the presence of cerium in the interface with damage morphology. On part B1 exhibiting very high cerium concentration in the interface, the "gray haze" damage morphology can be easily seen such as previously described by Kozłowski *et al.* [16]. Figure 6(a) shows such a gray haze damage like observed with a Nomarski microscope. When cerium content decreases, the gray haze morphology disappears to leave place to more classical small damage sites such as depicted in Figure 6(b). Some small damage clusters can be observed but no clear correlation has been seen between cerium concentration and quantities of these clusters like damage sites.
