# Impact of storage induced outgassing organic contamination on laser induced damage of silica optics at 351 nm

**Abstract:** The impact of storage conditions on laser induced damage density at 351 nm on bare fused polished silica samples has been studied. Intentionally outgassing of polypropylene pieces on silica samples was done. We evidenced an important increase of laser induced damage density on contaminated samples demonstrating that storage could limit optics lifetime performances. Atomic Force Microscopy (AFM) and Gas Chromatography -Mass Spectrometry (GC-MS) have been used to identify the potential causes of this effect. It shows that a small quantity of organic contamination deposited on silica surface is responsible for this degradation. Various hypotheses are proposed to explain the damage mechanism. The more likely hypothesis is a coupling between surface defects of optics and organic contaminants.

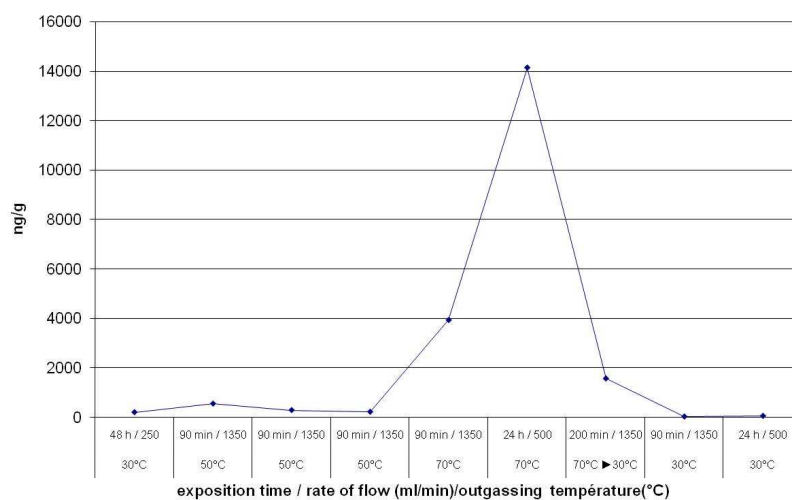
Fig. 1. Outgassing rate of polypropylene at different temperatures, flow rates and durations

The amount of outgassing species increases with the duration and the temperature. Maximal outgassed quantity is measured around 70°C. The outgassing rates of major

molecules measured at 70°C during 24 h and at 30°C during 48 h corresponding to the first and sixth points of Fig. 1 are given in Fig. 2.

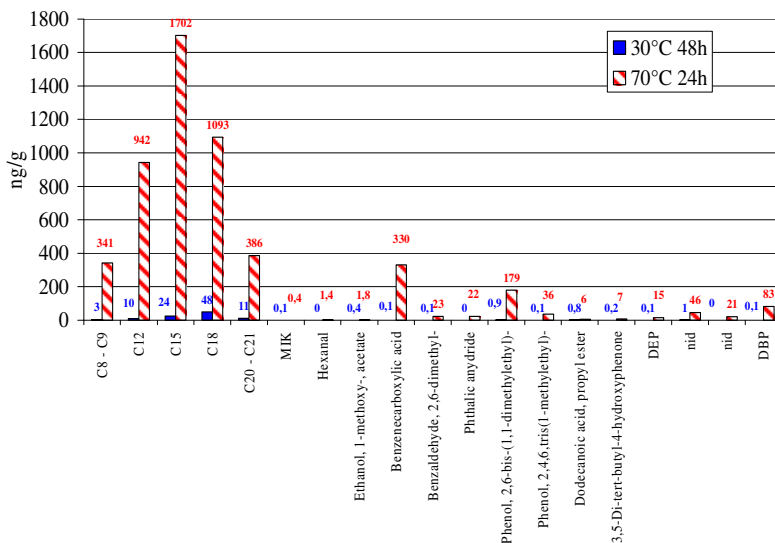
Fig. 2. Outgassed species at 70°C during 24 h by the selected polypropylene

The detected compounds were measured during the whole duration of the outgassing cycle. The alkanes and alkenes come probably from decomposition of other higher molecules. Dibutylphthalate and diethylphthalate are esters of phthalic acid and are mainly used as plasticizers, substances added to plastics to increase their flexibility. The other molecules are measured at the beginning as well as at the end of the outgassing cycle; consequently, they probably come from NPP material and not from a surface contamination of the analyzed NPP sample. Moreover, outgassed species at 70°C and at 30°C are similar. It means that an outgassing at 70°C during 24 h can be equivalent to an outgassing at 30°C during many days which is representative of a long term outgassing such as optics storage conditions. Consequently a temperature of 70°C during 24 h was chosen for the outgassing contamination phase.

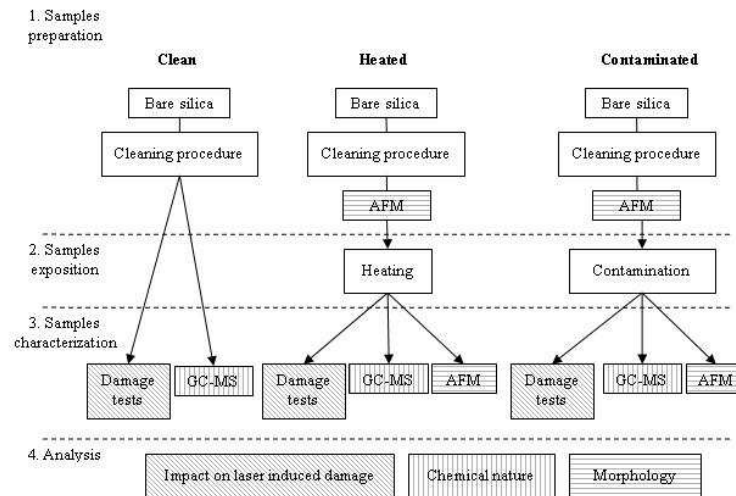
We used plano-parallel Corning 7980 fused silica polished samples. An experimental protocol detailed in Fig. 3, was used for contamination, for laser damage tests and for characterization. Preliminary, samples were cleaned using an automated cleaning procedure in a spray system machine with RBS 50 soap followed by an ethanol drag wipe. At this step, all bare samples exhibit the same laser induced damage density as typical clean LMJ optics, that is to say approximately 0.1 damage/cm<sup>2</sup> at 351 nm, for 10 J/cm<sup>2</sup>, and 3 ns pulse length. The contamination process is then carried out in the following way: the sample to be contaminated is placed in a clean glass box with 60 g of NPP. Silica sample and NPP in the glass box are then put in an oven programmed to do a cycle consisting in a rising slope of 6 h to 70°C followed by a stage of 24 h at this temperature and an abrupt return at ambient temperature during 15 min to help condensation of the outgassed species on the silica surface. To avoid any external contamination and guaranty the repeatability of the contamination process, glass box and NPP sample are cleaned in a washing machine with L51 soap followed by an ethanol cleaning prior to contamination experiment. To evaluate the impact of NPP outgassing, each contaminated sample is compared with a reference clean sample. Nevertheless, as the contaminated phase includes a heating cycle, a second reference sample is used; it is cleaned with the previous procedure and is heated with the previous temperature cycle without NPP in a similar glass box. These references were used for the following samples characterization

Fig. 3. Experimental protocol

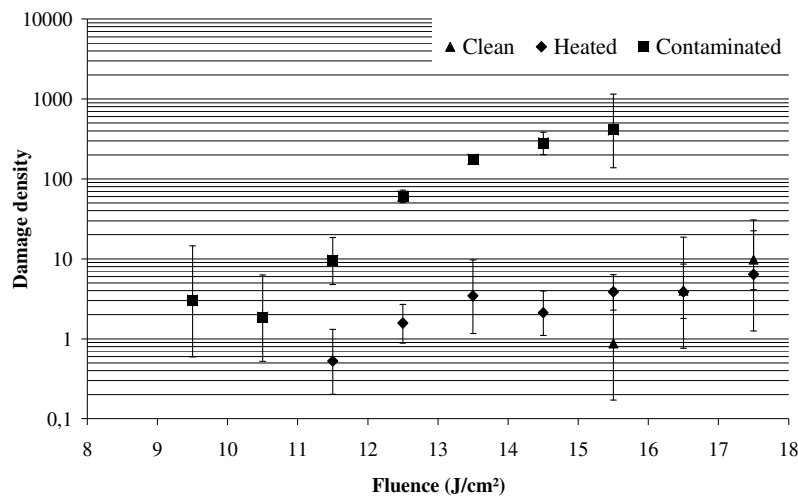
Laser induced damage tests have been made on several clean, heated, and contaminated silica samples. The total surface tested is about 100 cm<sup>2</sup> for each type of sample. Results are presented on Fig. 4. Firstly, damage tests reveal that clean and heated samples are similar. It demonstrates that the outgassing protocol without NPP has no effect on damage density. Laser damage tests on clean sample did not generate damage at fluences below 14 J/cm<sup>2</sup>. Secondly, the impact of NPP outgassing is significant. Indeed, from 11 J/cm<sup>2</sup> to 14 J/cm<sup>2</sup>, damage density is increased by a factor of 5 to 200 on contaminated samples.

Fig. 4. Laser induced damage tests of clean, heated and contaminated silica samples

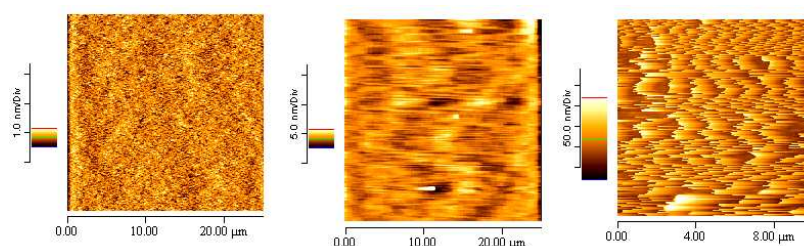
AFM measurements were made to determine the morphology of the contaminant layer. The measurements after cleaning and after contamination with NPP were compared. The same areas were analyzed each time. After cleaning, as shown on Fig. 6a, all samples exhibit a root mean square roughness of 0.1 nm with a standard deviation of 0.01 nm; which is conform to manufacturer's roughness specifications. Then, we performed the same measures after contamination. As showed on Fig. 6b, on the contaminated sample, streaks appear on the picture. AFM manufacturers warn that these streaks are artifacts related to a tip contamination [19]. They appear especially in location where there are sharp features and edges on the sample surface such as scratches or digs.

Fig. 6. AFM picture of bare silica samples after cleaning (a) and after contamination (b) – solvent spread on a fused silica sample (c)

These artifacts are relevant of a tip problem; the tip can be charged with liquid when scanned over the surface. To be sure that these artifacts are linked to the presence of liquid on the surface, a surface with a droplet of solvent deliberately deposited on it with a micro syringe, was measured. As shown on Fig. 6c, the presence of many streaks demonstrates that this behaviour of the tip is linked with the existence of a liquid film. Nevertheless, as this kind

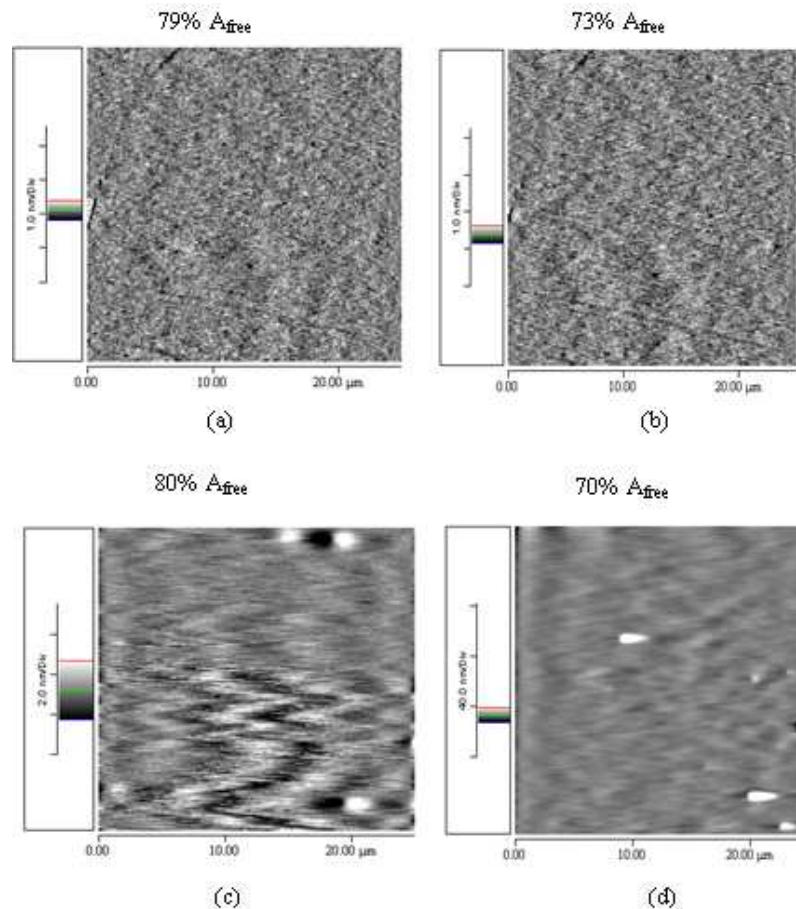
of pictures can also be attributed to the fact that the approach of the tip is not effective, complementary experiments were performed. AFM images of clean silica samples and contaminated ones were made with different set point amplitude values (Fig. 7). For 79% or 73% of the free amplitude, respectively images a and b of Fig. 7, clean bare silica surface is well distinguishable. We found the same root mean square roughness certified by the manufacturer. On contaminated samples, for low forces (80% of the free amplitude, Fig. 7c) the tip generates streaks and for higher force (70% of the free amplitude, Fig. 7d), the silica surface is still not apparent. Indeed, at the end of the measure, after the withdrawal step, the natural oscillating amplitude of the tip has decreased of about 20 nm and a shift of natural frequency was noticed. In normal conditions, the natural oscillating amplitude and frequency come back to the ordered values at the end of the withdrawal.

Fig. 7. AFM picture of bare silica samples after cleaning (a and b) and after contamination (c and d) for different set point amplitude values

In a similar experiment, imaging droplets, Pompe [20] noticed various behaviors for trace and retrace signal as well as amplitude and resonance frequency shifts of the cantilever, depending on the chosen set point amplitude value. It was attributed to the instability of the cantilever motion against the attractive capillary forces. For small set point, a permanent liquid bridge between the tip and the liquid drop is formed. This liquid bridge is likely to alter our AFM measurements.

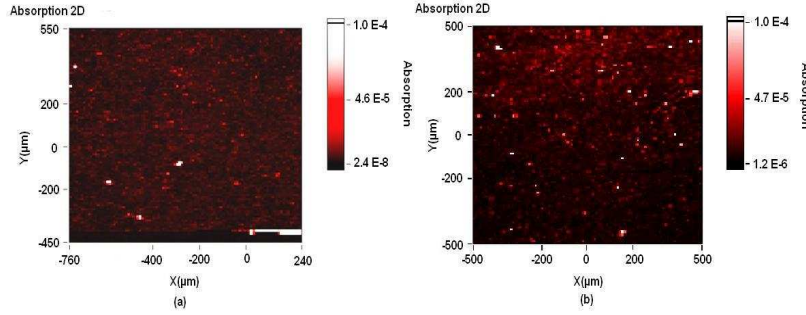
Fig. 8. Absorption mapping of clean (a) and contaminated (b) samples obtained by photothermal deflection with a sampling step of 20  $\mu\text{m}$

For the clean sample, a mean value of  $2.93 \cdot 10^{-5}$  with a standard deviation of  $4.08 \cdot 10^{-6}$  was measured; for the contaminated sample, a mean value of  $1.95 \cdot 10^{-5}$  with a standard deviation of  $9.43 \cdot 10^{-6}$  was measured. The difference between the clean and the contaminated sample is not significant showing that contamination does not affect absorption mappings. This technique is not adapted to measure such absorption. Furthermore, the more absorbing points visible are due to micrometer sized particles on the sample. We must outline that Palmier demonstrated that particles cannot be linked to damage in similar conditions (polished fused silica samples damage tested at 351 nm) [22,23].

The measurements were made on various areas of the sample and two times for each kind of sample. The same result has been found each time, which indicate that the signal is independent of the liquid contamination morphology. An example of experimental measurement results is given in Fig. 8
