Behaviour of ion irradiated chromium coatings on zircaloy-4 substrate

BEHAVIOUR OF ION IRRADIATED CHROMIUM COATINGS ON ZIRCALOY-4 SUBSTRATE

WU Alexia¹, RIBIS Joel¹, BRACHET Jean-Christophe¹,
CLOUET Emmanuel² et al.

NuMat 2016

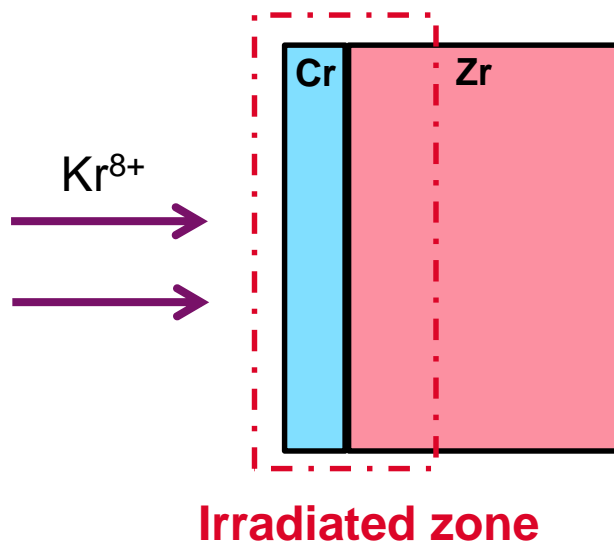
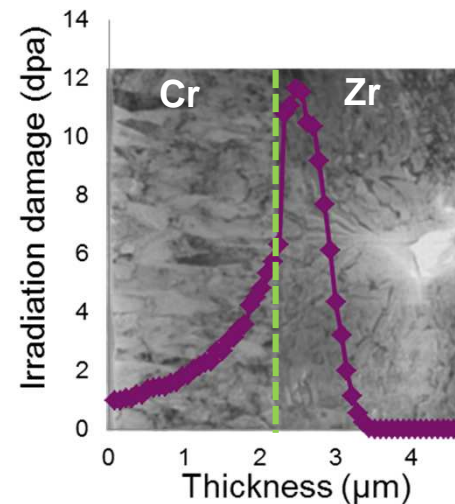
- Ion irradiations performed to get some fundamental insights on irradiation effects (*and thus to anticipate neutron irradiation behavior*)
- Ex-situ irradiation (Jannus Saclay)
 - Bulk material
 - Ions Kr^{8+}
 - Energy **20 MeV**
 - Irradiation temperature **400°C**
 - Average flux **$2,8 \cdot 10^{11} \text{ ion.cm}^{-2} \cdot \text{s}^{-1}$**
 - ~ **6 hours** irradiation
 - Dose **$5,97 \cdot 10^{15} \text{ ions.cm}^{-2}$**
 - Damage at the interface: **~10 dpa**

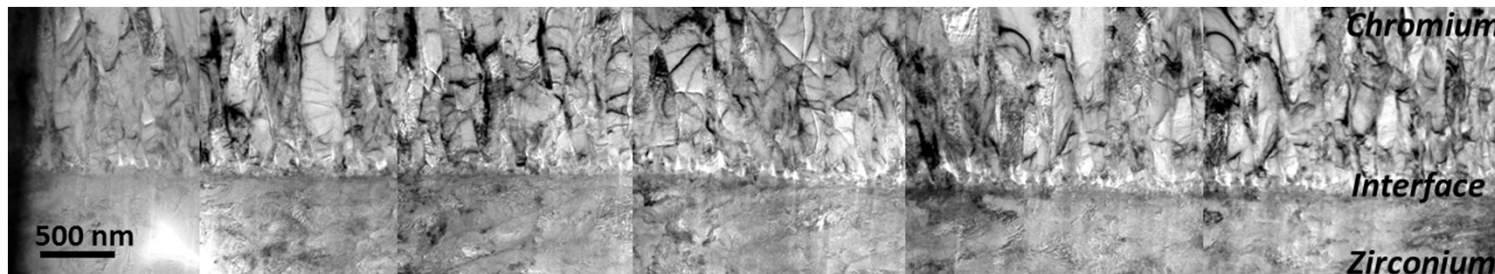
- Transmission Electron Microscopy characterisations:

- No microcracks, no voids at the interface
- Fully dense coatings, very good chromium / zirconium bonding

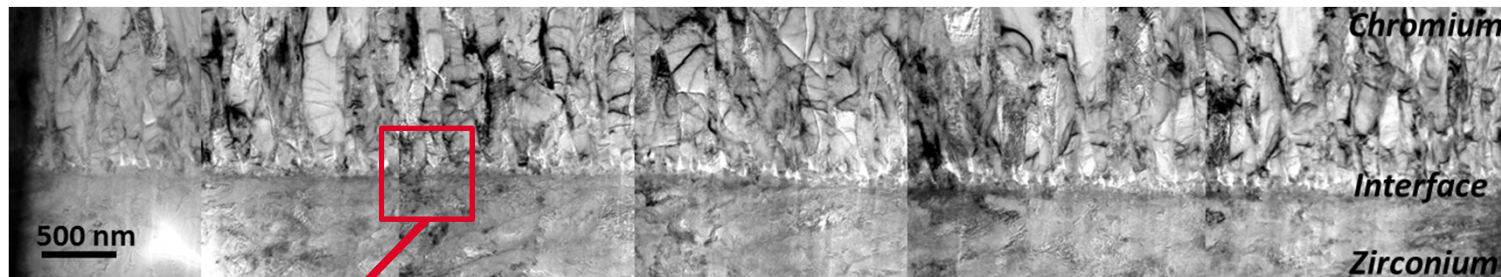
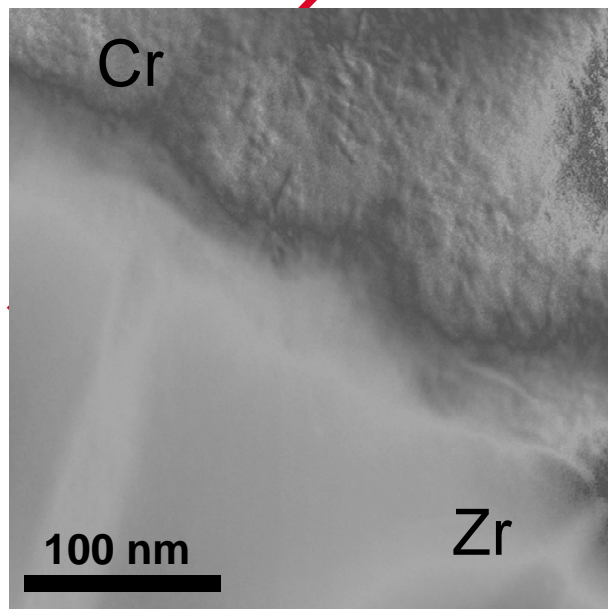
- TEM observation of a FIB thin foil sample

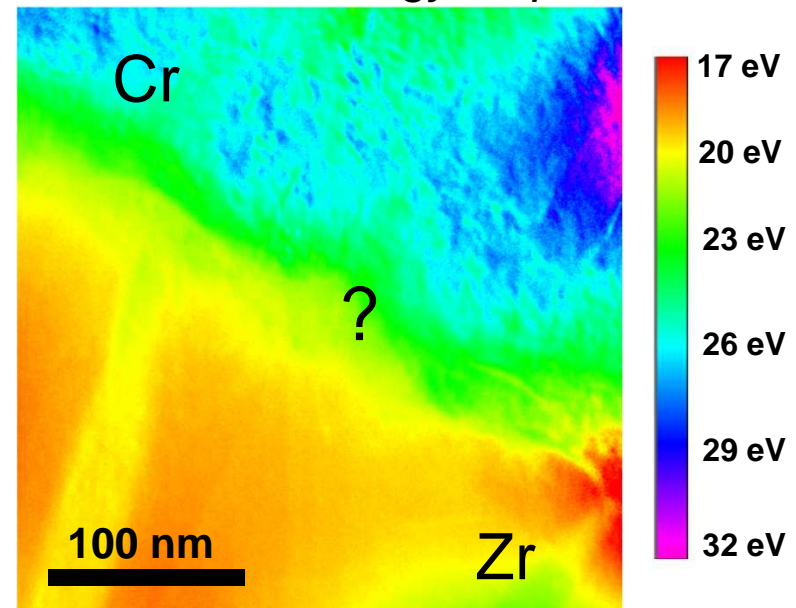
Plasmons energy map

- Plasmons energy showing intermediate values at the interface?

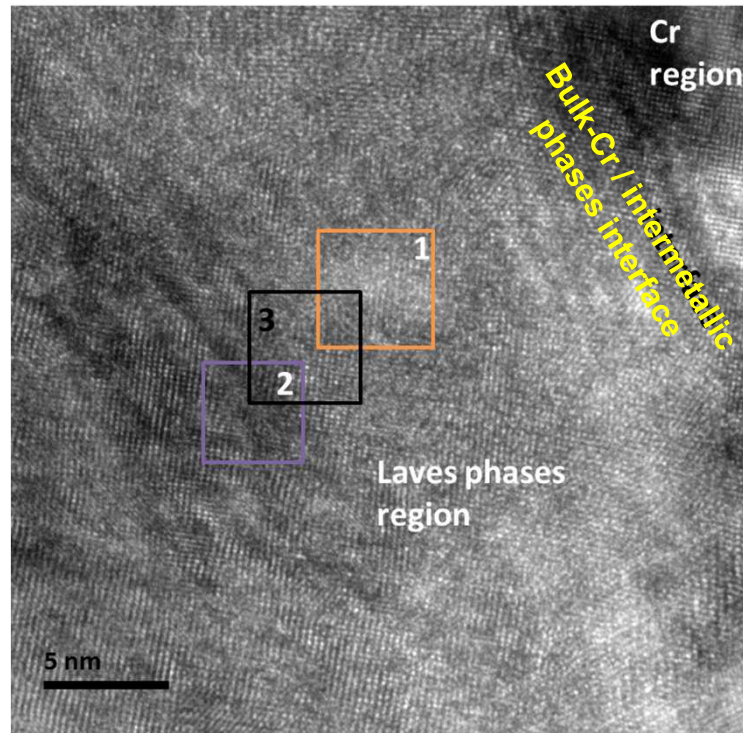
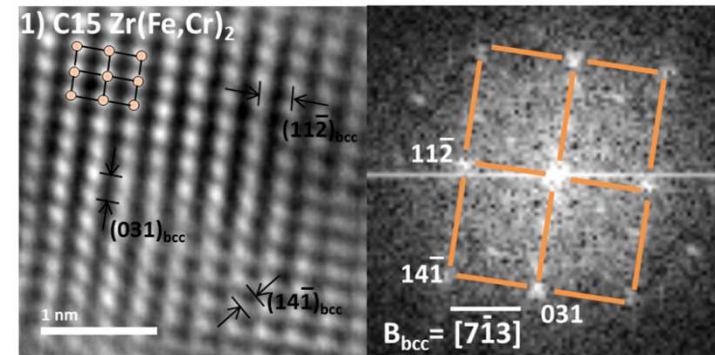
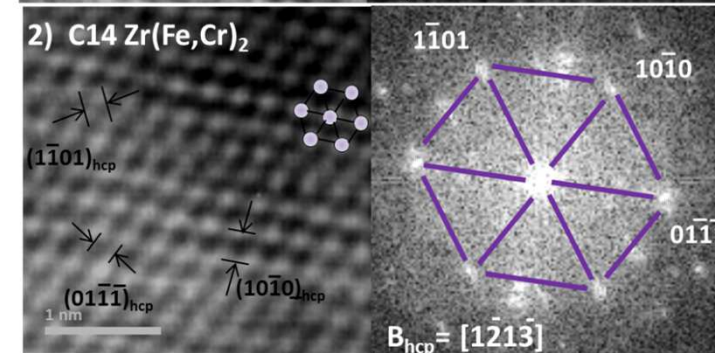
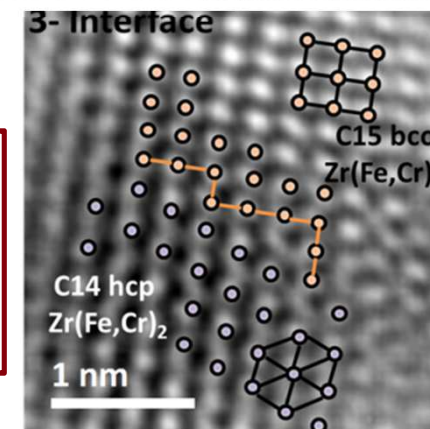
- High Resolution TEM (HRTEM) observation of a FIB thin foil sample

- Two intermetallic Laves phases $Zr(Cr,(Fe))_2$: C14 (hcp) & C15 (bcc) evidenced at Zr-Cr interface
=> polytype structure of the Laves phases (interface) layers

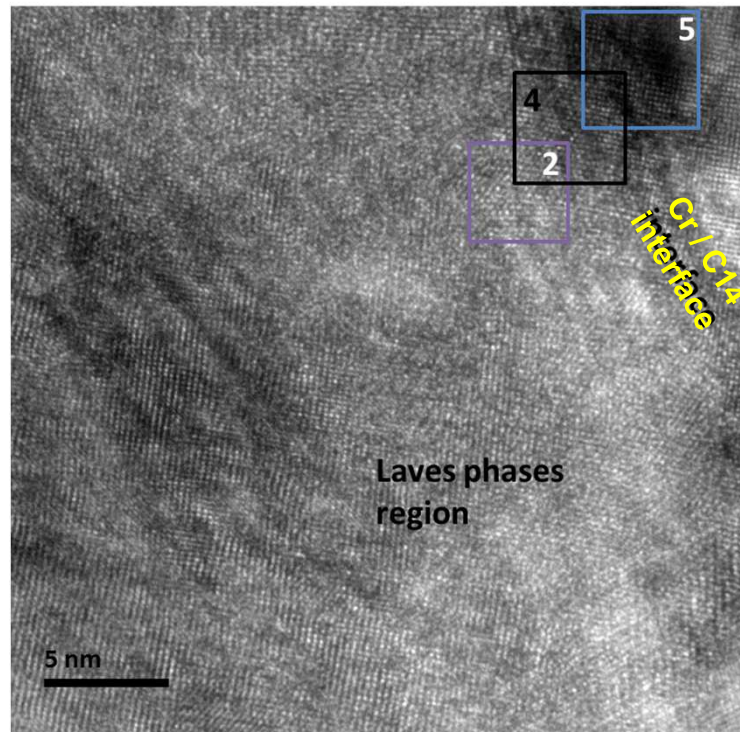
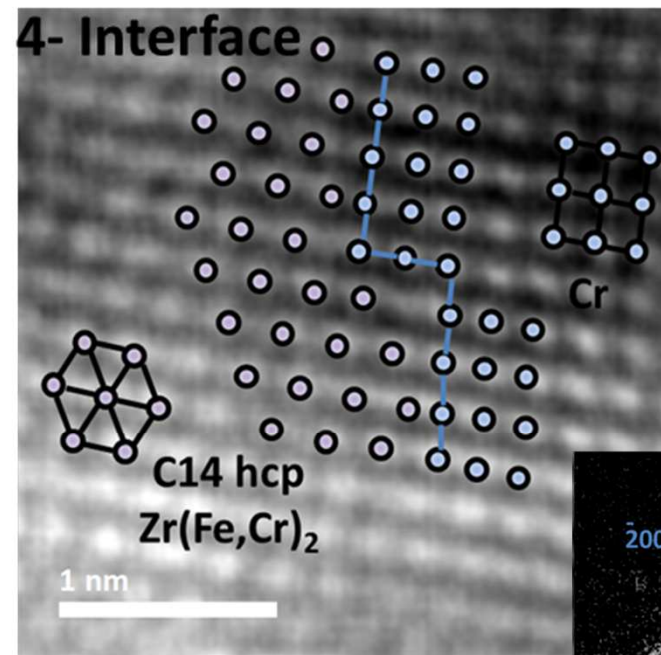
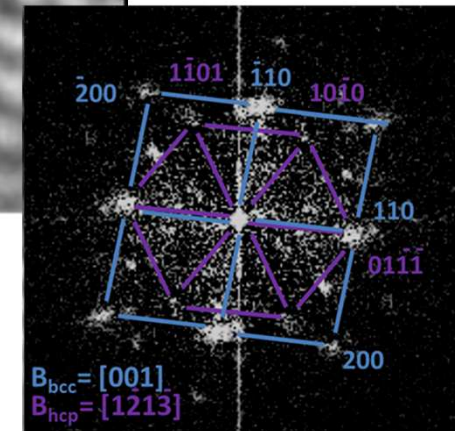
- HRTEM observation of a FIB thin foil sample

- Ledged interface between C14 - $Zr(Cr,(Fe))_2$ and Cr
=> **crystallographic continuity**
- Coherency along $[110]_{Cr} // [01\bar{1}\bar{1}]_{C14}$

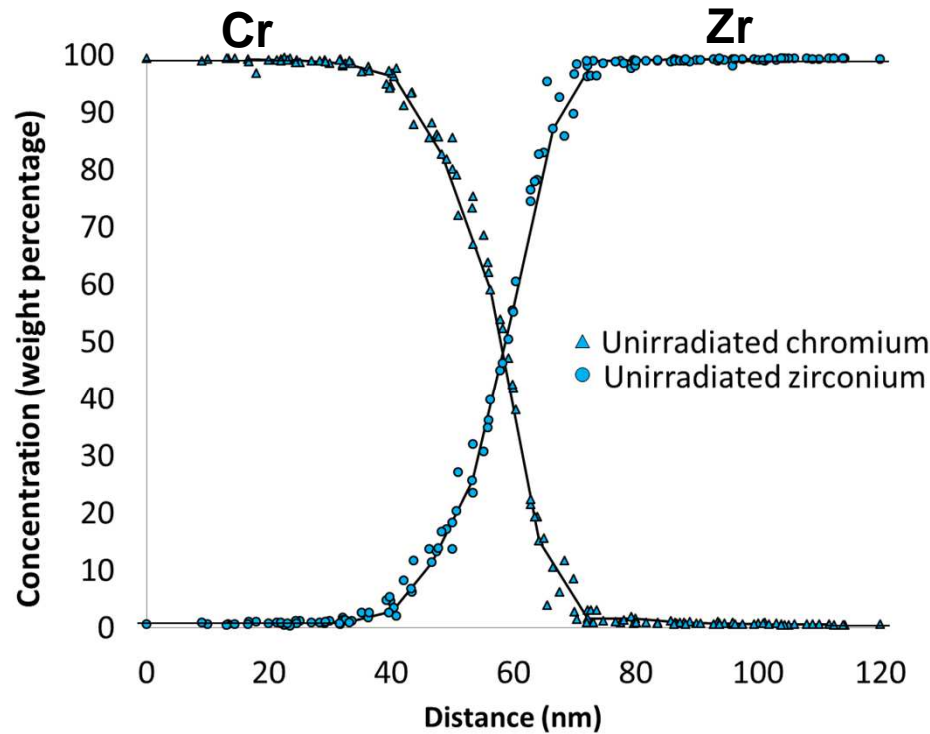
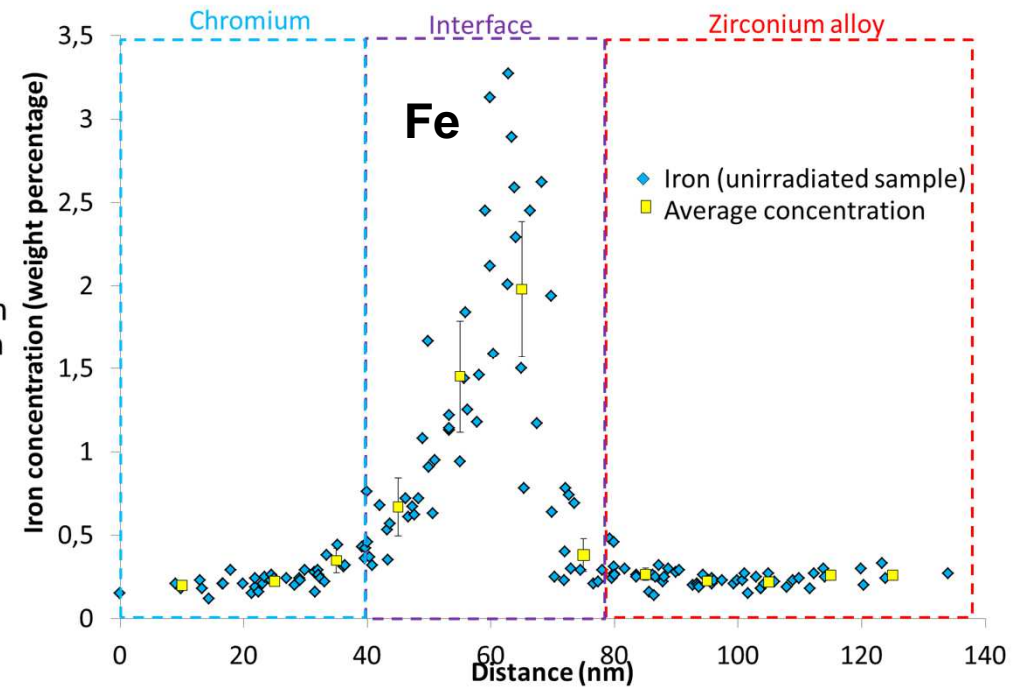
➤ Semi-quantitative chemical profiles (EDSX) at the interface

- *Some Fe enrichment at the interface prior to irradiation*
- *Evolution after irradiation?*

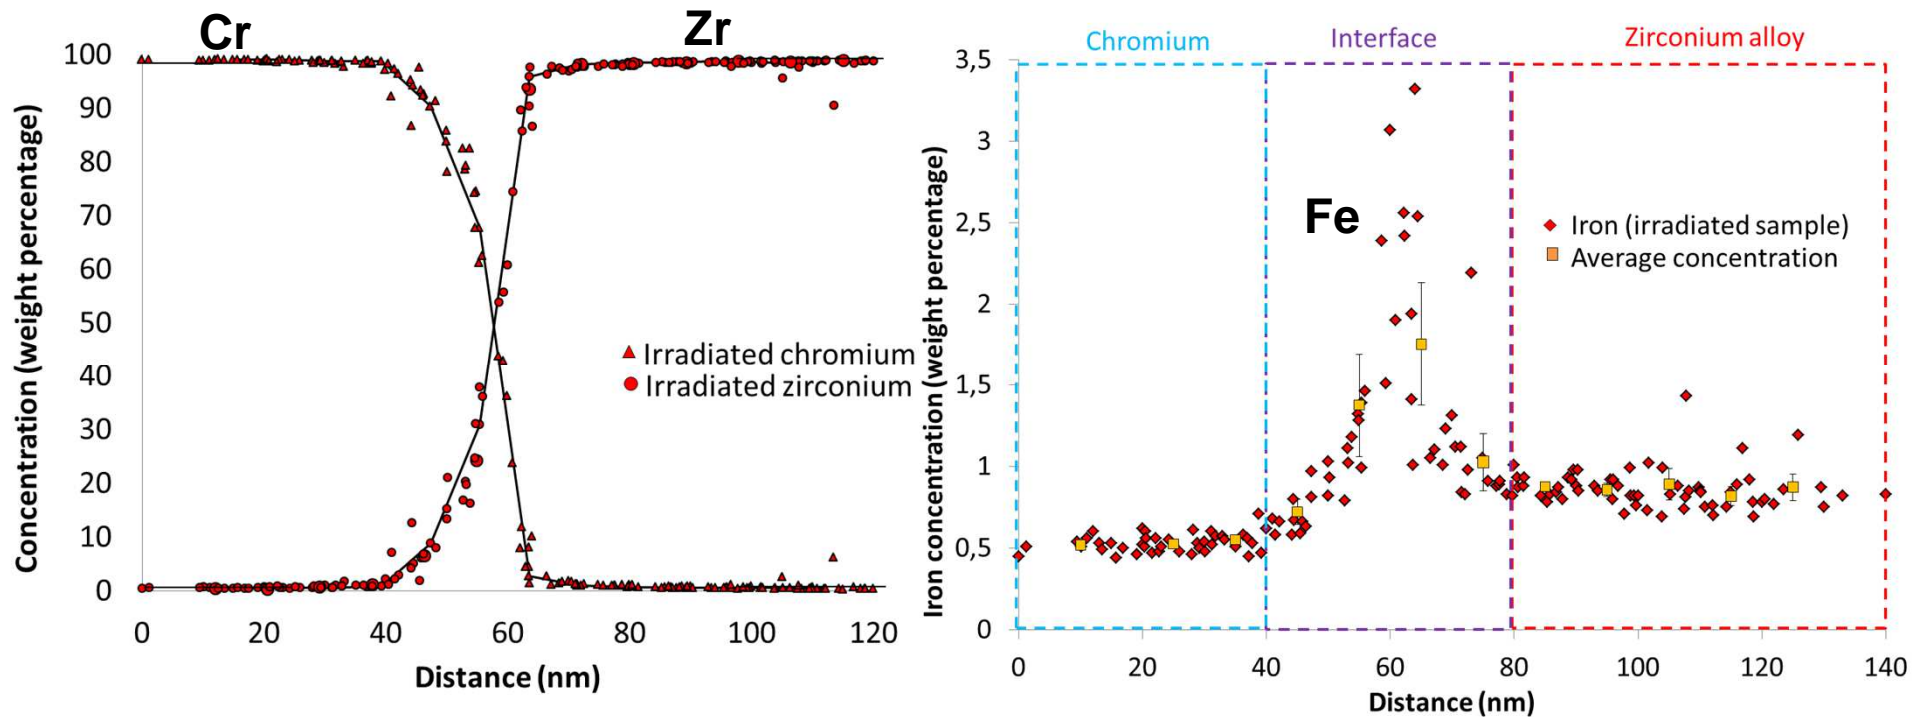
Ion irradiation up to ~10 dpa at the interface

➤ Semi-quantitative chemical profiles (EDSX) at the interface

➤ Fe enrichment still present at the interface after irradiation

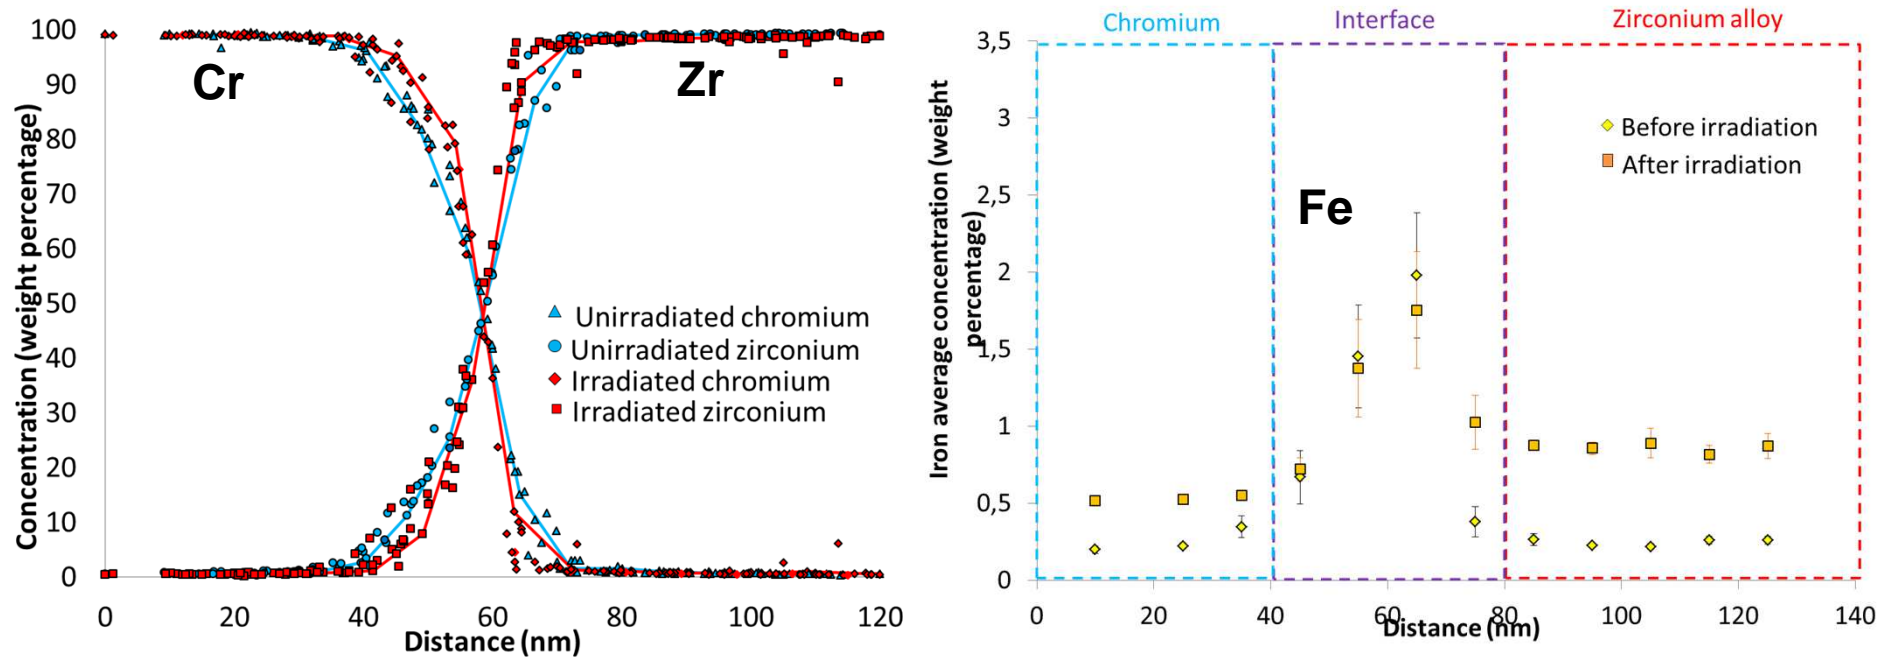
Ion irradiation up to ~10 dpa at the interface

- Semi-quantitative chemical profiles (EDSX) at the interface
=> Comparison before/after irradiation

- No significant additional interdiffusion between Cr and Zr after irradiation:
=> **Overall chemical stability of the interface**
- *No significant additional Fe enrichment at the interface
but apparent %Fe increase in neighbouring Zr and Cr after irradiation*

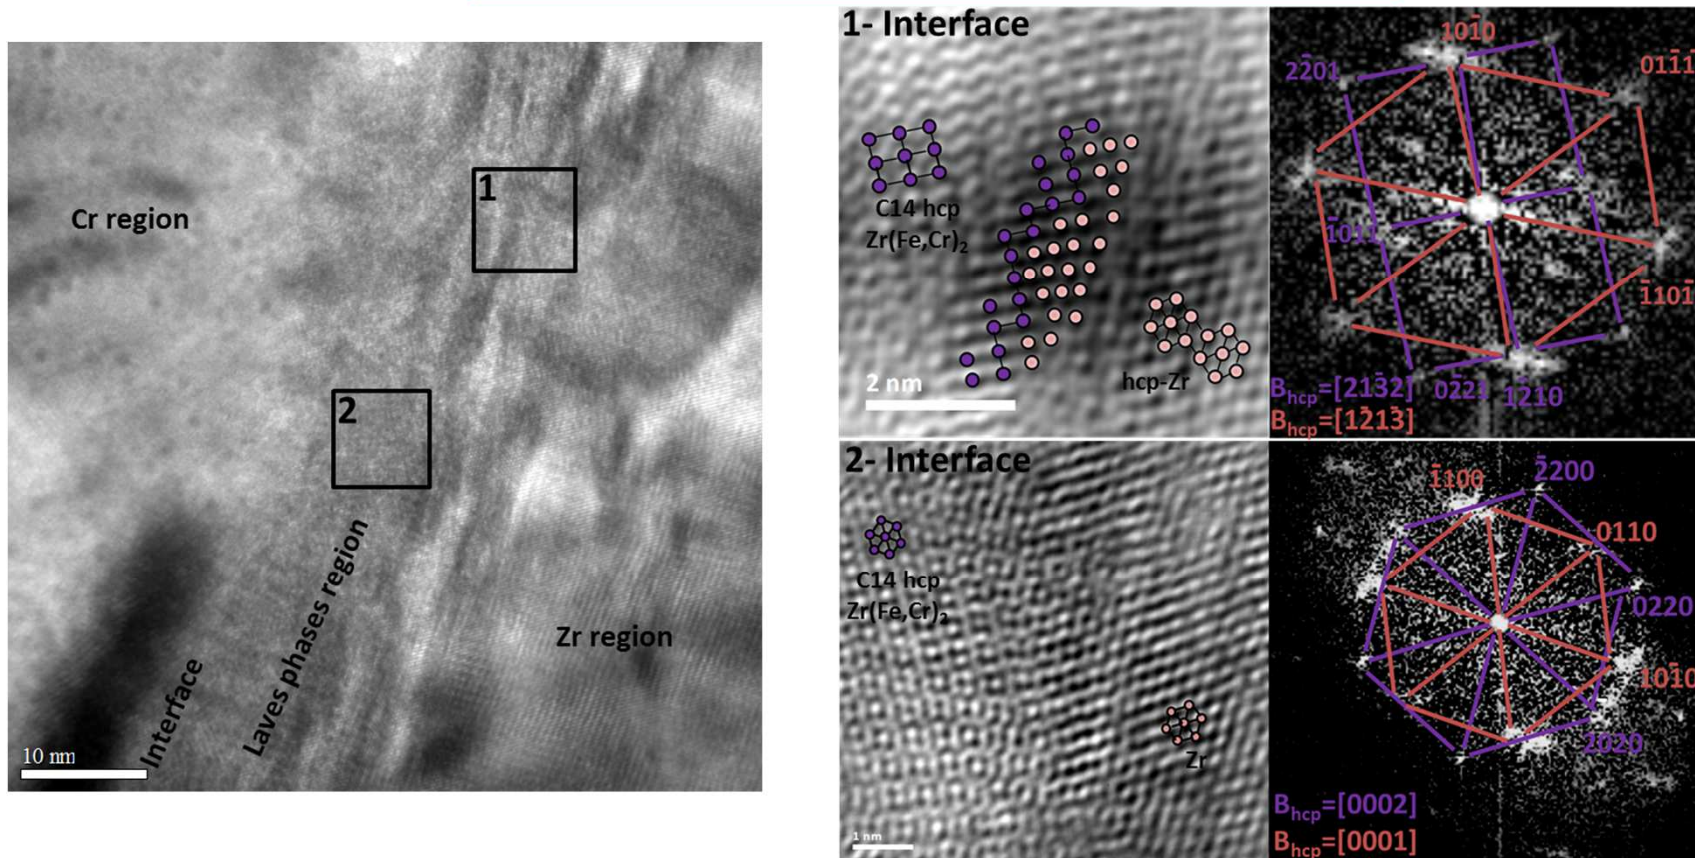
Ion irradiation up to ~10 dpa at the interface

- HRTEM observation of a FIB thin foil sample **after irradiation**

- Only C14 Laves phase observed (disappearance of the C15?)

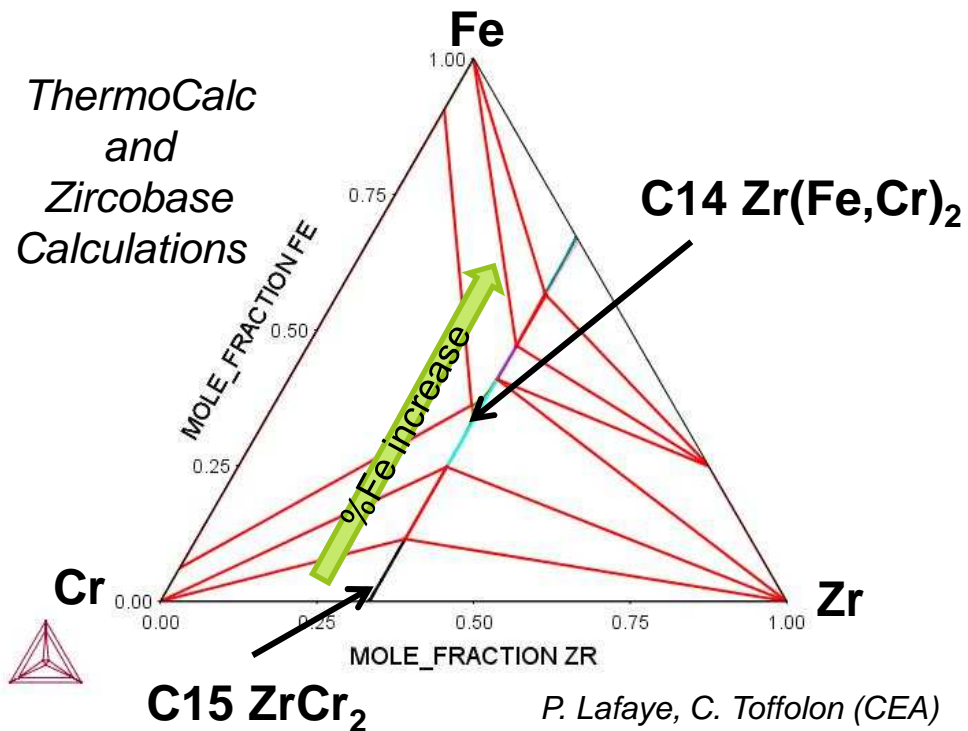
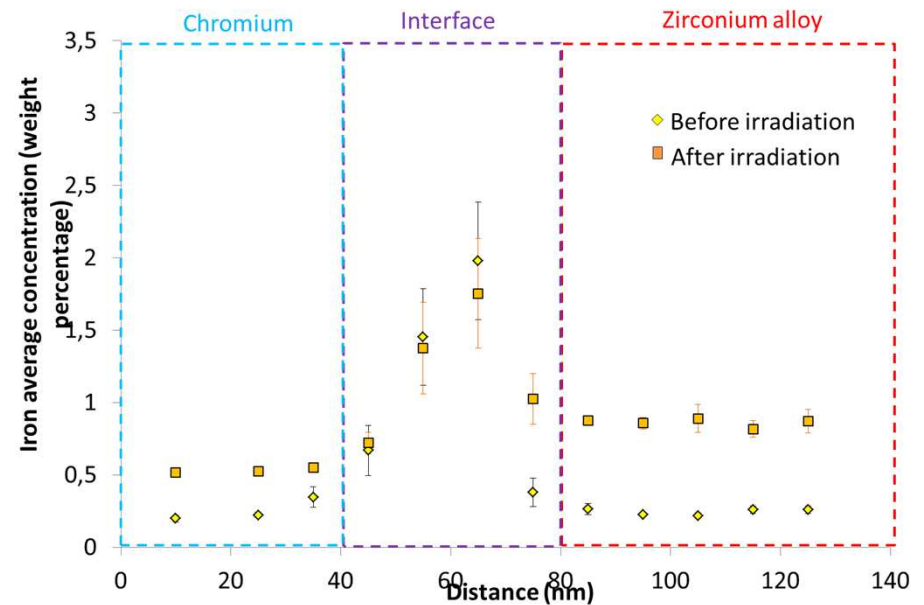
Ternary phase diagram Zr,Cr,Fe
(400°C)

➤ Possible explanation: Transformation of C15 Laves phase to C14 due to thermodynamic stabilizing effect of Fe

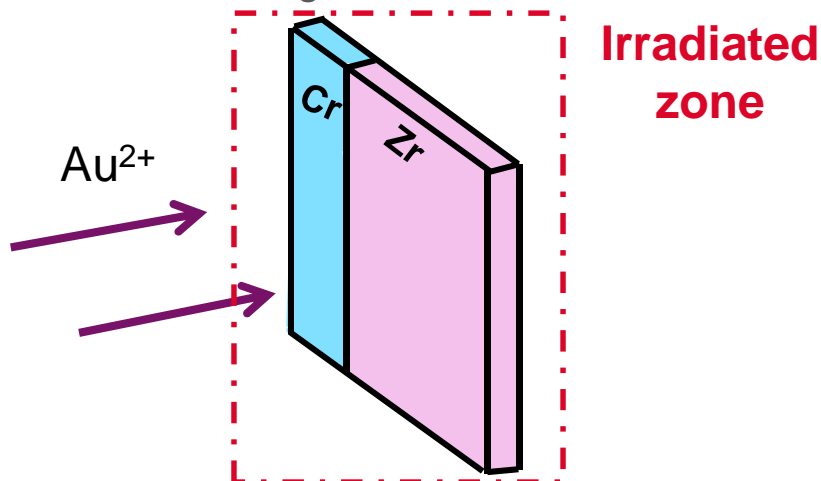
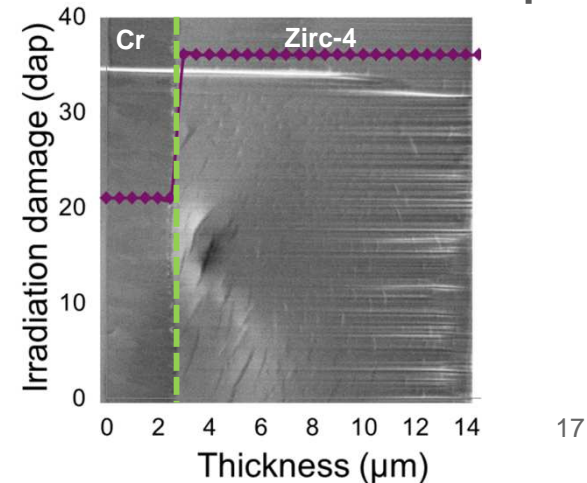
- What happens if we increase the damage?
 - In-situ irradiation (Jannus Orsay) up to **30 dpa** at the interface
 - FIB thin foil sample
 - Ions Au²⁺
 - Energy 4 MeV
 - Irradiation temperature 400°C
 - Average flux $2,8 \cdot 10^{11}$ ion.cm⁻².s⁻¹
 - Total dose $6 \times 8 \cdot 10^{14}$ ion.cm⁻²
 - Dose totale
 - In Cr: ~ 21 dpa
 - In Zr: ~ 36 dpa
 - At the interface: ~ 30 dpa

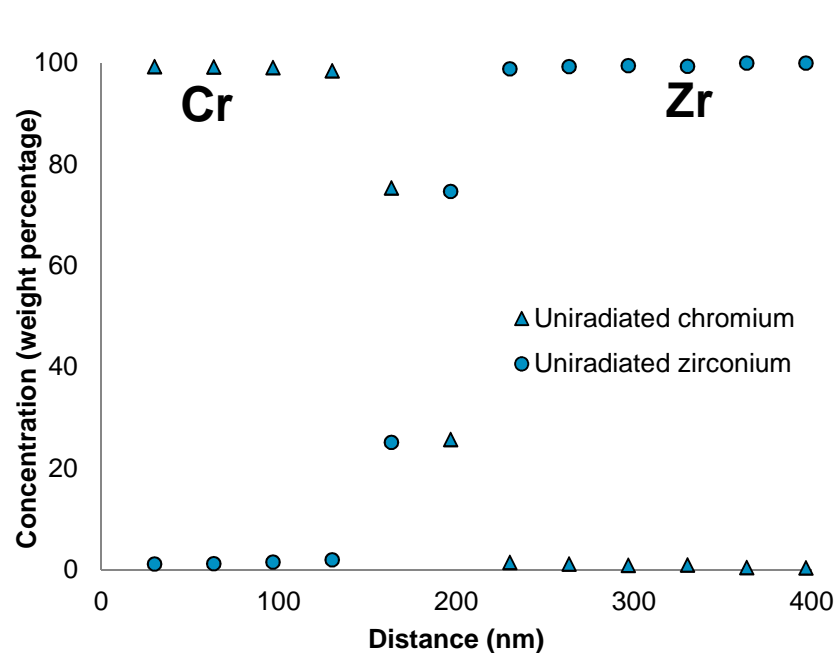
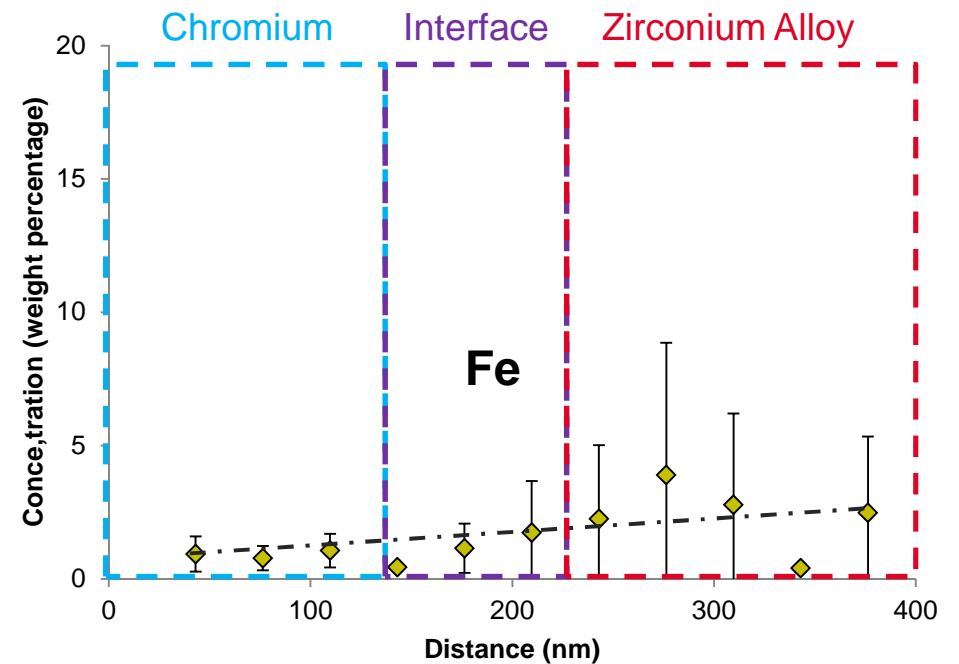
➤ In-situ characterisations: EDS before irradiation

➤ *On some very localized zone, apparent Fe enrichment into the Zircaloy-4 substrate just close to the Zr-Cr interface*

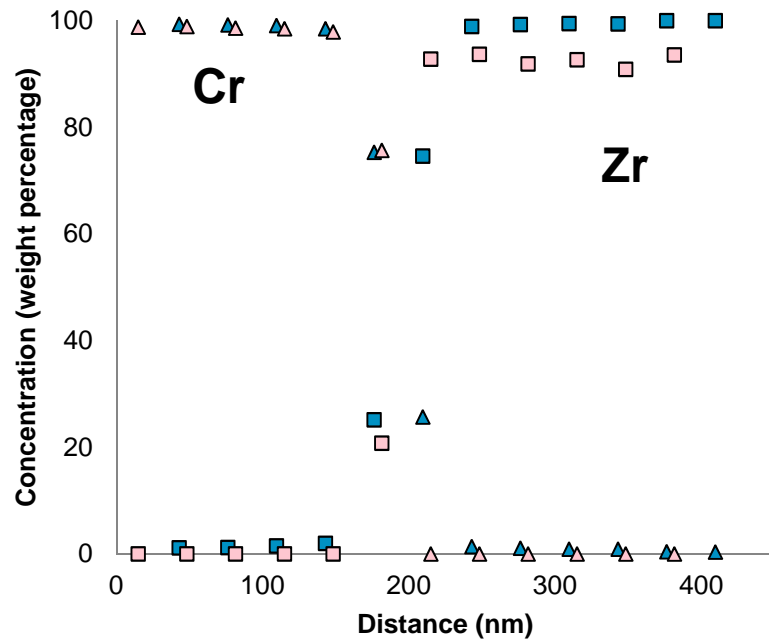
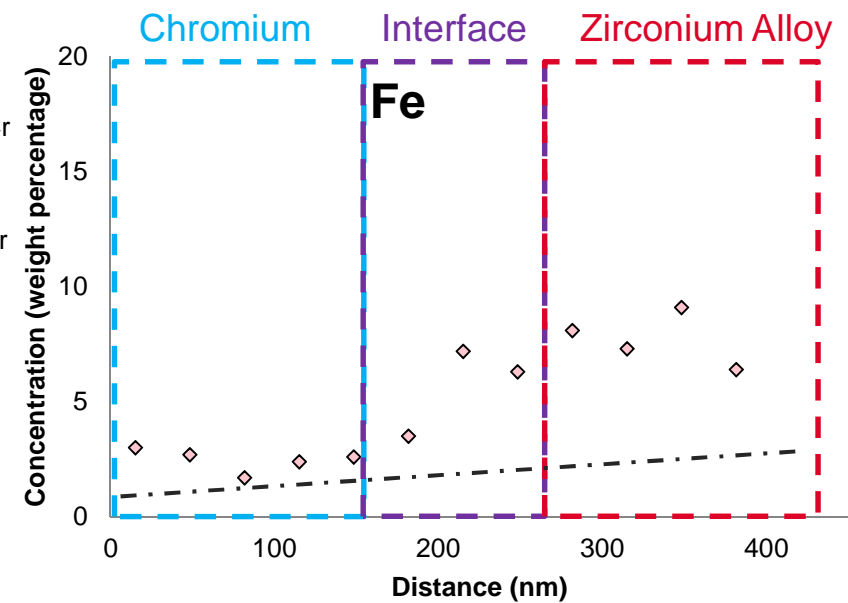
Ion irradiation up to ~10 dpa at the interface

➤ In-situ characterisations: EDS during ion irradiation

- **Stability of the Zr / Cr profiles after irradiation up to 25 dpa**
- *Apparent additional Fe enrichment into the Zirc-4 substrate close to the interface when the irradiation dose increases (needs more statistics)*

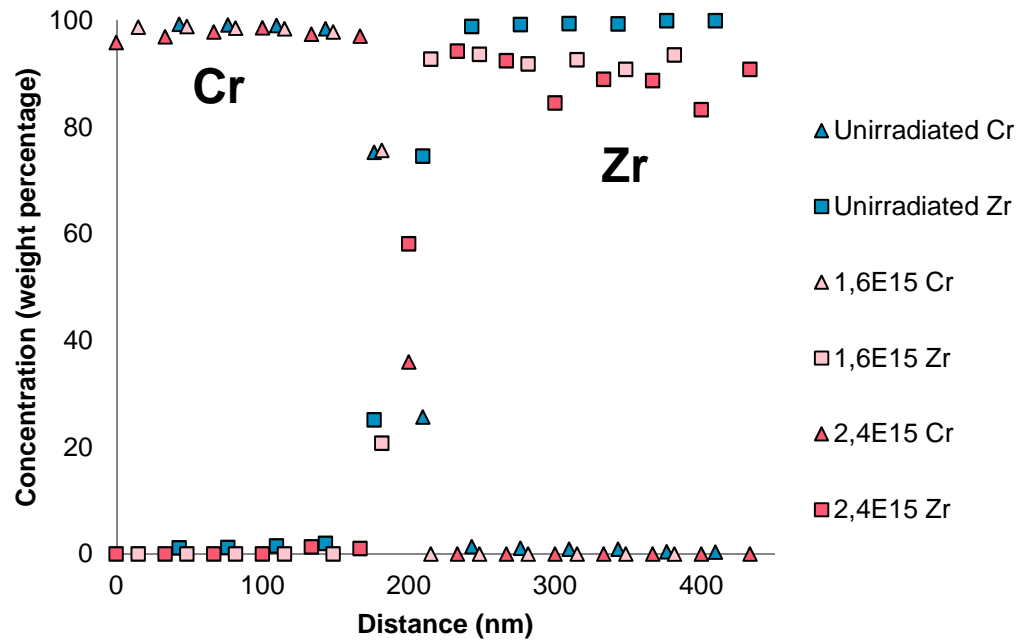
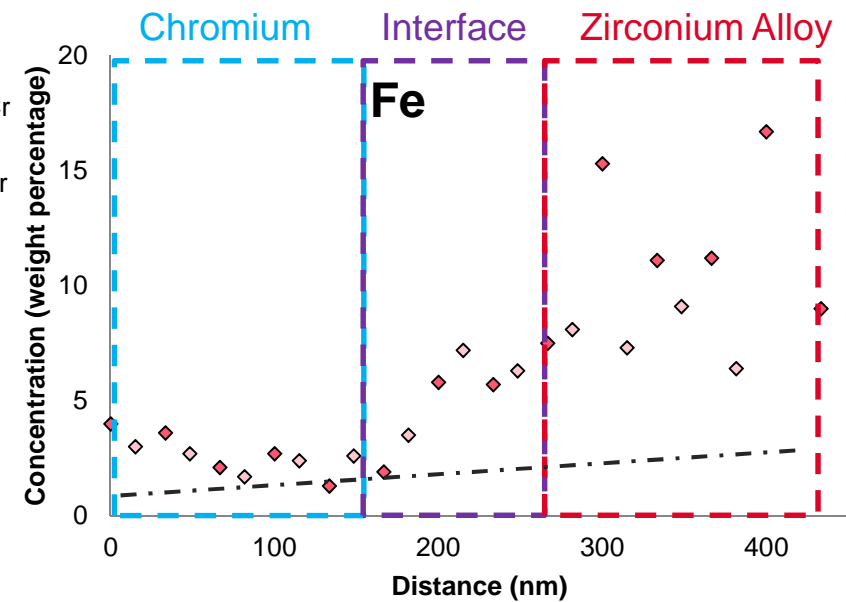
Ion irradiation up to ~15 dpa at the interface

➤ In-situ characterisations: EDS during ion irradiation

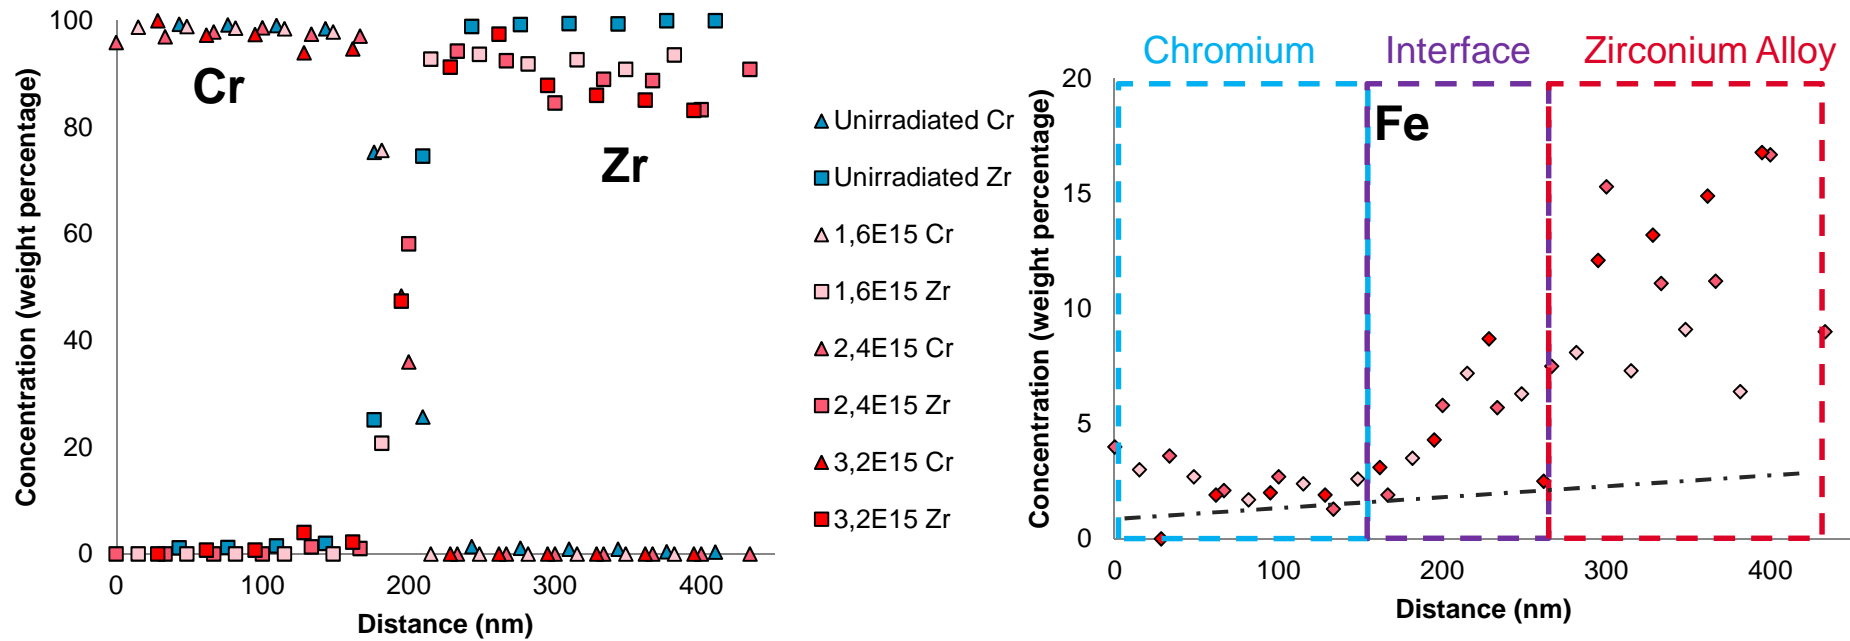
Ion irradiation up to ~20 dpa at the interface

➤ In-situ characterisations: EDS during ion irradiation

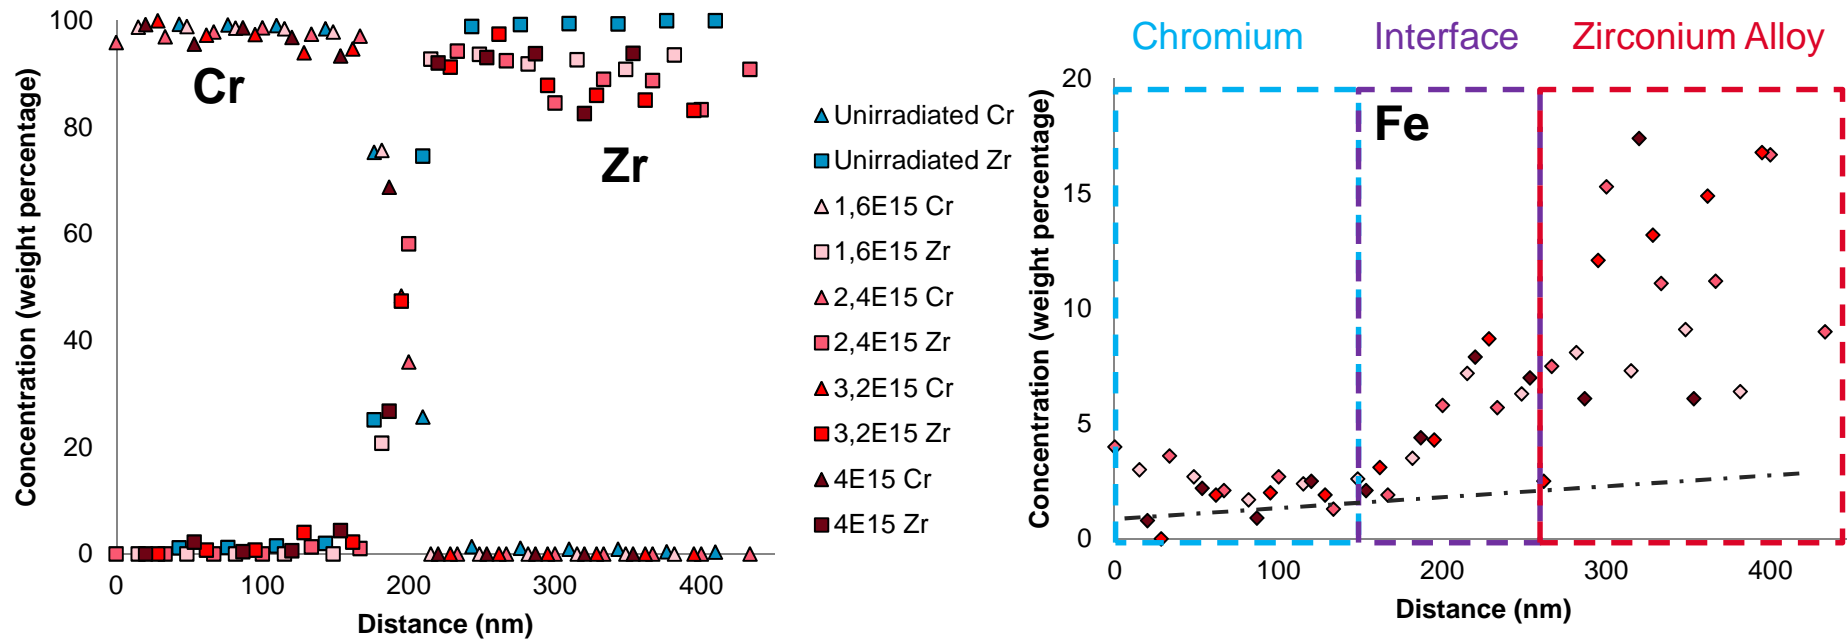
Ion irradiation up to ~25 dpa at the interface

➤ In-situ characterisations: EDS during ion irradiation

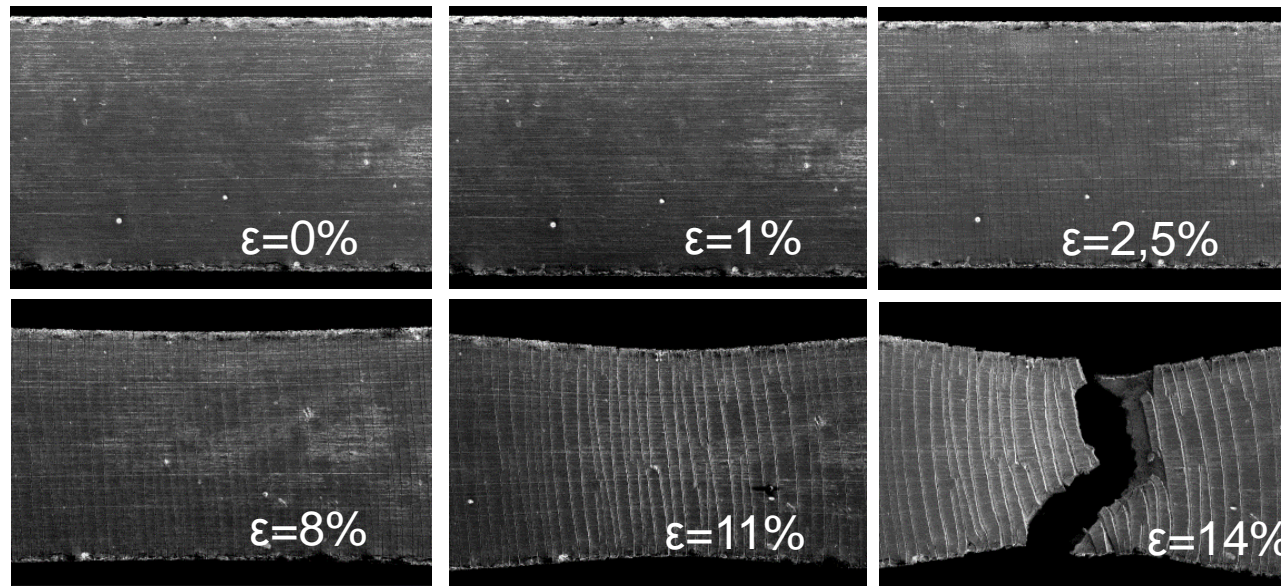
➤ **In-situ (SEM) mechanical testing of unirradiated and irradiated coatings**

No Cr coating delamination up to rupture

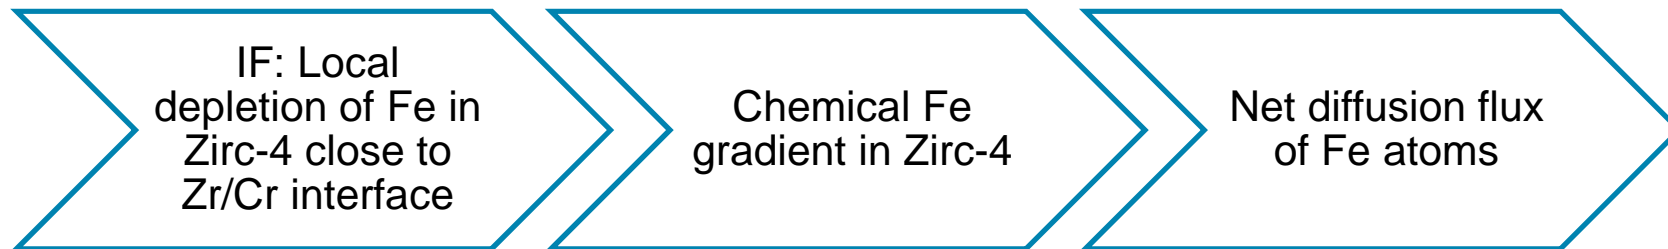
➤ 1) Fe is a fast interstitial-like diffusing elements in Zr

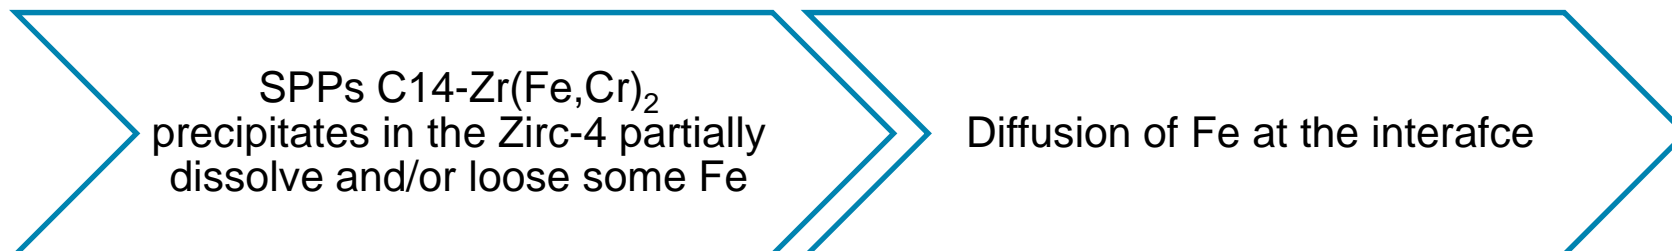
➤ 2) Limited content of residual Fe in the Zirc-4 matrix solid-solution

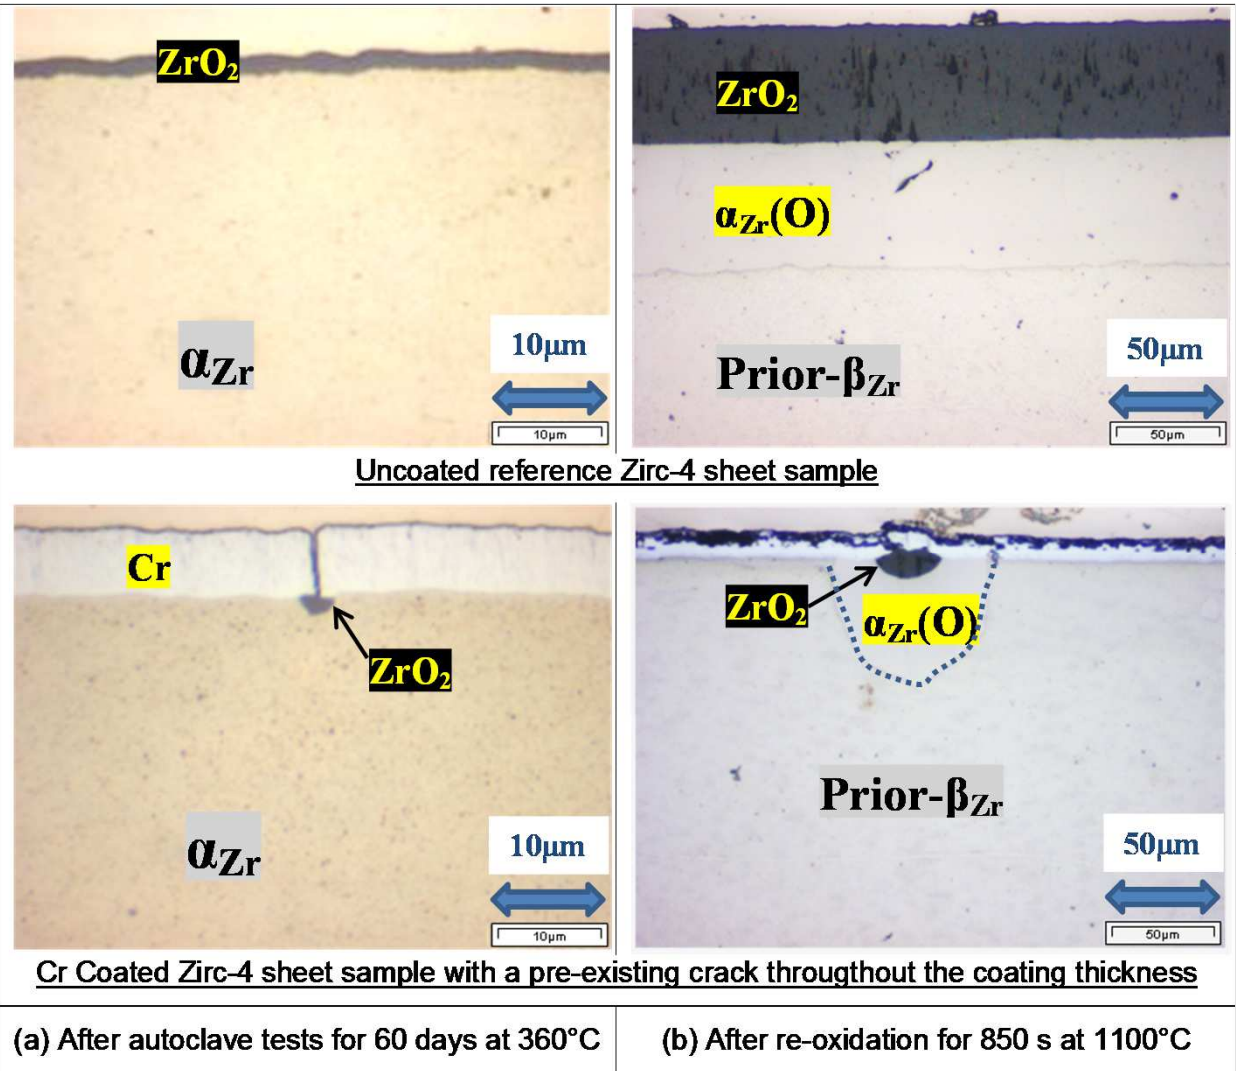
The potential negative impact of a pre-existing defect (i.e., as-received crack) within the Cr coating on the subsequent coated clad oxidation is an important issue:

⇒ Results obtained so far show only a limited and very localized impact of a pre-existing thru-wall Cr layer crack on the subsequent oxidation behavior for both nominal and accidental (LOCA) conditions (i.e., neither local accelerated corrosion, nor coating spallation)

⇒ However, further work is necessary: longer oxidation times...
