## Solar Reflector Materials Degradation Due to the Sand Deposited on the Backside Protective Paints

Aránzazu Fernández-García, Adel Juaidi, Florian Sutter, Lucía Martínez-Arcos, Francisco Manzano-Agugliaro

Aránzazu Fernández-García, Adel Juaidi, Florian Sutter, Lucía Martínez-Arcos, Francisco Manzano-Agugliaro. Solar Reflector Materials Degradation Due to the Sand Deposited on the Backside Protective Paints. *Energies*, 2018, 11 (4), pp.808. 10.3390/en11040808 . cea-02482464

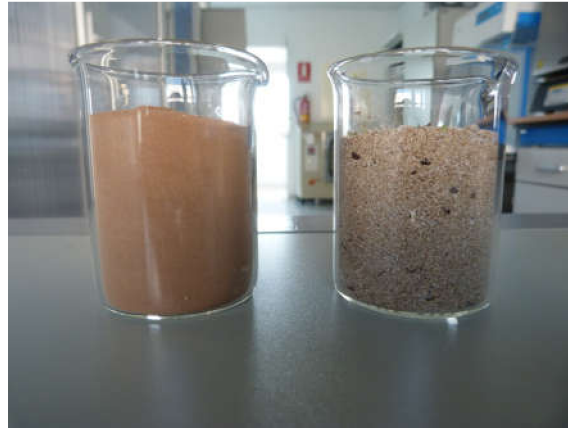
The two sand types are shown in Figure 2. As can be observed, the color of the sand from Morocco is red and the color of the sand from Dubai is light brown. The sand was sifted with a sieve shift, imposing a maximum of 180  $\mu\text{m}$  to simulate the particle sizes that might be expected to be deposited on the backside of the reflectors.

**Figure 2.** Picture of the two sands employed in the study, from Morocco (left) and the United Arab Emirates (UEA) (right).

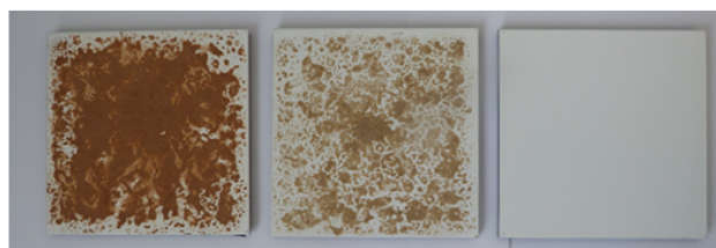
To deposit the sand on the backside of the reflector samples, the first step consisted in spraying demineralized water to wet the surface. After that, a weight of 1 g of sand was deposited with the fingers over the entire surface. Finally, demineralized water was sprayed again on the backside surface and the sand was kept dry for 24 h. The result after the 24 h is presented in Figure 5.

**Figure 5.** Picture of the set of samples after the sand deposition, with sand from Ouarzazate (left), with sand from Dubai (center), and without sand (right).

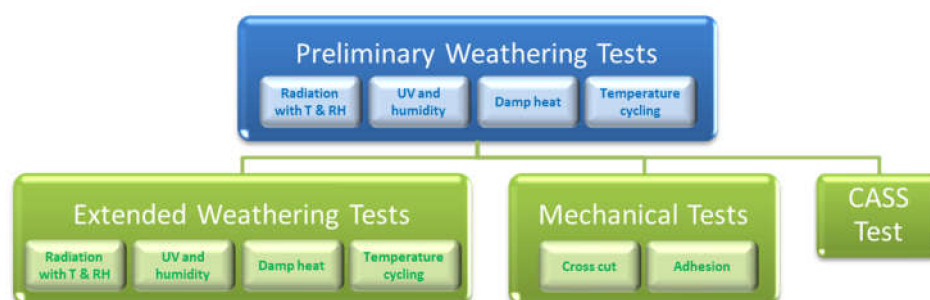
Figure 6 includes a scheme of the testing protocol followed.

Figure 6. Scheme of the test campaign.
