Corrosion issues in LWR: Other phenomena

D. Feron. Corrosion issues in LWR: Other phenomena. NuCoSS 15 - Nuclear corrosion summer school, Jul 2015, Bled, Slovenia. cea-02509665

CORROSION ISSUES IN LWR

« OTHER PHENOMENA »

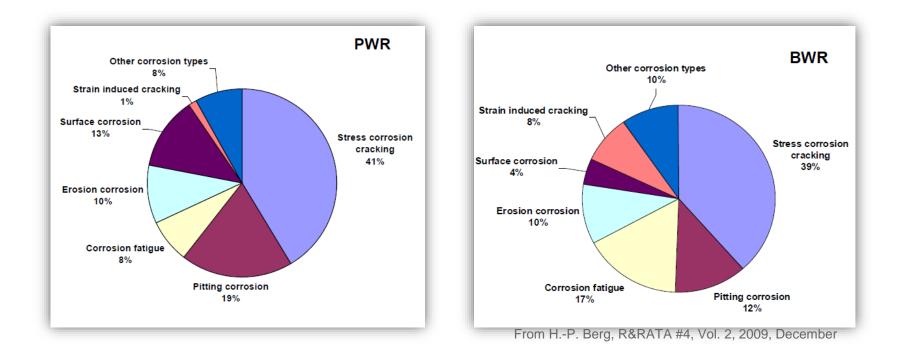
Distribution of corrosion types in PWR and BWR plants in Germany (1968–2001)

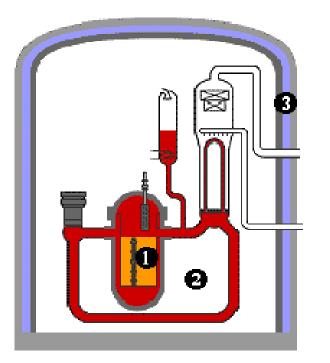
first barrier - fuel cladding : the fuel, inside which most of the radioactive products are already trapped, is enclosed within a metal cladding;
 second barrier - reactor coolant boundaries : the reactor coolant system is enclosed within a pressurized metal envelope that includes the reactor vessel which houses the core containing the fuel rods;

③ - third barrier – reactor containment: the reactor coolant system is itself enclosed in a thickwalled concrete containment building (for the EPR[™] reactor, the containment is a double shell resting on a thick basemat, the inner wall being covered with a leak-tight metallic liner).

If one of the barriers is leaking, the reactor is stopped

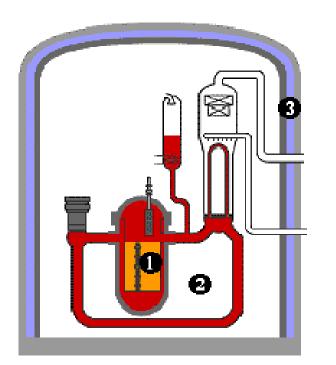
1 - fuel cladding : zirconium alloys / limited residence time (3 years)

2 - reactor coolant boundaries : pressure vessel (irradiation damages) but also pipes and steam generator tubes / life time of the plant (repairs except for the RPV)

Maintaining the integrity and leak tightness of just one of these barriers is sufficient to contain radioactive fission products.

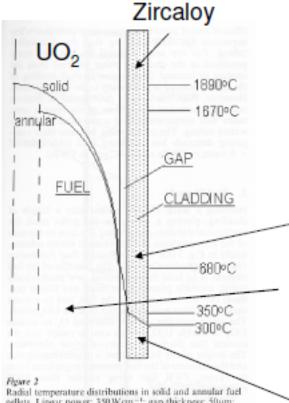
Radial temperature distributions in solid and annular fuel pellets. Linear power: 350 W cm⁻¹, gap thickness: 50 µm; fuel diameter: 10mm; control hole diameter in annular pellet: 2mm; gap gas: 20% senon, 80% helium. Pressure vessel: 40-60 years operation, < 1 dpa</p>

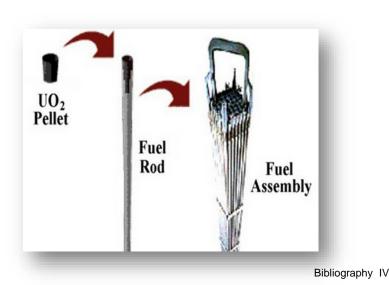
Chemistry: lithium /boron & hydrogen (Zn injection)
 Total residence time: 3 years increased to 5 years
 Burnup: from 30 GWd/t to 75-100 GWd/t
 Fuel cycles increased from 18 to 24 month cycle
 Evolution of the zircaloy alloy from Zircaloy4[®] to M5[®]

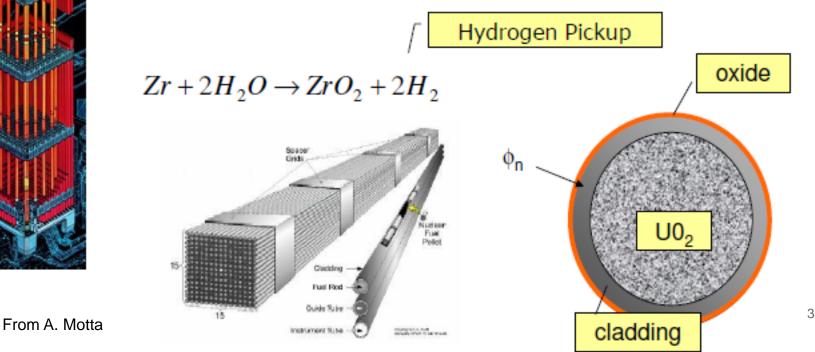
In reactor, Zr alloy cladding undergoes

- on the outersurface (water side)
 - General corrosion from primary water
 - Hydriding
- on the innersurface (oxide side)
 - Stress corrosion cracking (iodine)

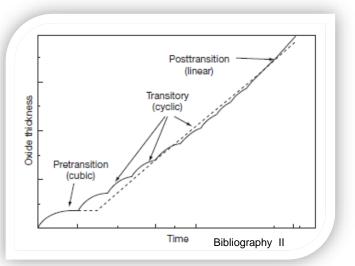
Schematic representation of the zirconium alloy corrosion showing the pretransition, the transitory and the postransitory regions

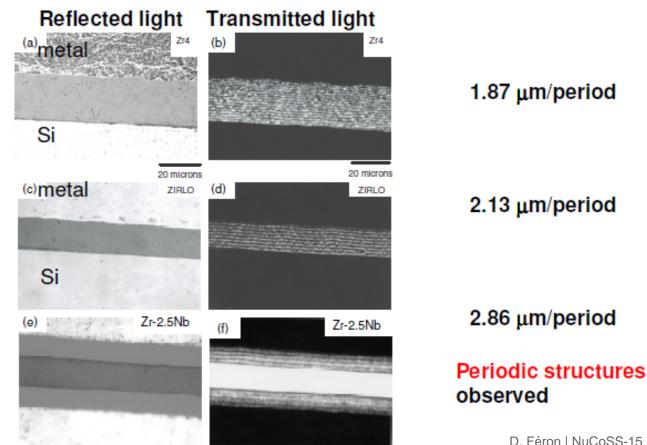
Transition thickness is characteristic of alloy, chemistry and very reproducible

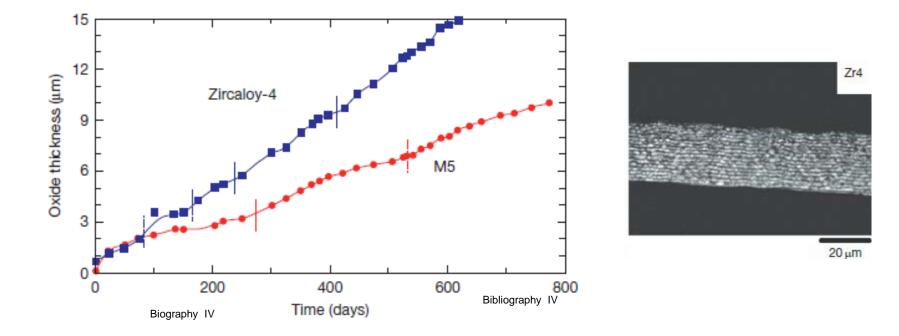
Oxidation rates of Zircaloy-4 and M5TM

measured in primary water conditions by autoclave tests (at 360°C, with10 ppm of Li and 650 ppm of B in water). Cycles appear with transitions

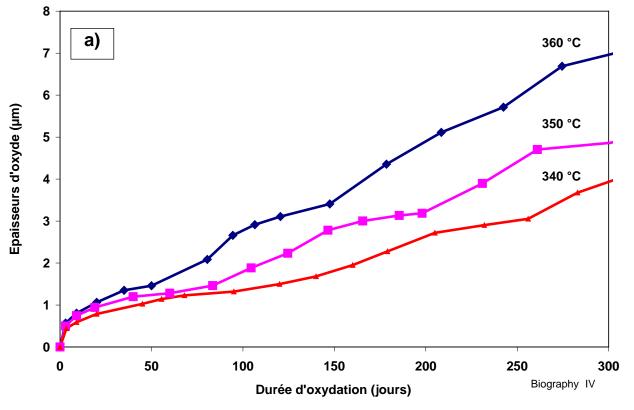
Temperature influence on the oxidation rate of Zyrcaloy-4 in primary water conditions

- Major influence of the temperature -

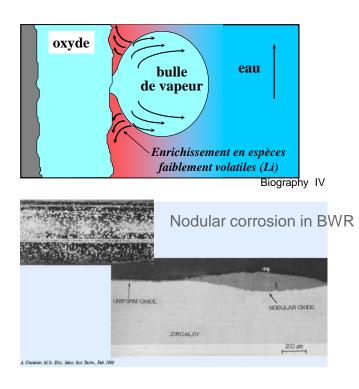
Boiling on cladding

- Temperature increase
- Sequestration of non volatile species (Li)

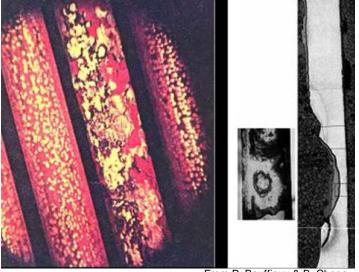
Crud deposition on cladding

- Temperature increase
- Steam pockets

Cladding corrosion and crud deposits observed on BWR with brass condensers

Local increases of the temperature: one of the explanations of observed local degradations (nodular corrosion & Crud Induced Localized Corrosion – CILC)

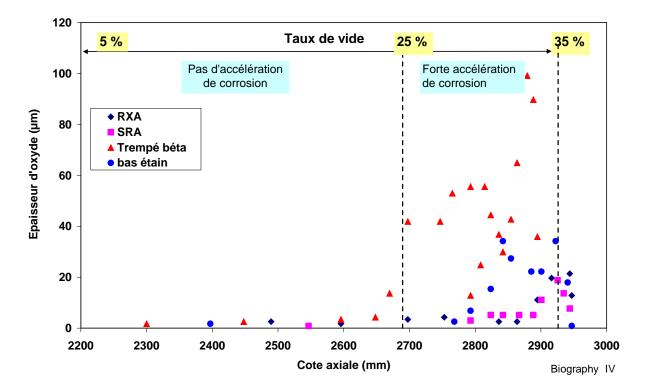
Axial profile of the oxide thickness measured along several claddings made of Zy4:

Important increase of the oxide thickness at the top of the fuel tubes where the temperature is the highest

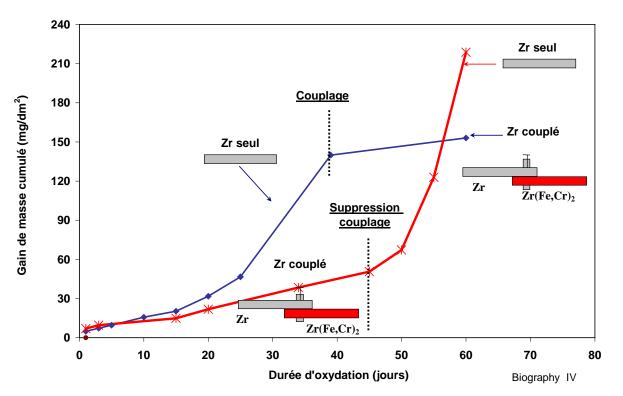
Galvanic corrosion / coupling effects (at 360°C, with 10 ppm of Li and 650 ppm of B)

- with no coupling, Zr oxidation rate is high
- Coupled to $Zr(Fe, Cr)_2$, Zr oxidation rates are lower

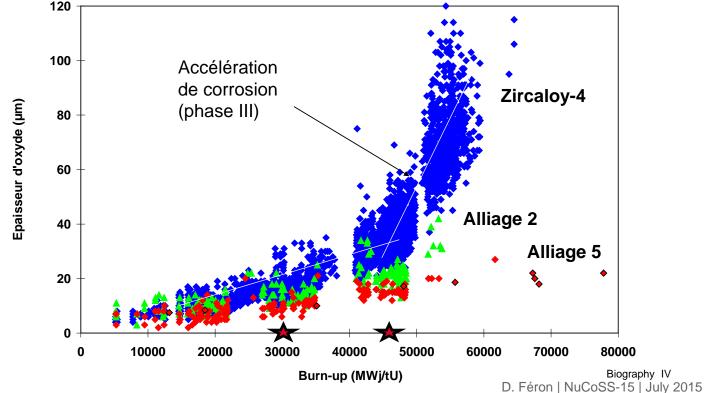
Thickness of the oxide measured by Foucault currents, on site and in hot laboratories on claddings made of Zyrcaloy-4 (1.3 % Sn), $M5^{TM}$ (alliage 5) and alliage 2 (0.5 % Sn)

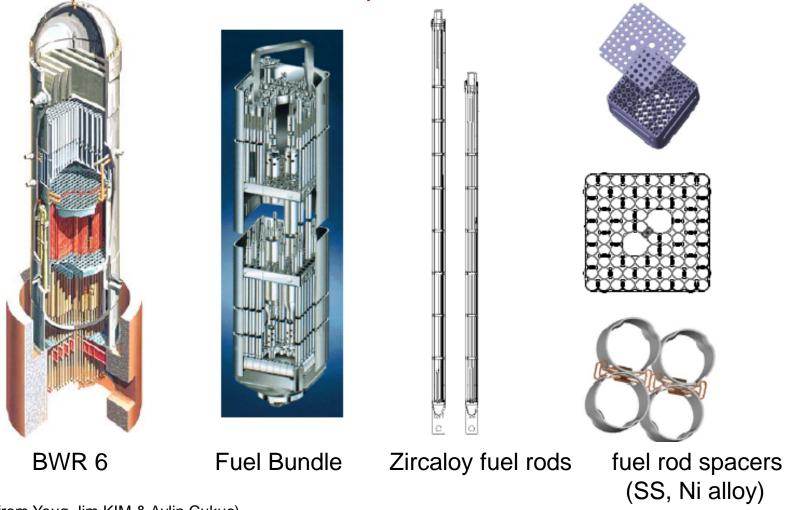
Shadow corrosion: specific to BWRs

Shadow corrosion observed after in reactor service

- Ziracloy 2 surface adjacent to spacer (SS or Ni alloy)
- Thicker oxide in shadow
- No correlation with hydrogen pickup
- No shadow corrosion in PWR
- No shadow corrosion in lab.
- Radiation enhanced corrosion

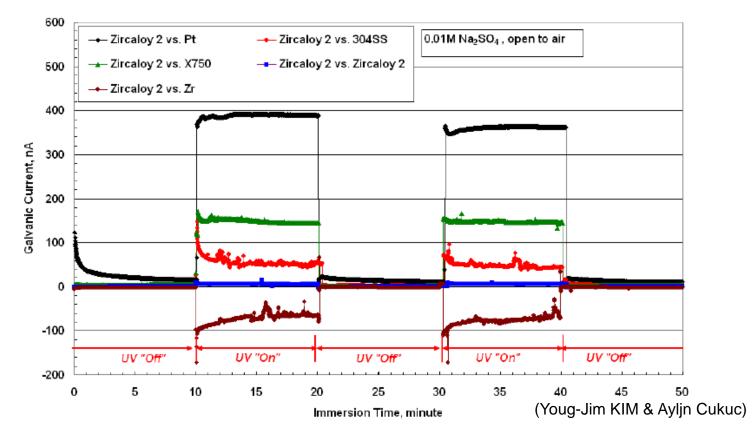
Galvanic corrosion tests

- UV « On »: positive current flow indicates the anodic dissolution of zircaloy 2
- > UV is needed (radiation needed)

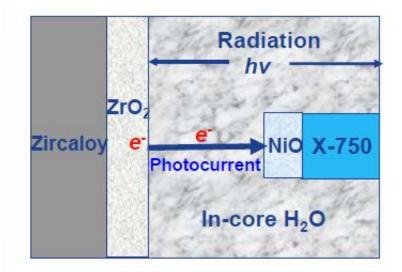
- The holes migrate to the surface, reacting with an donor state while the electron moves to the backside contact.
- Anodic photocurrent
- NiO (p-type film)
 - The electron migrates to the surface and reacts with oxidized chemical species in the electrolyte
 - Cathodic photocurrent
- Galvanic corrosion
- Corrosion potential diffrence between the two alloys)

- Zry2: Low corrosion potential, anodic Dissolution, high corrosion rate
- X-750: High corrosion potential, cathodic reaction, low corrosion rate
- Electron transfer from Zry2 to X-750

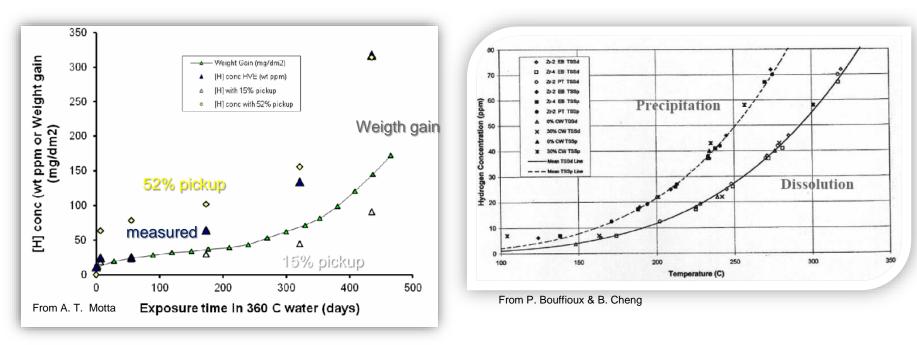
- The Zr alloy absorbs a fraction of hydrogen produced by the zirconium oxidation in primary environments (liquid water & steam)
- The absorbed hydrogen precipitates as hydrides when the solubility limit is exceeded

Hydrogen pickup fraction (correlated to the oxide layer thickness)

Hydrogen precipitation and dissolution of Zr hydrites

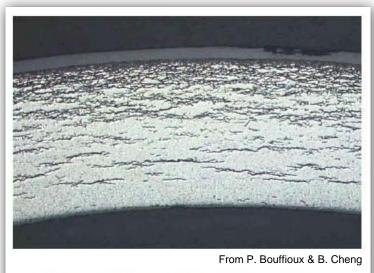
In PWR with high burnup: a hydride rim (30-60 µm) is observed close to the colder outer surface (oxide thickness > 50µm)

PWR – CWSR Zy4 - ZrO₂ > 50 μ m

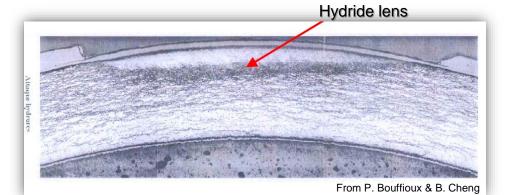
- If oxide layer delaminates, the outer surface will be colder (better cooling) and hydrogen precipitates to form hydride lens

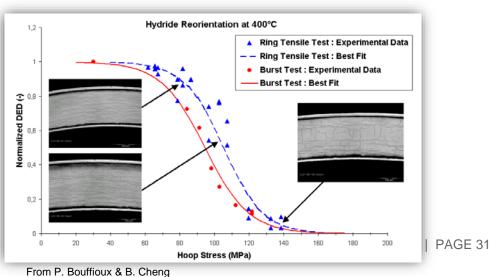
Ductile (1) to brittle (0) transition as function of the hoop tress

- Crack initiates in the rim or lens and propagates (high burnups with Zircaly 4)
- Ductility is reduced
- Delayed hydride cracking (DHC phenomenon occurs at lower temperatures, for instance during dry storage / crack initiation under reactor operation and crack propagation at lower temperatures)
- Hydride reorientation (HRO) occurs when tensile hoop stress are generated by internal pressure (during cooled down often) and results in a ductile cracking

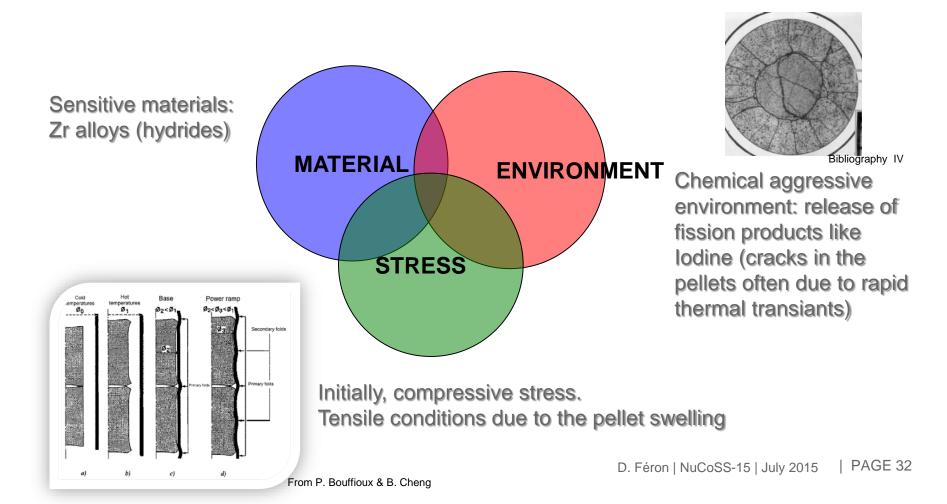
Stress corrosion cracking of phenomena of zirconium cladding Internal surface of the fuel tube

Stress corrosion cracking of clad during a power transient

With hydrides, significant crack lengths may be observed

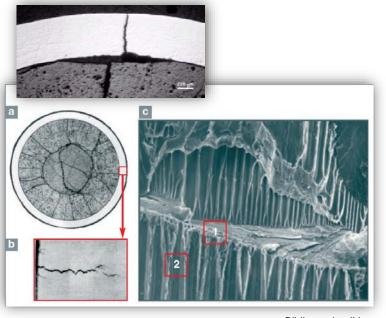
a & b: during a power variation in test reactor c: in presence of iodine during a laboratory test

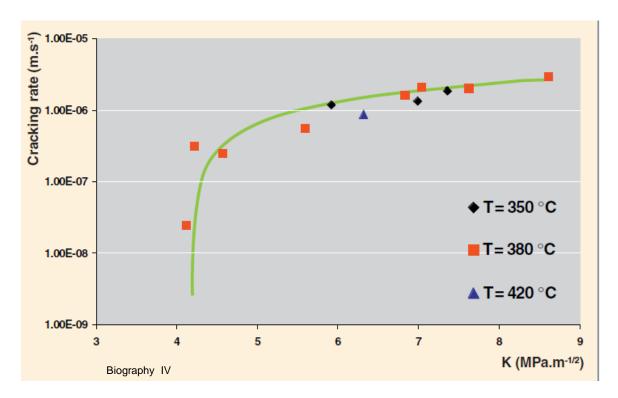
Crack propagation rate as function of the initial stress intensity factor and for 3 temperatures SCC-I / Zircaloy-4

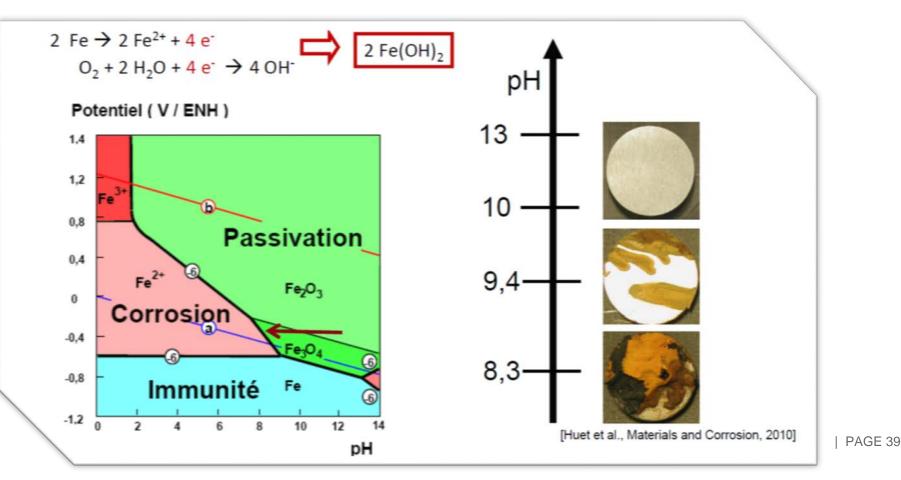
- In new concrete, pH is around 13 and the steel is passive
 With time, concrete minerals react with carbonic gas and pH
- decreases

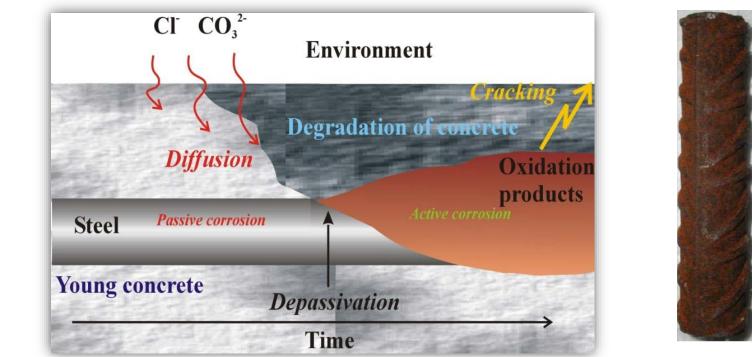
- Reaction with CO₂ leads to pH decreases
- Depassivation occurs as function of pH and pollutants like chlorides
- -Expansive corrosion products
- Cracking of the concrete

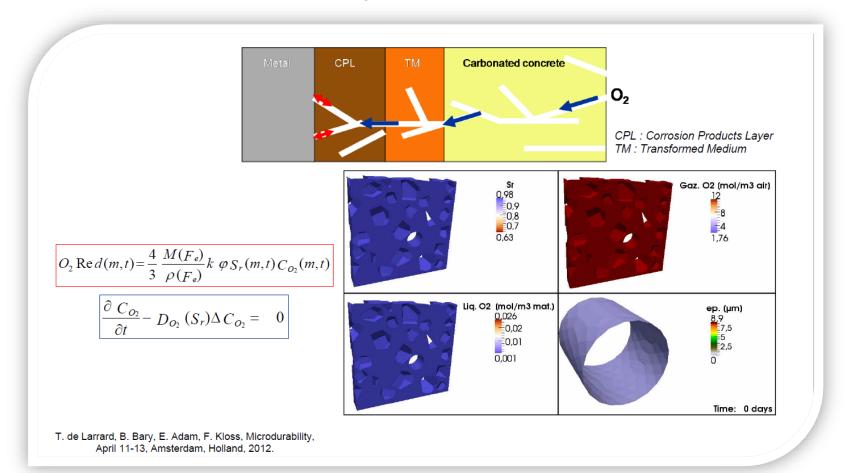
Mechanical modelling coupled with chemical evolution simulation (carbonatation), oxygen transport and corrosion

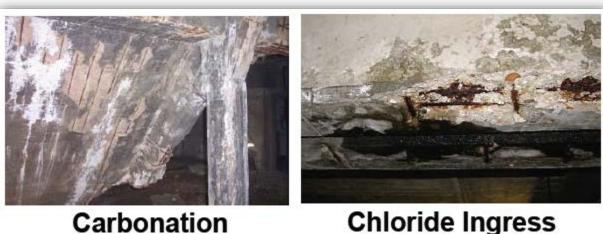
Chinon

Chloride Ingress

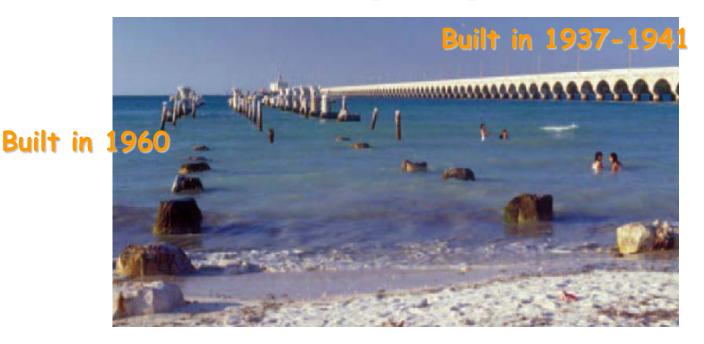
Pier(s) in the Mexico gulf (Progreso, Yucatan)

The two piers (1,2 km) have been built with reinforced concrete without maintenance up to around 2000....

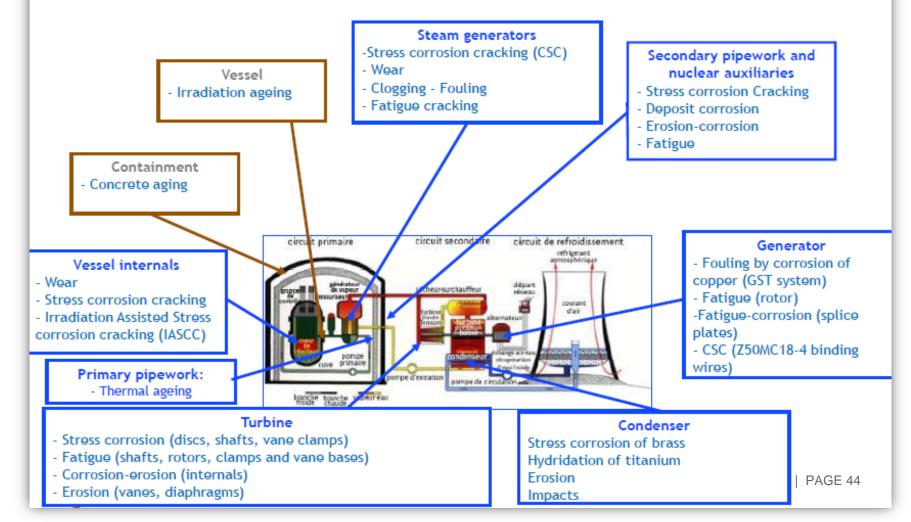
THE MAIN TYPES OF DETERIORATION OF COMPONENTS
