# Refurbishment of a Nuclear Facility in operation : Focus on the check and thorough maintenance of hot cell's handling equipment

<sup>1</sup>French Alternative Energies and Atomic Energy Commission, Nuclear Energy Division,  
CEA Marcoule – Installation de Surveillance des Assemblages Irradiés, Bagnols sur Cèze, France

## Context

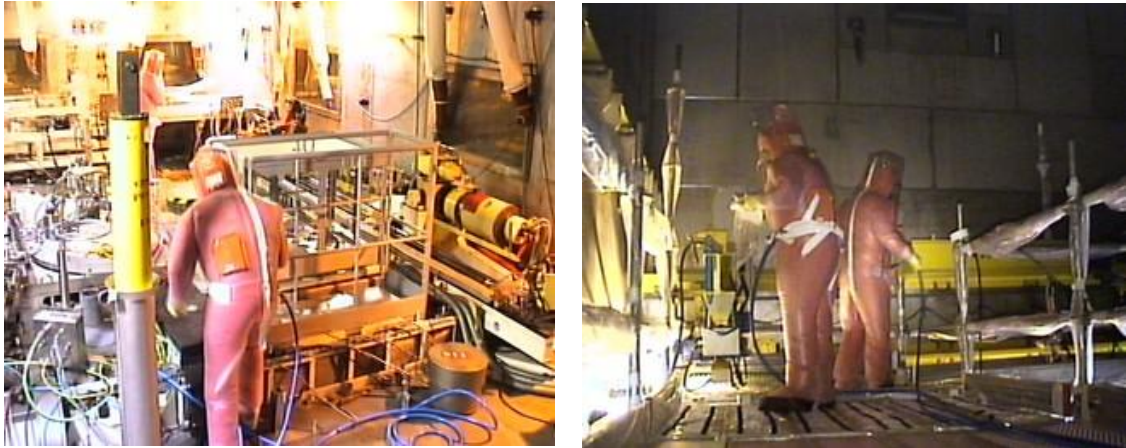
**Figure 3.** Cleaning-up floor and + 5m

First, a cartography of contamination was made with telemanipulator to determine humans intervention conditions after evacuation of all irradiative source term of the cell. The aim was to attain low contamination to authorize maintenance intervention without Air Fed suits.

The height of handling equipment needed introduction and progressive assembling scaffolding on the entire square of the cell at successive different height (3m, 5m and 7m). For each level, clean-up was necessary.

A complete contamination and irradiation cartography per square meters from floor to ceiling permitted to decommission temporary from red zone to orange one.

The global radiation dosimetry of this operation was approximately 3,4 mSv for 108 interventions of 2 hours each.

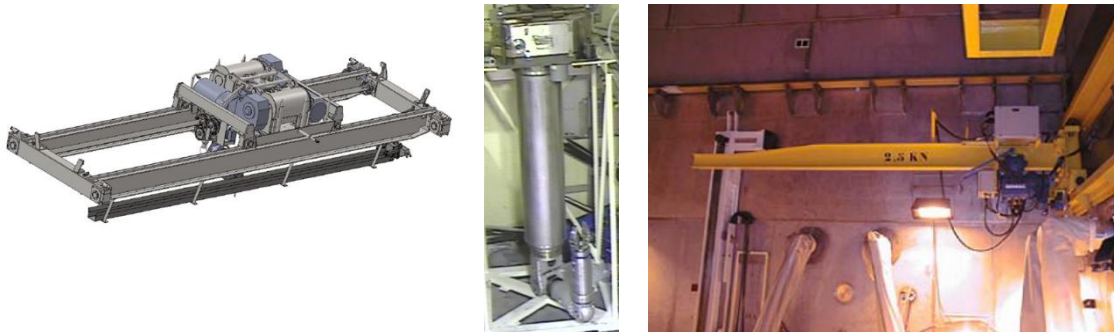
**Figure 4.** Overhead crane (3D model) - Power telemanipulator - Single girder wall travelling crane

The preparation of this operation consisted in considering each crane to identify unattainable parts and potentially worn parts. All long-lead items were ordered at the earliest.

All final as-built drawings of 1983 were used to fabricate the elements and to model the equipment in three dimensions.

The operators also checked the clamping strength of the handling equipment's anchor in the cell.

The expertises on the different equipment showed the thorough maintenance of unattainable part should permit to limit future operating incident and perturbation on the ISAI evacuation capability.
