R Mitteau, P Chappuis, L Moncel, J Schlosser. Evidence of damage in carbon fibre composite tiles joined to a metallic heat sink under high heat flux fatigue. *Journal of Nuclear Materials*, 1998, 258-263, pp.972 - 977. 10.1016/s0022-3115(98)00314-6 . cea-03134221

## **EVIDENCE OF DAMAGE IN CARBON FIBRE COMPOSITE TILES JOINED TO A METALLIC HEAT SINK UNDER HIGH HEAT FLUX FATIGUE**

Association Euratom - CEA sur la Fusion Contrôlée.

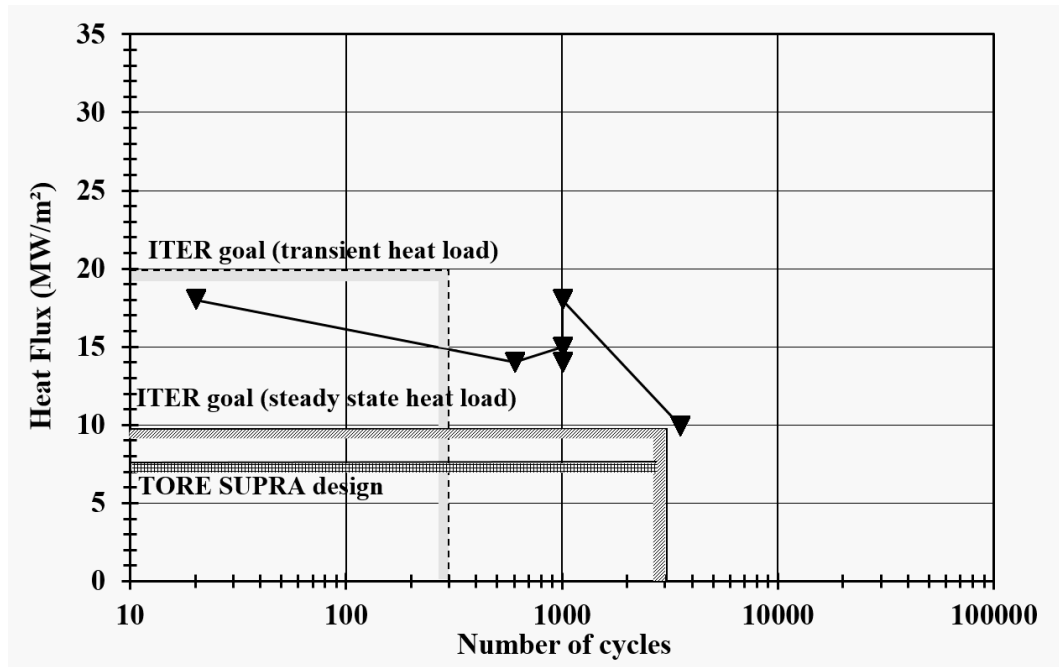
Figure 1 : results of high heat flux tests of CFC armour to Cu heat sink joints.

With NS31 from SEP and Dunlop concept 2, SMS 2B and 3B were cycled during 1000 cycles at 18 MW/m<sup>2</sup>, showing an evolution of the surface temperature, and intense erosion but no tile detachment. Those tests compare well with the literature (figure 1, see also [10]).

The AMC bond in flat tile geometry, although less capable in term of highest heat load, is the second ever tested in term of number of cycles.

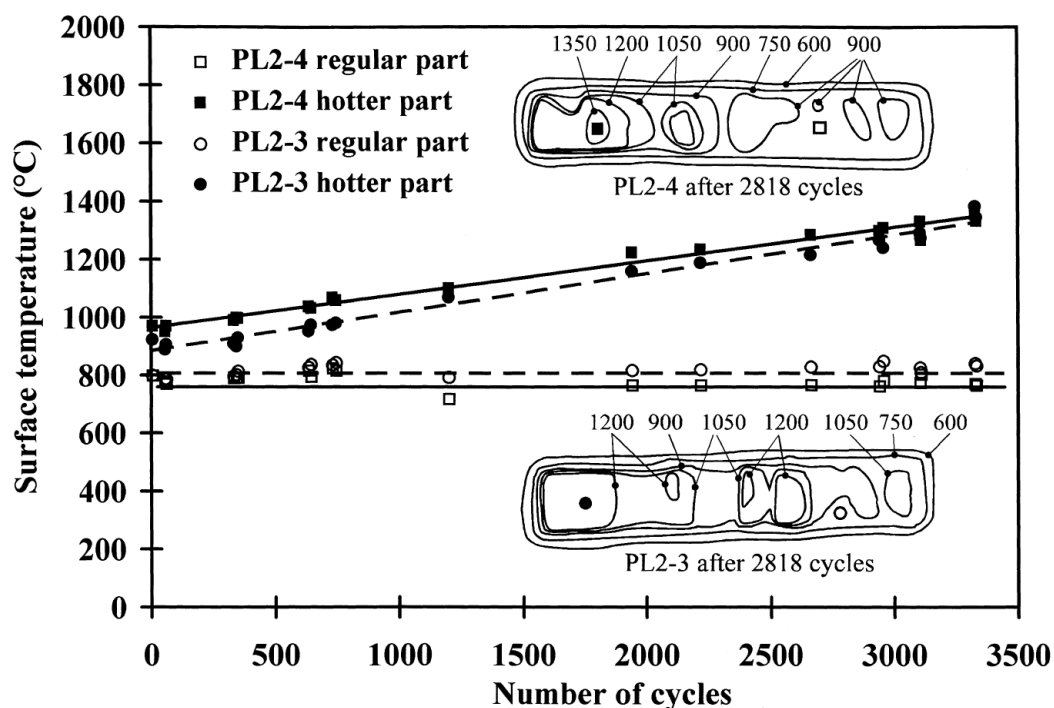
Figure 3 : Evolution of the surface temperature versus number of cycles for TPL prototype elements.

The temperatures of the regular tiles of both fingers are almost constant, around 800°C. Hotter parts on both fingers show a steady increase of the temperature with the cycling, from 950°C to 1350°C. The temperature rise of the hot tiles cannot be attributed to lower tile conductivity or beam profile, which are constant during the test. For this reason, this temperature rise is linked to progressive damage at the interface, either as the progression of a crack or to progressive micro-cracking.

The temperature variation on neighbouring points gives the uncertainty of the method. For 0, 500, 1000 and 3000 cycles where at least two temperatures for close number of cycles are known, the fluctuations can be evaluated to 30 °C. Therefore, the temperature rise of ~ 400°C of the hotter parts of PL2-3 and PL2-4 is significant.

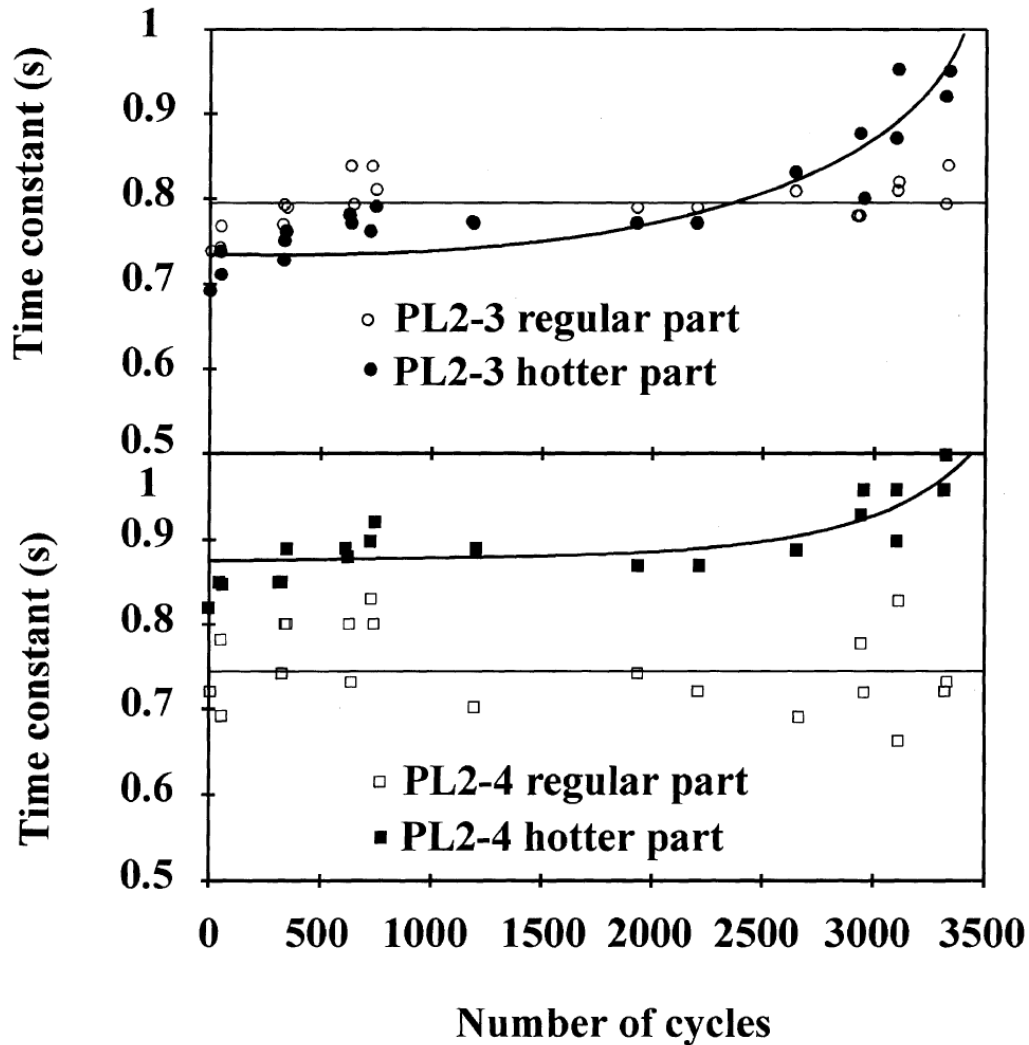
Figure 4 : Evolution of the time constants.

Rather big fluctuations are observed, around 0.07 second while the time constant is around 0.7 second. However, different evolutions between the spots are still significant. The time constants of the regular zones are approximately constant, while those of the hotter parts always increase with the number of cycles. The hotter tiles always finish with longer time constants than the regular tiles. For PL2-3, the increase is around 23 % of the initial value, and for PL2-4 around 12%. The time constants, although less precise than the surface temperature measurements, confirm the degradation of the heat transfer capability of the structure. However,

the damaged tiles remain remarkably actively cooled, with time constants smaller than 1 second and a surface temperature still acceptable for operation.

The interface damage is also characterized by a longer time response of the tiles. The time constants of the tiles are calculated during the transients. They are given figure 4 for hotter and regular parts.

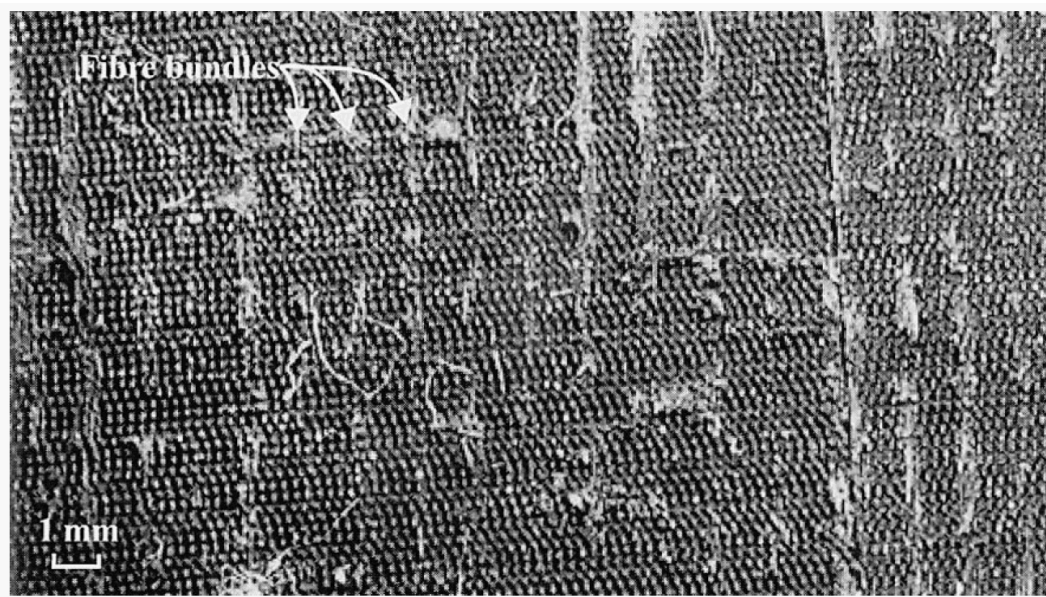
Figure 5 : Macrography of the heat sink after tests at  $18 \text{ MW/m}^2$  (the defective tile was removed in laboratory)

On broken tiles removed from the mock-up after test at  $18 \text{ MW/m}^2$  (figure 5), the copper is mainly black, with many cones visible. The cones are made out of copper that has solidified in the laser - machined holes in the CFC during the AMC process. Fibre bundles often remain attached to the copper. Very few copper is visible on the fractured area of the tile. These elements indicate that such cracks propagate mainly in the CFC or just beneath. Moreover, some black dust falls from the tile, suggesting a disintegration of the CFC material in the vicinity of the bond.

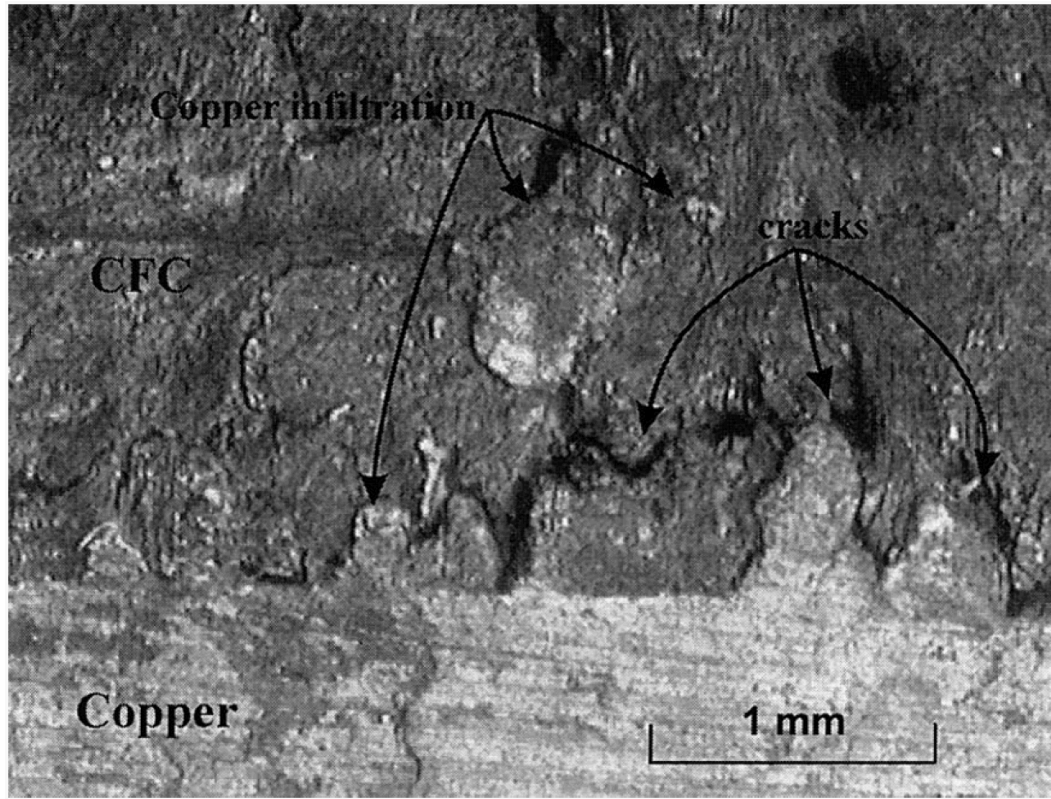
In the CFC (figure 6), cracks are observed above the cones, on top of the cones or between cones. On the edges, cracks start in the CFC in front of the cones. Inside the tiles, the cracks begin at the interface to copper or inside the CFC. Cracks can be observed at the interface between the copper and the CFC. More often such cracks are hybrid, that is they propagate indifferently in the CFC or at the interface of the CFC to copper. In these areas, the cones recede from the CFC, leaving a crack

that follows the cones or sometimes goes through the CFC between two cones. On some very damaged tiles, continuous cracks that go straight through the cone and the CFC could be observed.

Figure 6 : Macrography of cracks in the CFC and at the interface CFC-copper.

Internal voids in the CFC near the interface are sometime filled with copper or carbides. Such inclusions in the CFC are to expand and shrink during thermal cycling. As the CFC has a lower thermal expansion coefficient, it will undergo cyclic compression. This suggests a damage mechanism which could explain the disintegration of the CFC above the bond. In some cases, such inclusions were observed above cracks, showing that the crack was subsequent to the manufacture of the AMC bond.

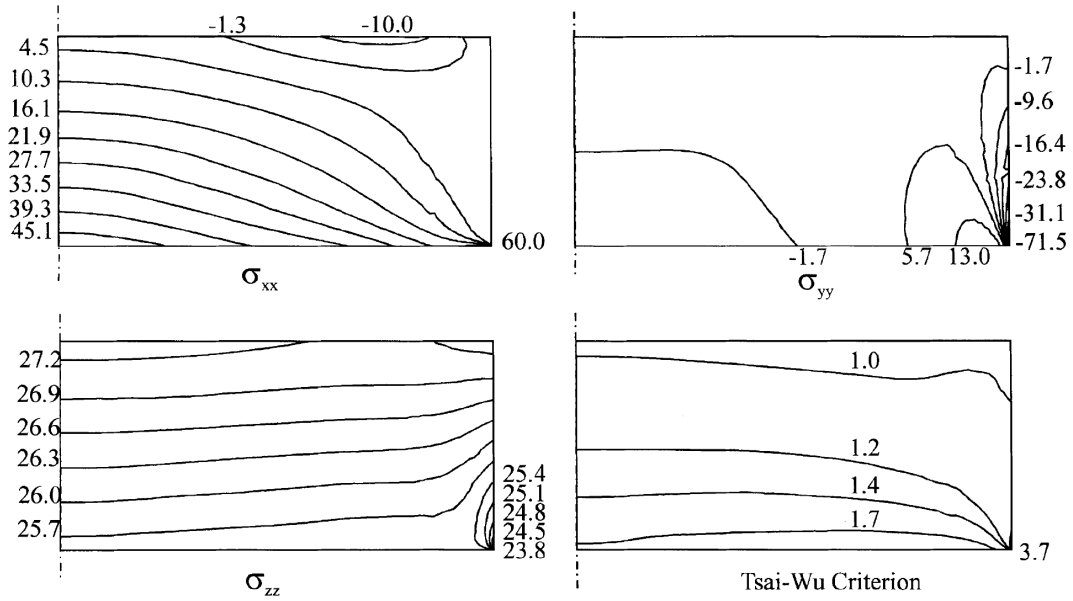
Finite element calculations are done to evaluate the stresses in the structure of a finger. A new non-linear model was specially developed and implemented for the CFC [11]. Stresses in a CFC tile of the LPT for 10 MW/m<sup>2</sup> and a computation of the Tsai-Wu criterion are shown figure 7.

In most of the tile, the criterion exceeds 1, showing the CFC material should break. Even if the criterion may be overestimated, the level of stress explains the observed cracks. It explains also the kind of disintegration of the CFC observed above the bond. However, the cracks also allow the CFC to accommodate somehow the imposed deformation, which could explain that damaged tiles still hold to the heat sink. These results also point out the limitation of the Tsai-Wu criterion, which isn't suitable for this configuration. A new criterion is currently under development at Tore Supra to characterize the stress level.

Figure 7 : Stresses (MPa) in a CFC tile under 10 MW/m<sup>2</sup> (2D generalised plain strain calculation)
