## **EVIDENCE OF DAMAGE IN CARBON FIBRE COMPOSITE TILES JOINED TO A METALLIC HEAT SINK UNDER HIGH HEAT FLUX FATIGUE**

Association Euratom - CEA sur la Fusion Contrôlée.

### **ABSTRACT**

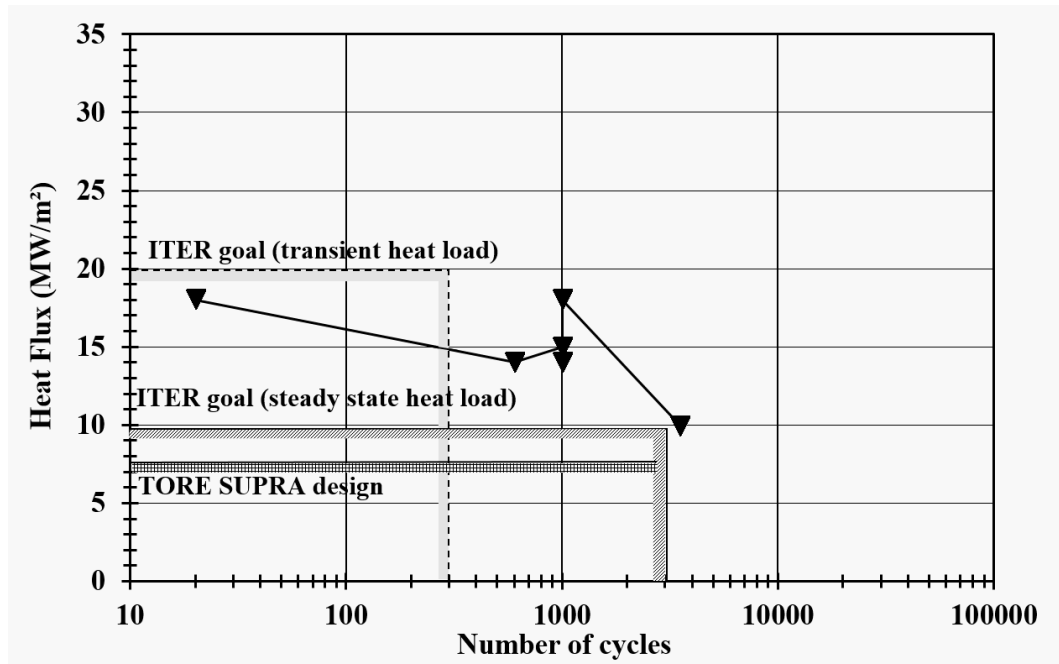
Figure 1 : results of high heat flux tests of CFC armour to Cu heat sink joints.

With NS31 from SEP and Dunlop concept 2, SMS 2B and 3B were cycled during 1000 cycles at 18 MW/m<sup>2</sup>, showing an evolution of the surface temperature, and intense erosion but no tile detachment. Those tests compare well with the literature (figure 1, see also [10]).

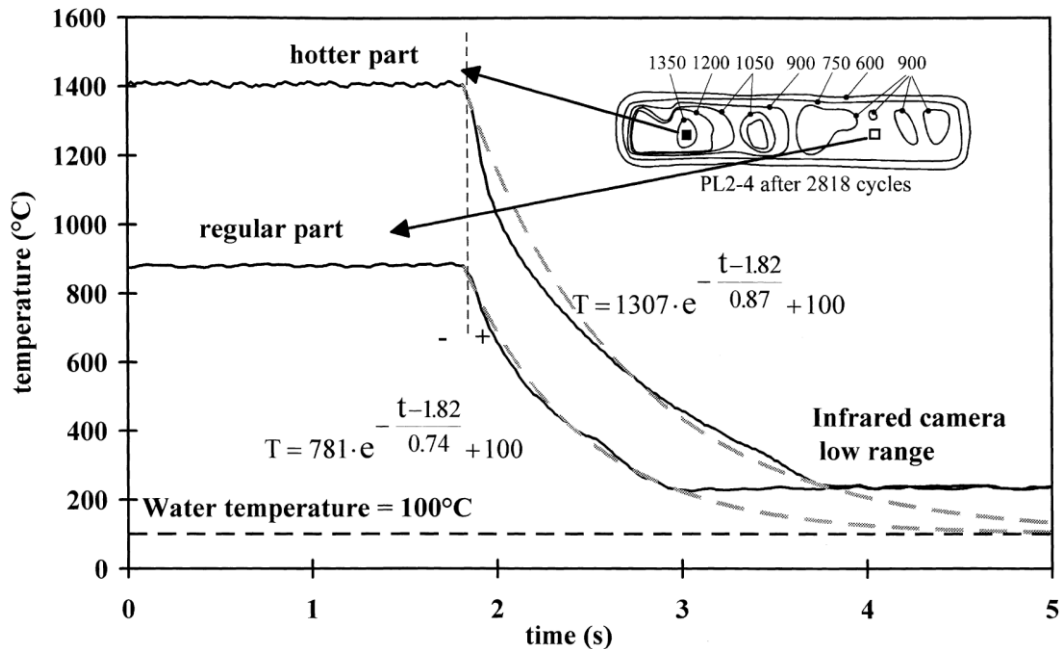
Figure 2 : time evolution of the surface temperature after stopping the incident power after 2818 cycles on PL2-4.

The infrared view shows regular and hotter parts (figure 2). The hotter parts can be attributed to numerous effects such as deteriorated bonds, lower tile conductivity, local differences in the surface emissivity and non evenness of the beam. After the cycling, surface temperature of both parts versus time are extracted by averaging on 10\*10 pixels zones (figure 2).

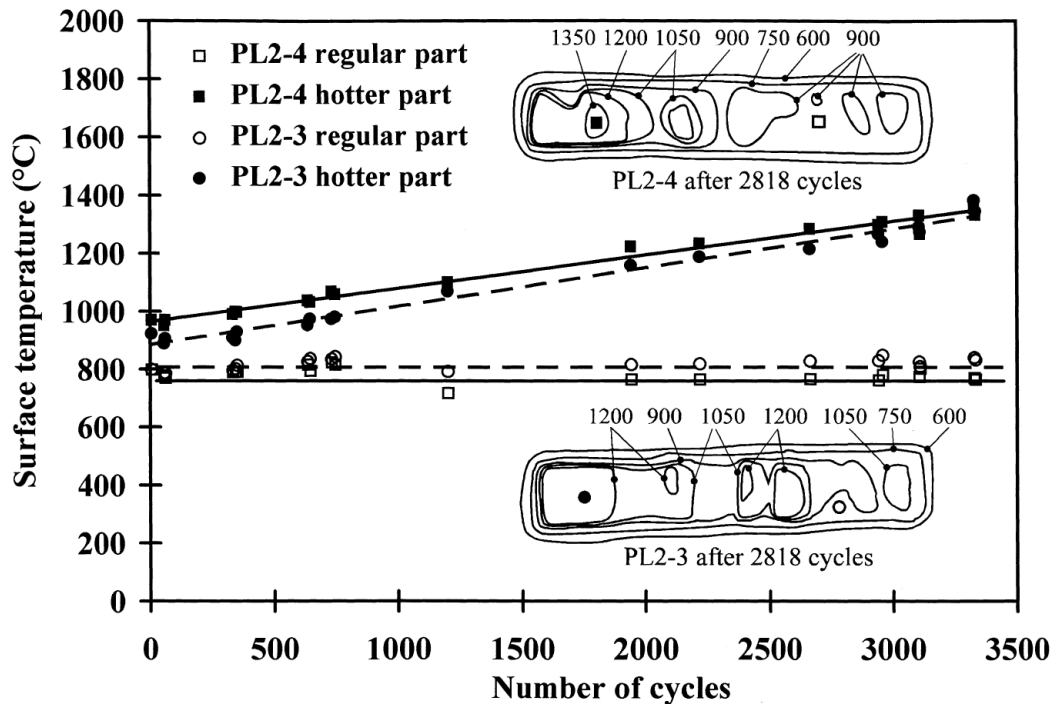
Figure 3 : Evolution of the surface temperature versus number of cycles for TPL prototype elements.

The temperatures of the regular tiles of both fingers are almost constant, around 800°C. Hotter parts on both fingers show a steady increase of the temperature with the cycling, from 950°C to 1350°C. The temperature rise of the hot tiles cannot be attributed to lower tile conductivity or beam profile, which are constant during the test. For this reason, this temperature rise is linked to progressive damage at the interface, either as the progression of a crack or to progressive micro-cracking.

The temperature variation on neighbouring points gives the uncertainty of the method. For 0, 500, 1000 and 3000 cycles where at least two temperatures for close number of cycles are known, the fluctuations can be evaluated to 30 °C. Therefore, the temperature rise of ~ 400°C of the hotter parts of PL2-3 and PL2-4 is significant.

The surface temperature is calculated on the plateau and the time constant during the cooling of the structure. The emissivity of the surface was set to 0.85. Calibration shots before and after the tests showed that the correction coefficient (transmission of the windows, tile emissivity, etc...) didn't noticeably changed during tests. Only the cycles with a heat flux higher than 10 MW/m<sup>2</sup> (ranging from 10.6 to 11.5 MW/m<sup>2</sup>) were taken into account in this study. The surface temperatures were normalised to 10 MW/m<sup>2</sup> according to finite element calculations to allow comparison. The normalised surface temperature of regular and hotter parts of PL2-3 and PL2-4 are given versus the number of cycles (figure 3).

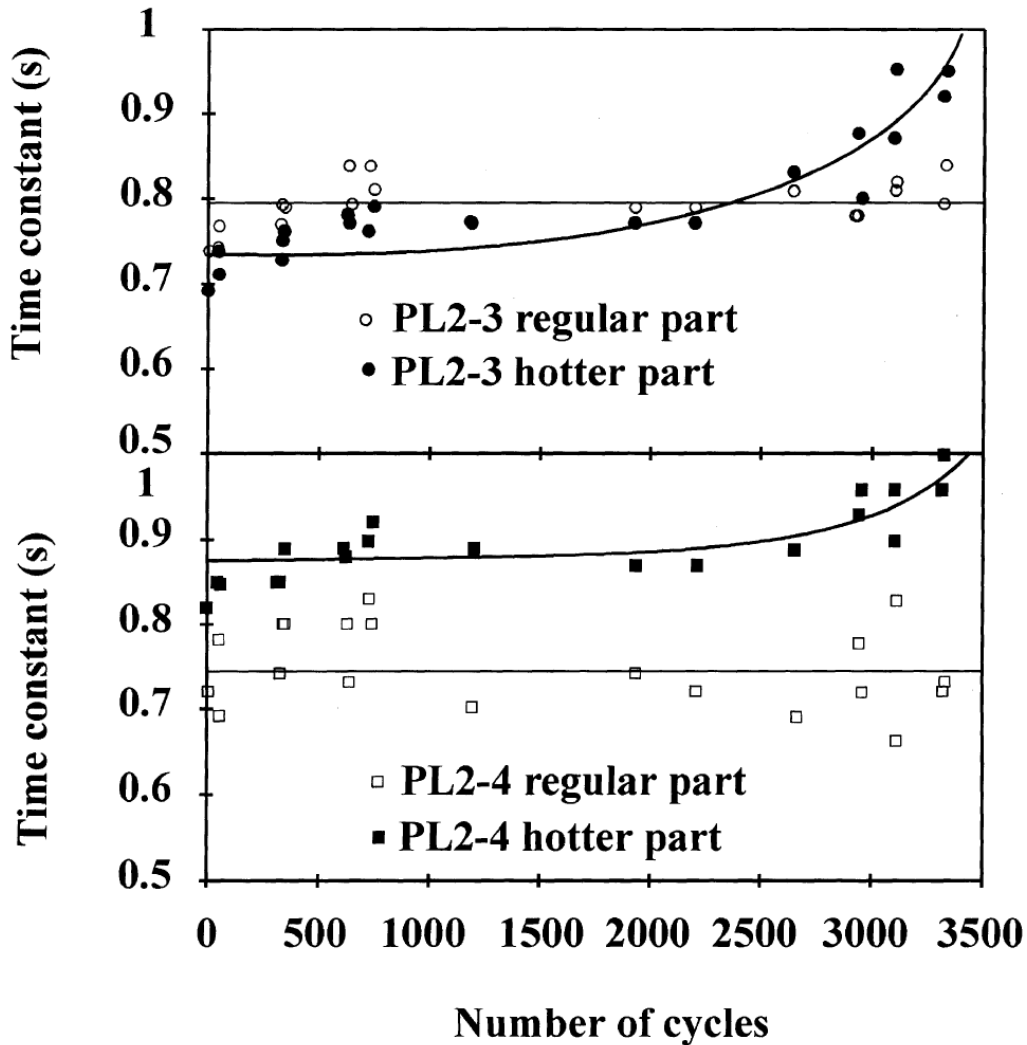
Figure 4 : Evolution of the time constants.

Rather big fluctuations are observed, around 0.07 second while the time constant is around 0.7 second. However, different evolutions between the spots are still significant. The time constants of the regular zones are approximately constant, while those of the hotter parts always increase with the number of cycles. The hotter tiles always finish with longer time constants than the regular tiles. For PL2-3, the increase is around 23 % of the initial value, and for PL2-4 around 12%. The time constants, although less precise than the surface temperature measurements, confirm the degradation of the heat transfer capability of the structure. However,

the damaged tiles remain remarkably actively cooled, with time constants smaller than 1 second and a surface temperature still acceptable for operation.

The interface damage is also characterized by a longer time response of the tiles. The time constants of the tiles are calculated during the transients. They are given figure 4 for hotter and regular parts.

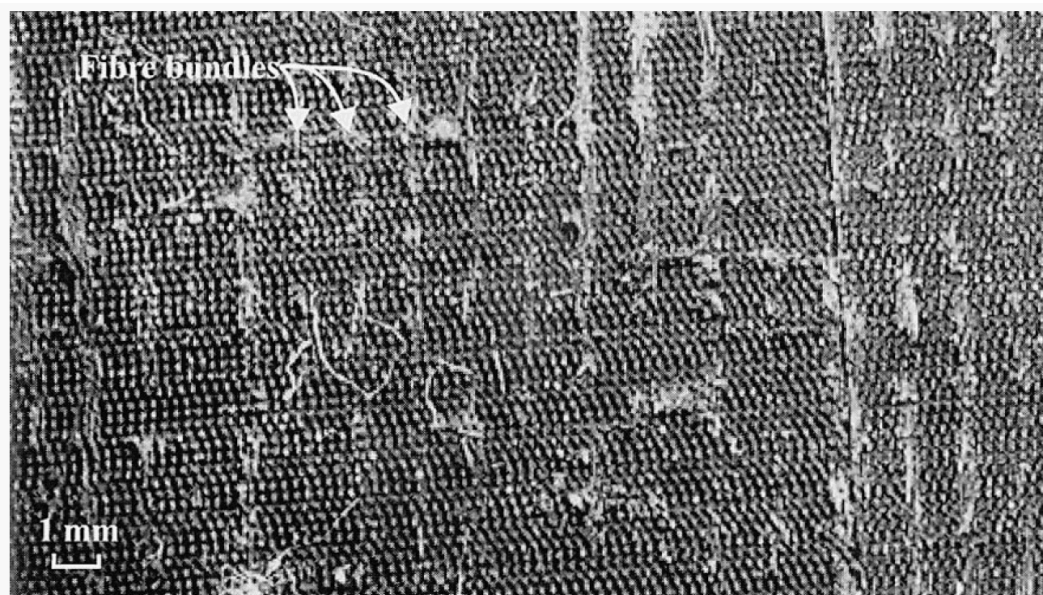
Figure 5 : Macrography of the heat sink after tests at  $18 \text{ MW/m}^2$  (the defective tile was removed in laboratory)

On broken tiles removed from the mock-up after test at  $18 \text{ MW/m}^2$  (figure 5), the copper is mainly black, with many cones visible. The cones are made out of copper that has solidified in the laser - machined holes in the CFC during the AMC process. Fibre bundles often remain attached to the copper. Very few copper is visible on the fractured area of the tile. These elements indicate that such cracks propagate mainly in the CFC or just beneath. Moreover, some black dust falls from the tile, suggesting a disintegration of the CFC material in the vicinity of the bond.

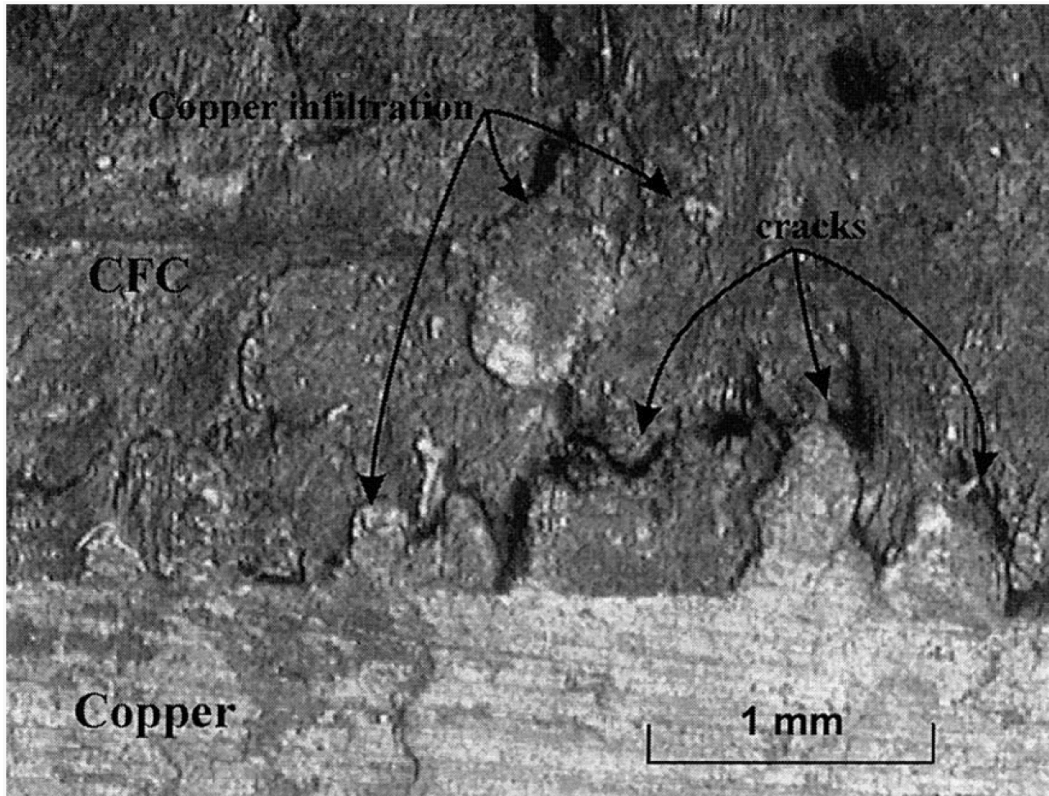
In the CFC (figure 6), cracks are observed above the cones, on top of the cones or between cones. On the edges, cracks start in the CFC in front of the cones. Inside the tiles, the cracks begin at the interface to copper or inside the CFC. Cracks can be observed at the interface between the copper and the CFC. More often such cracks are hybrid, that is they propagate indifferently in the CFC or at the interface of the CFC to copper. In these areas, the cones recede from the CFC, leaving a crack

that follows the cones or sometimes goes through the CFC between two cones. On some very damaged tiles, continuous cracks that go straight through the cone and the CFC could be observed.

Figure 6 : Macrograph of cracks in the CFC and at the interface CFC-copper.

Internal voids in the CFC near the interface are sometime filled with copper or carbides. Such inclusions in the CFC are to expand and shrink during thermal cycling. As the CFC has a lower thermal expansion coefficient, it will undergo cyclic compression. This suggests a damage mechanism which could explain the disintegration of the CFC above the bond. In some cases, such inclusions were observed above cracks, showing that the crack was subsequent to the manufacture of the AMC bond.

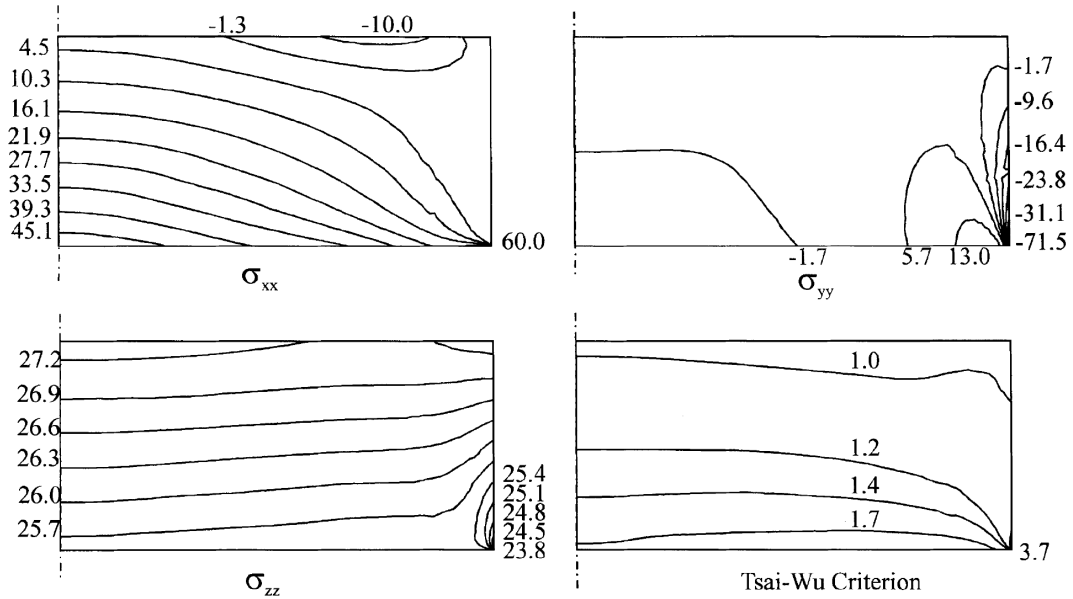
Finite element calculations are done to evaluate the stresses in the structure of a finger. A new non-linear model was specially developed and implemented for the CFC [11]. Stresses in a CFC tile of the LPT for 10 MW/m<sup>2</sup> and a computation of the Tsai-Wu criterion are shown figure 7.

In most of the tile, the criterion exceeds 1, showing the CFC material should break. Even if the criterion may be overestimated, the level of stress explains the observed cracks. It explains also the kind of disintegration of the CFC observed above the bond. However, the cracks also allow the CFC to accommodate somehow the imposed deformation, which could explain that damaged tiles still hold to the heat sink. These results also point out the limitation of the Tsai-Wu criterion, which isn't suitable for this configuration. A new criterion is currently under development at Tore Supra to characterize the stress level.

Figure 7 : Stresses (MPa) in a CFC tile under 10 MW/m<sup>2</sup> (2D generalised plain strain calculation)
