# Modelling of wear defects under Anti Vibration Bars in U-bend for the Eddy Current inspection of Steam Generator tube

Audrey Vigneron<sup>1</sup>, Edouard Demaldent<sup>1</sup>, Jean-Marc Decitre<sup>2</sup>,  
Thierry Sollier<sup>2</sup>

<sup>1</sup> Université Paris-Saclay, CEA LIST, France

<sup>2</sup> IRSN, France

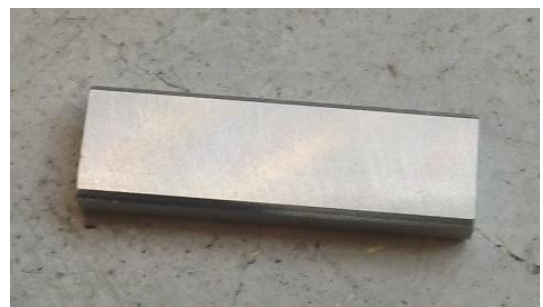
Figure 4: Representative sample of an AVB in Inconel 600.

To facilitate the movement of the probe, a puller/pusher system is employed, and the resulting EC signals are acquired using an impedance-meter. A dedicated test bench securely holds the tubes to be inspected and positions a representative sample of an anti-vibration bar. The AVB is constructed from Inconel 600, as depicted in Figure 4, with the specific dimensions provided in Figure 5. The position of the AVB in relation to the tube is adjustable: a micrometric table enables precise adjustment of the distance between the sample and the external wall of the tube, while a rotating table allows for angular placement of the AVB with respect to the tube's axis, as illustrated in Figure 6.

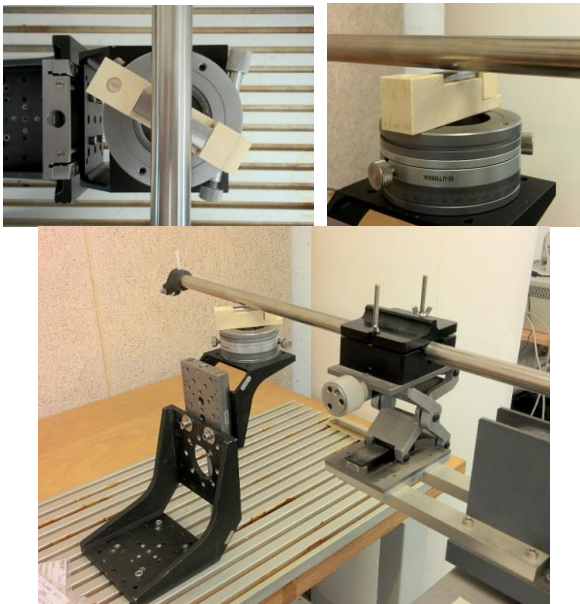
Figure 6: Experimental bench for positioning of the AVB near to the tube inspected.
