Electrical induced cracking of PZT films and its effect on electrical properties of piezoelectric capacitors

Hugo Kuentz^{1,2*}, Baba Wagué¹, Nicolas Vaxelaire¹, Valérie Demange², Christophe Poulain¹,
Maryline Guilloux-Viry² and Gwenael Le Rhun¹

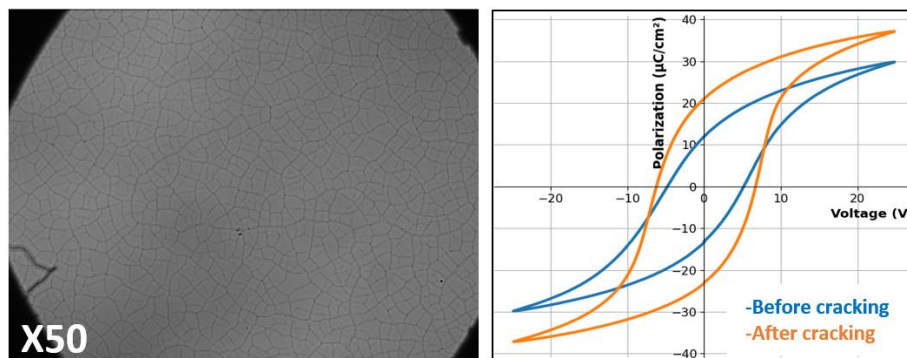
Figure 1: Optical image of cracked PZT film and effect of cracking on hysteresis PV loop.

In the present study, PZT based capacitors (2 μm thick) were operated under electric field, either bipolar or unipolar with various amplitudes, until cracking. The density of cracks varies as a function of the applied signal conditions. The effect of the cracks on the PZT properties has been evaluated by conducting various electrical tests, before and after cracking: ferroelectric polarization loops, dielectric capacitance curves, leakage currents and piezoelectric measurements. Remnant polarization and maximum polarization tend to increase by almost 100% and 40%, respectively (Figure 1), whereas permittivity and piezoelectric coefficient $d_{33,f}$ decrease down to 20% and 30%, respectively. In addition, XRD measurements show a clear modification of the PZT crystallographic pattern, suggesting that the observed evolution of electrical properties results from a change in domain structure associated with stress relaxation.
