STRESS CORROSION CRACKING IN THE CONTEXT OF DEEP GEOLOGICAL NUCLEAR DISPOSAL: INVESTIGATIONS ON P235 AND P265 STEELS

A. Didot, E. Herms, **D. Féron**, CEA, Université Paris-Saclay, France
J. Chêne, Université d'Evry-Val-d'Essonne
D. Crusset, Andra, Châtenay-Malabry, France

LTC 2016, 6TH INTERNATIONAL WORKSHOP ON LONG -TERM
PREDICTION OF CORROSION DAMAGE IN NUCLEAR WASTE
SYSTEMS, TORONTO, CANADA, MAY 9-12, 2016

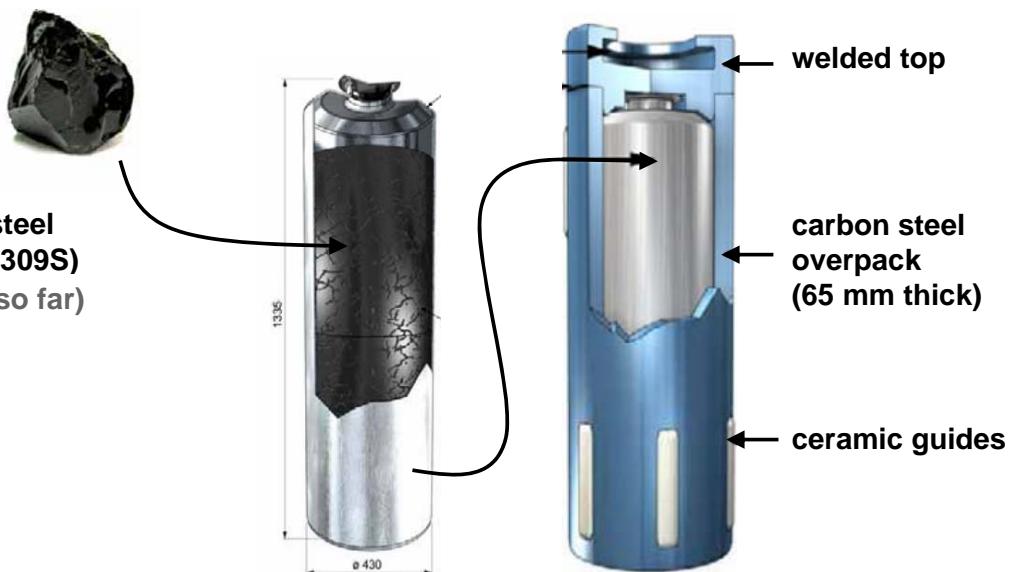
- ① Vitrified nuclear waste
Limitation of radionuclides' release
(10^5 years)

- ② Stainless steel container (309S)
No function (so far)

③ Carbon steel overpack

Isolation of the vitrified nuclear waste from interstitial water
(10^3 years)

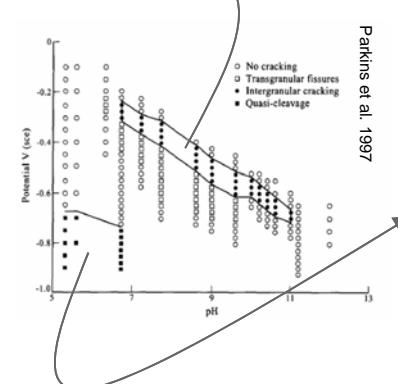
2 cracking mechanisms have been identified in buried pipes,
characterized by specific potential-pH domain

Intergranular

« passive » Steel
alcaline pH

Transgranular

« active » steel
quasi-neutral pH
Dynamic loading

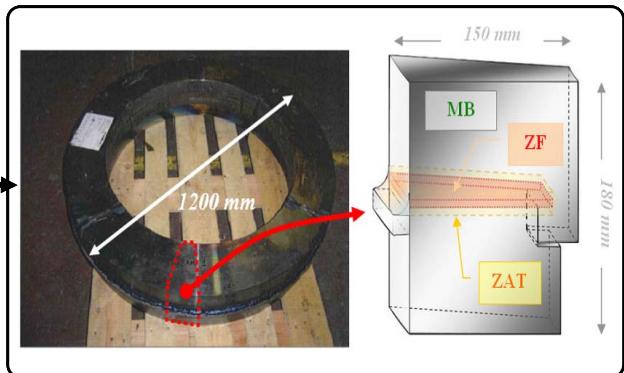
Coupons have been taken from two mock-ups.

2 grades

P265
→ weld
P235
→ bulk

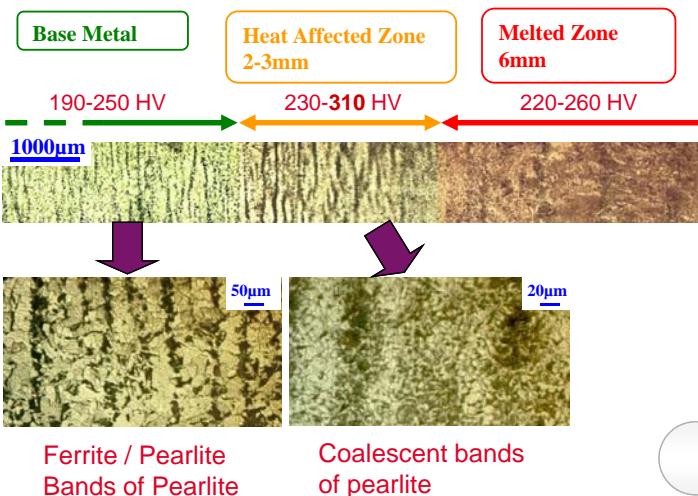
P265 (weld)

P235 (base metal)
Bands of PearliteMicrostructure in bands:
risk of SCCHardness>250Hv
risk of Hydrogen EmbrittlementSensitivity to stress corrosion cracking of
the steel in storage environmentMechanical dynamic solicitations
(10^{-7} à 10^{-4} s⁻¹ → 1 - 800 hours).

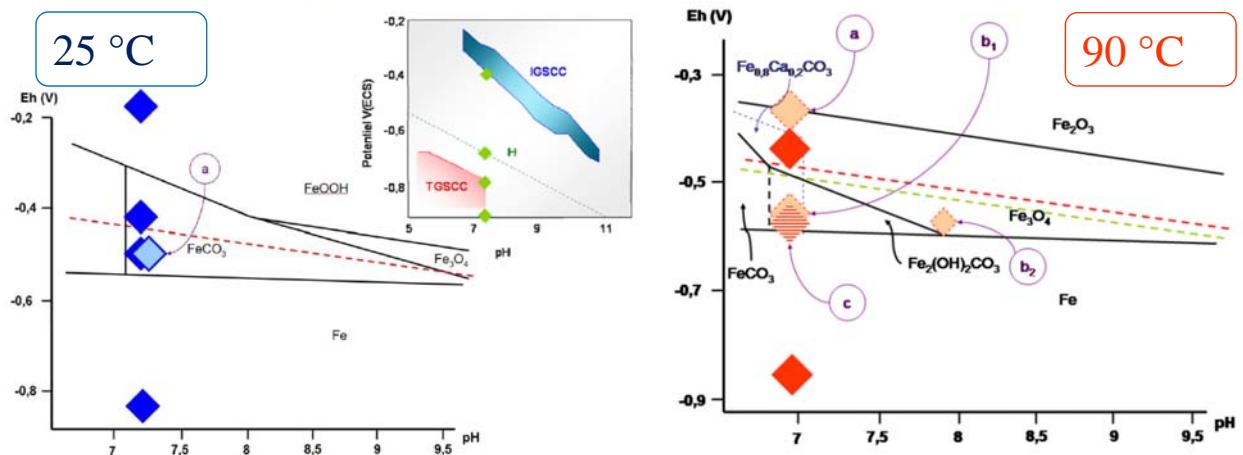
Polarisation potentials used during the slow strain rate tests plotted in the Pourbaix diagram

- ❖ a and b₁ are related to measured or calculated corrosion potentials
- ❖ b₂ is related to a measured pH

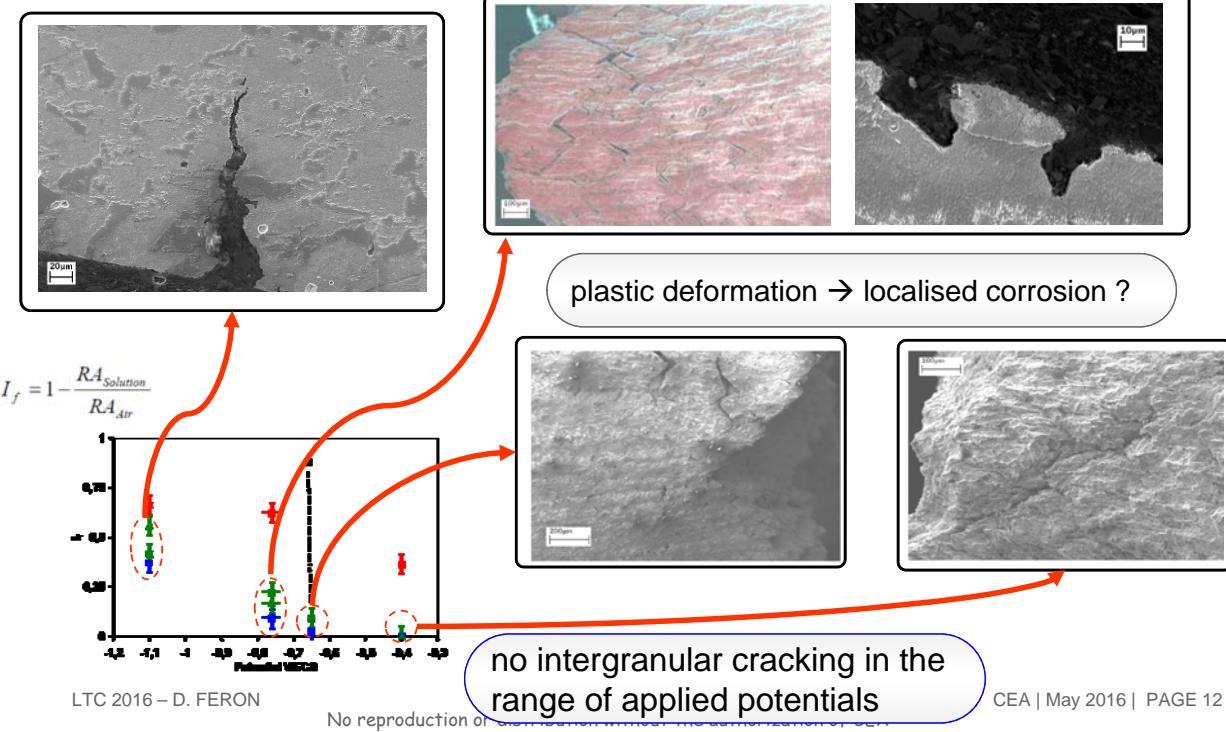
Transgranular cracking

25 °C

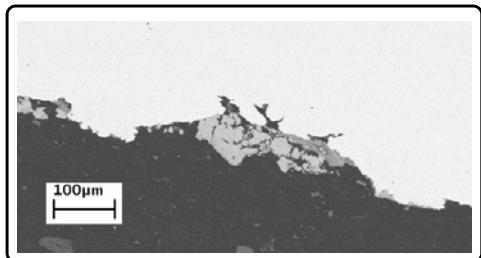
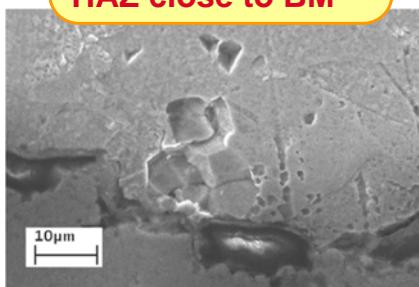
Intergranular degradation

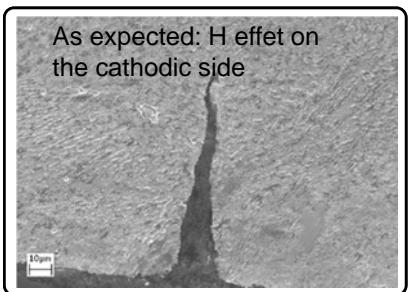
Hydrogen embrittlement at the tested corrosion potentials

25 °C

As expected: H effect on the cathodic side

Hydrogen embrittlement at the corrosion potential at 25 °C.

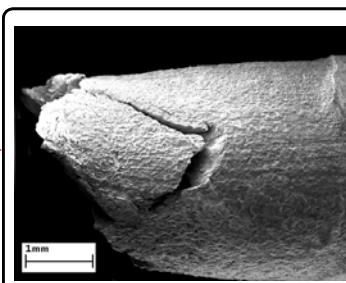
Severe plastic deformation and localized corrosion

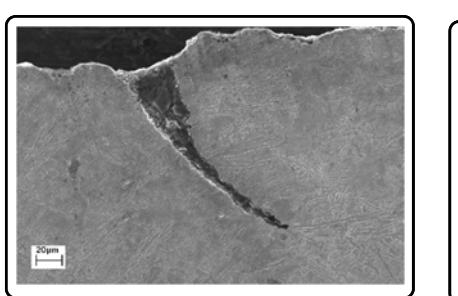
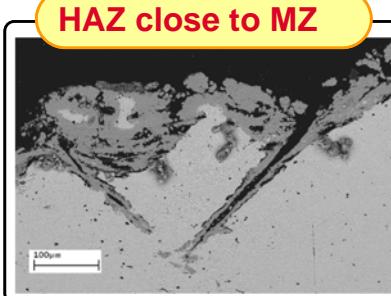
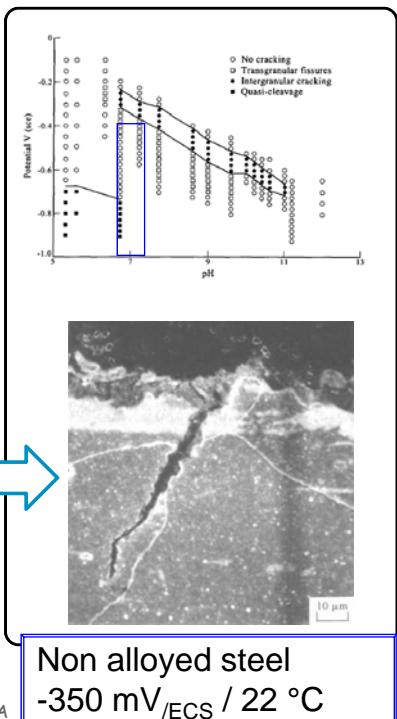
Hydrogen embrittlement ?
→ plastic deformation & localized corrosion.

90 °C

The mechanism of passive film cracking is possible at 90 °C.

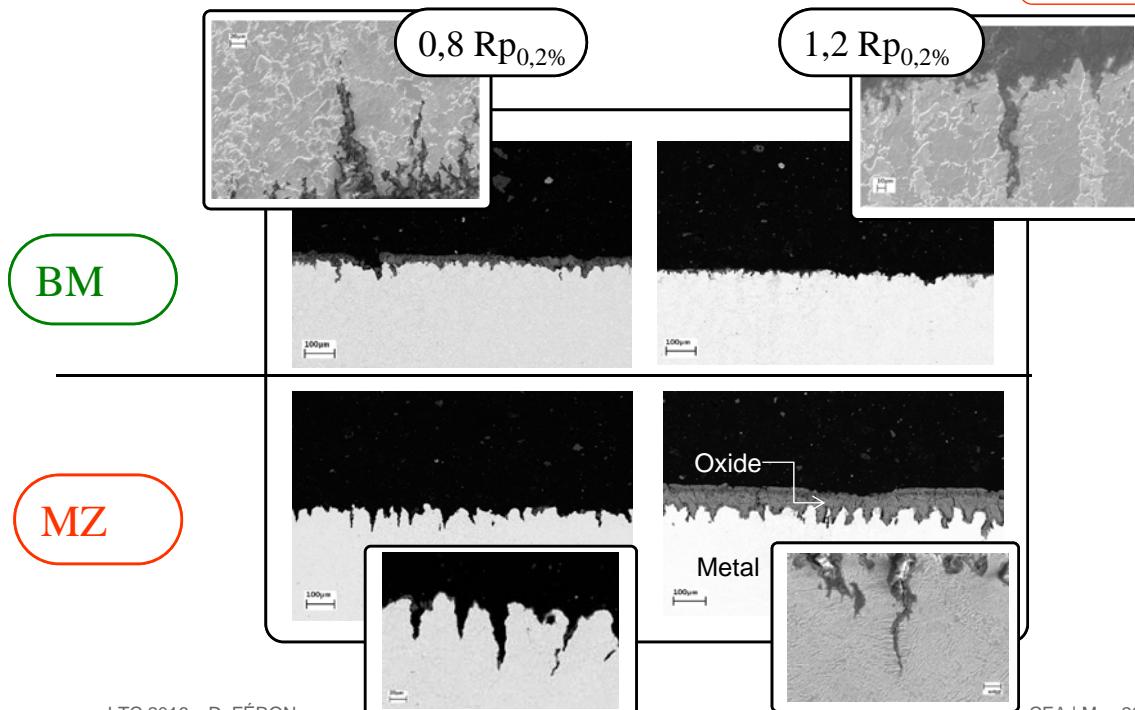
P265

After 1 year → Multi cracking in BM and WZ

90 °C

Cracks localized on the pearlite bands.

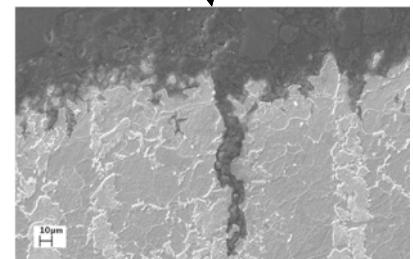
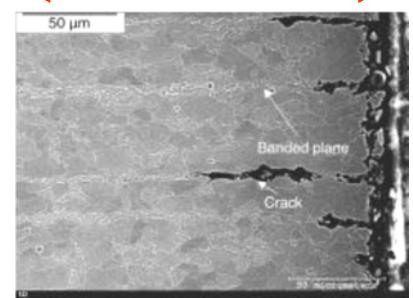
Cracks resulting from stress?
From chemical attack?

Literature → same results reported,
But not necessarily correlated to the
stress direction.

Galvanic coupling between ferrite and pearlite.

Deleterious effect of band structures.

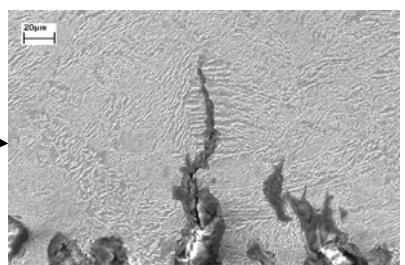
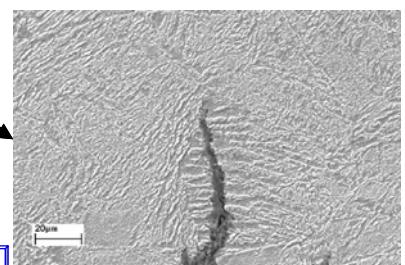
Transgranular cracking

Not localized corrosion (no branching in secondary dendrites)

+
Mechanical loading

Hydrogen embrittlement-like phenomenon with
a delayed cracking.

Caused by the excessive hardness of the
welded zone (up to ~ 300Hv)...

... in the case of buried pipes, recommended
hardness shouldn't exceed 250 Hv
