Power operation with reduced heat transmitting tiles at Tore Supra

R. Mitteau, J. Schlosser, M. Lipa, A. Durocher. Power operation with reduced heat transmitting tiles at Tore Supra. *Journal of Nuclear Materials*, 2009, 386-388, pp.844 - 846. 10.1016/j.jnucmat.2008.12.260 . cea-02942091

POWER OPERATION WITH REDUCED HEAT TRANSMITTING TILES AT TORE SUPRA

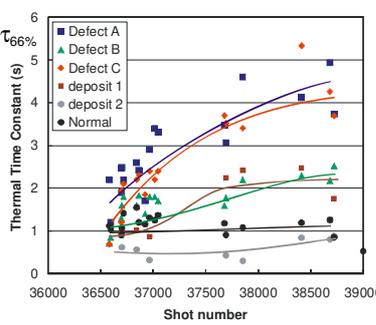
Monitoring during the experimental campaign

Figure 5 : Evolution of the thermal time constants of defective tiles and reference pick-up points during 2006.

Thermal time constant is evaluated during the rapid cool down following a disruption.

- Normal is constant
- Deposit : small or no increase
- Defects : increase of 300%

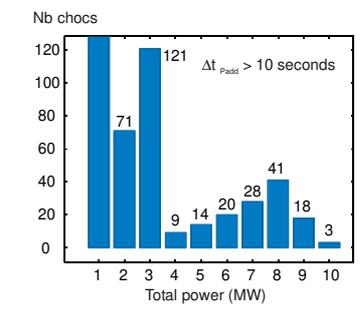
Histogram of discharges in 2006

The analysis is done during the 2006 campaign, in which high power operation is pursued (Fig. 4). High power discharges are also the most damaging for the bond between the tile and the heat sink. Fig. 3 shows that 62 pulses over 7.5 MW and lasting at least 10 s are achieved during that campaign (mainly toward the end.). The value of 10 seconds is chosen on the basis that thermal steady state must have been achieved to get the full amplitude of the stress cycle on the bond – the stress cycle being the reason for crack propagation. The campaigns from 2002 to 2005 add only 25 of such shots so that most of the damage is attributed to the 2006 campaign.

62 discharges > 7.5 MW & $t > 10$ s
2006 is record from that point of view (only 25 such discharges 2001-2005)
Most of the damage was done in 2006
