POWER OPERATION WITH REDUCED HEAT TRANSMITTING TILES AT TORE SUPRA

R. Mitteau¹, J. Schlosser¹, M Lipa¹, A. Durocher¹

¹*Association Euratom-CEA, CEA/DSM/DRFC, Centre de Cadarache, 13108 Saint-Paul-Lez-Durance, France*

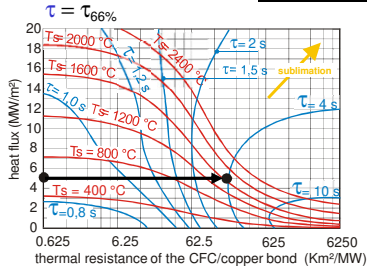
Abacus of defective bonds

Defects \Rightarrow longer time constant
 Black shift (arrow) is tile A&C evolution in 2006

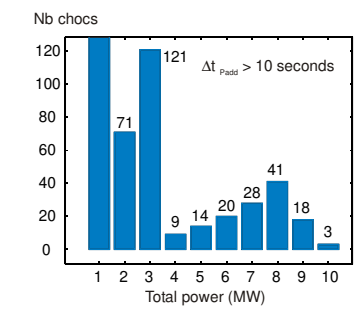
Histogram of discharges in 2006

62 discharges > 7.5 MW & $t > 10$ s
 2006 is record from that point of view (only 25 such discharges 2001-2005)
 Most of the damage was done in 2006
