Thermal loads in gaps between ITER divertor monoblocks: first lessons learnt from WEST

J. P. Gunn, J. Bucalossi, Y. Corre, M. Diez, E. Delmas, N. Fedorczak, A. Grosjean, M. Firdaouss, J. Gaspar,^a T. Loarer, M. Missirlian, P. Moreau, E. Nardon, C. Reux, M. Richou, E. Tsitrone, and the WEST team^b

Abstract

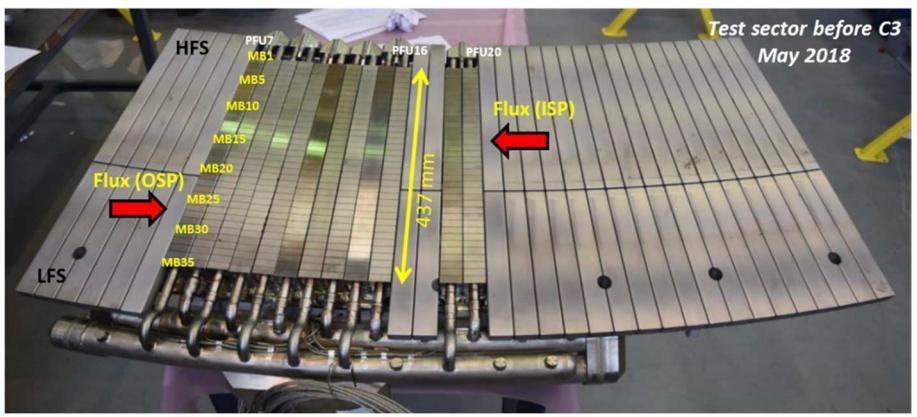
Figure 1. Photograph of the WEST lower divertor sector that was equipped with 12 ITER-like PFUs for the C3 experimental campaign. PFUs are numbered from 1 to 38 running in the toroidal direction (from left to right on the image), and the MBs are numbered from 1 to 35 running in the poloidal direction from the HFS to the LFS. The poloidal length of the ITER-like PFUs (437 mm) is indicated. The remaining PFUs are made of graphite with a 15 μ m coating of W. The direction of the parallel heat flux is indicated at the inner and outer strike points (ISP and OSP).

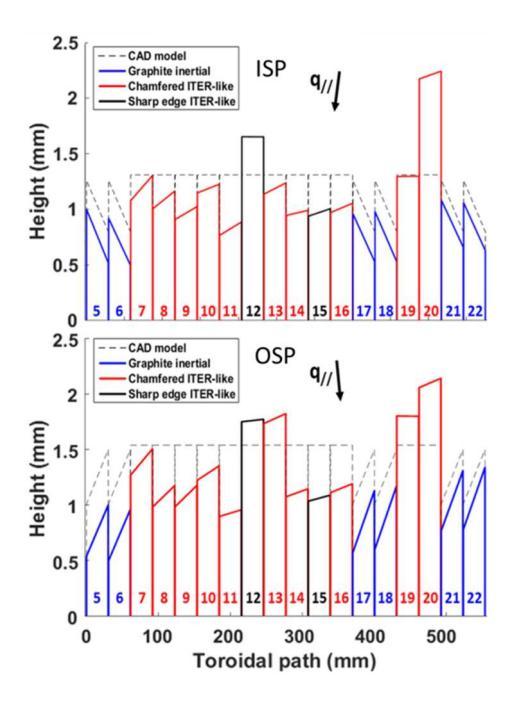
During the third WEST experimental campaign in the second half of 2018 (referred to as the C3 campaign), one of the lower divertor sectors was partially equipped with 12 actively cooled ITER-like PFUs provided by three different suppliers (3 from China, 3 from Japan, and 6 from Europe), each of which has 35 MBs (Figure 1) of 12 mm poloidal width separated by 0.5 mm toroidal gaps. They were monitored by a very-high-resolution infrared camera (3.9μ m wavelength, minimum temperature threshold ~ 300° C, 0.1 mm/pixel) [7]. The ITER-like PFUs were not beveled; some of them had 1 mm chamfers at both leading and trailing edges, while others had sharp edges. While most of the PFUs were aligned within the ITER tolerances (at most ±0.3 mm perpendicular steps between neighbouring PFUs), three of them were not: for example, at the outer strike point (OSP) PFU#7, PFU#12, and PFU#19 were measured to protrude respectively +0.31 mm, +0.79 mm, and +0.63 mm above their neighbours (Figure 2).

Figure 2. Representation of the results of a metrology study before the C3 experimental campaign illustrating the misalignments of the PFUs with respect to their nominal positions (dashed lines). The beveled graphite PFUs are shown in blue, the chamfered W PFUs are in red (the chamfers are not shown here because the exaggerated vertical scale does not yield a useful image), and the W PFUs with sharp edges are in black. These toroidal profiles are centered on MB#17 at the ISP (upper panel), and on MB#25 at the OSP (lower panel). Note that the vertical scale is greatly exaggerated in order to clearly show the misalignments.

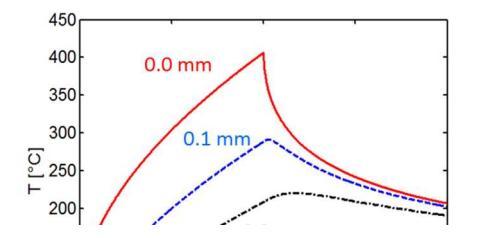
Figure 10. Thermal response of a 0.8 mm exposed leading edge to a square heat pulse of 190 MW/m² applied for 1 ms (heat flux factor = 6 MW m⁻² s^{1/2}). The temperature at the surface (0.0 mm, full curve) and at two depths below the surface (0.1 mm, dashed curve; 0.2 mm, dot-dash curve) are shown. The initial temperature is 70°C.

Returning to Figure 10, the surface temperature rises to 400°C, just slightly above the DBTT, so it is perhaps consistent that cracking was not observed under those loading conditions in JUDITH-1 [18]. In order to explore further the conditions that could lead to brittle fractures, thermal simulations were made for a range of incident heat flux and pulse durations. The peak surface temperature (Figure 11a) contours follow those of constant heat flux factor, as they should. The heat flux factor contour of 6 MW m⁻² s^{1/2} coincides with the contour T_{0.0}=400°C. The bulk temperature 0.2 mm into the MB, T_{0.2}, (Figure 11b) remains below the DBTT when following the same heat flux factor contour. However, for lower heat fluxes and correspondingly longer pulse durations, the heat pulse has more time to diffuse into the bulk, resulting in smaller thermal gradients. Indeed, in the limit of very small heat flux and very long heating time, the temperature profile would be nearly flat and no stresses would be generated. The heat flux factor alone is therefore not enough to determine whether brittle cracking could occur. High heat flux and short pulse durations result in stronger temperature gradients (Figure 11c), which should be more efficient at producing compressive stress during the heating phase, and tensile stress during the cooling phase.

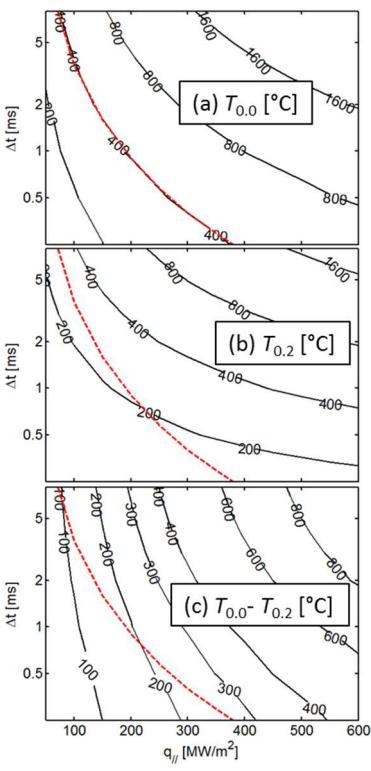
Figure 11. Thermal response of a 0.8 mm exposed leading edge to a square heat pulse as a function of parallel heat flux and exposure time. The dashed curve corresponds to a constant heat flux factor of 6 MW m⁻² s^{1/2} which is the threshold for brittle crack formation deduced in [18]. (a): Peak surface temperature. (b): Peak temperature at a toroidal depth of 0.2 mm from the leading edge. (c): The difference between (a) and (b).

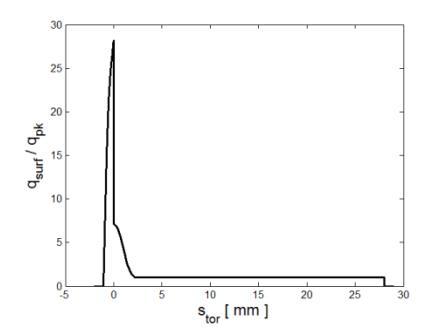
The heat flux to the surfaces of a WEST unshaped MB was calculated by ion orbit modelling [9] on a PFU that is misaligned by 0.8 mm with respect to its upstream neighbour (Figure 12). To represent the highest performance discharges that were obtained in the WEST C3 campaign, the heat flux to the top surface was $q_{pk}=2.5$ MW/m², ion and electron temperatures were $T_i=T_e=40$ eV, the magnetic field was B=4 T, and its angle of incidence with the top surface was $\alpha=1.9^{\circ}$. The peak heat flux on the exposed leading edge was 70 MW/m².

Figure 12. Toroidal profile of the heat flux to a misaligned WEST MB normalized by the heat flux to the top surface $q_{\rm pk}=2.5$ MW/m². The leading edge is at $s_{\rm tor}=0$ mm; negative values correspond to the front face inside the toroidal gap. The MB is misaligned by +0.8 mm.

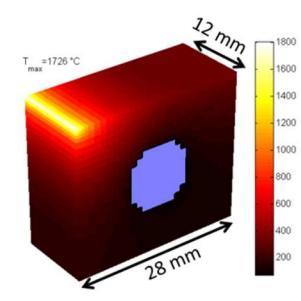
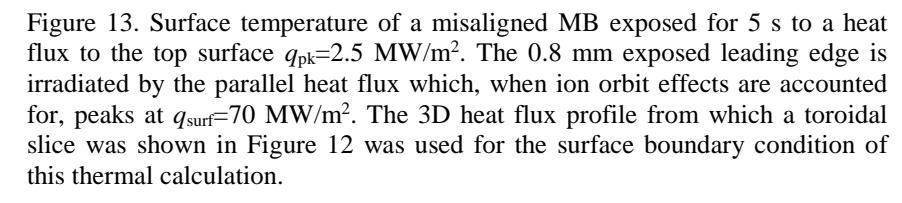
The peak temperature at the exposed leading edge, Figure 13, after a 5 s exposure to this heat flux profile, attained 1726°C, above the recrystallization temperature range of W. The local temperature gradient at the leading edge was ∇T =700°C/mm. The contour on which ∇T =200°C/mm forms a quarter circle centered on the leading edge with a radius of ~2.0 mm. The temperature along that contour is ~1000°C, and is roughly at the lower bound of the expected range of recrystallization temperatures.

This simple calculation indicates that

(1) the leading edges of misaligned monoblocks are probably recrystallized in a volume that extends ~1 mm in the toroidal and vertical directions, and
