Magnetorheological finishing for removing surface and subsurface defects of fused silica optics
Magnetorheological finishing for removing surface and subsurface defects of fused silica optics

Jérôme Neauport, Rodolphe Catrin, Daniel Taroux, Philippe Cormont, Cédric Maunier, Sébastien Lambert

Optical Engineering

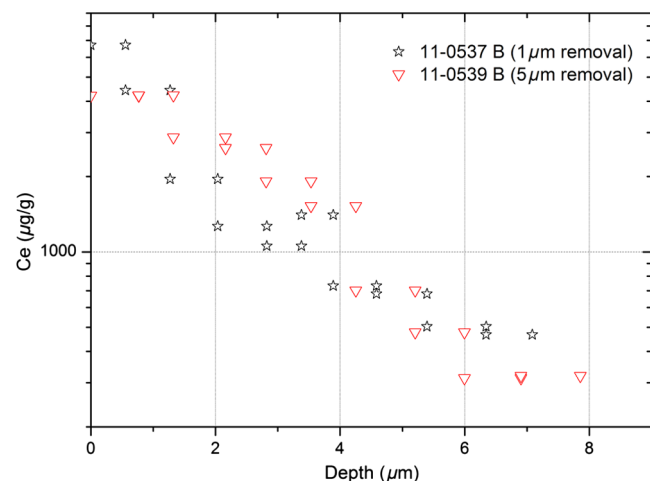
Fig. 8 Impact of MRF removal on cerium contamination.

Similar measurements were performed for cerium. Figure 8 shows that cerium pollution is independent of the material removal carried out and that cerium goes deeply into the substrates down to 7 μm.

measurements (Fig. 8) showing the existence of cerium in the glass interface. At higher fluence [Fig. 9(b)] damage evolves in a large damage typical of what is usually observed on fused silica polished parts, superimposed to the gray haze seen at lower fluences.
