## Effect of ion irradiation on aluminium hydroxide in an Al-Mg-Si alloy

# EFFECT OF ION IRRADIATION ON ALUMINIUM HYDROXIDE IN AN AL-MG-SI ALLOY

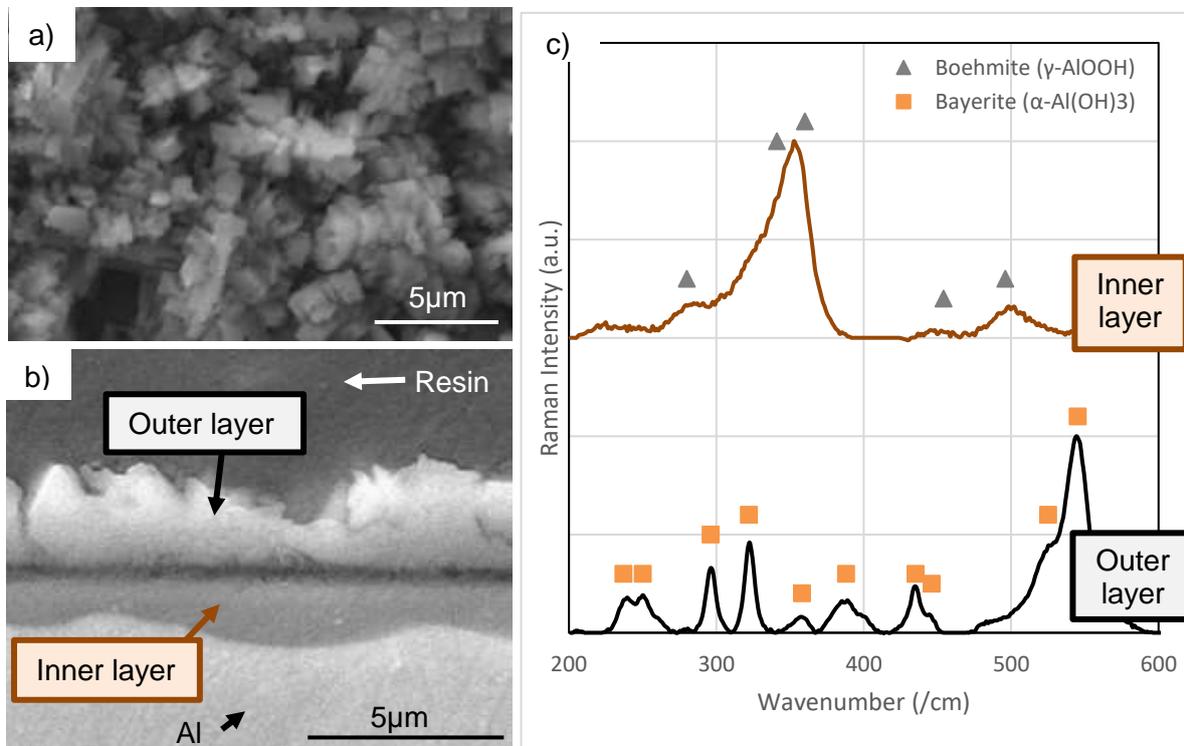
Fig 1. (a) Aluminium hydroxide crystals of the outer layer at the surface of the samples (top view, SEM, secondary electron mode), (b) cross section of the aluminium hydroxide found on the samples (SEM, secondary electron mode); (c)  $\mu$ -Raman spectra obtained on the inner and outer layers.

Before ion irradiation, the aluminium hydroxide film is composed of two layers: an inner and an outer layer, as seen in Fig 1.b. The outer layer, in contact with the aqueous media, is a crystalline hydroxide: micro-crystals of aluminium hydroxide are observed on the samples surface as seen in Fig 1.a. The  $\mu$ -Raman spectrum of this outer layer indicates it is composed of bayerite ( $\alpha$ -Al(OH)<sub>3</sub>, Fig 1.c, Raman peaks of bayerite : [13]).

Between the bayerite layer and the aluminium matrix, the inner layer is composed of a non-fully crystallised phase. The peaks of the  $\mu$ -Raman signal obtained on this inner layer can be

attributed to boehmite ( $\gamma\text{-AlOOH}$ , Fig 1.c, Raman peaks of boehmite : [13], [14]); however, the peaks are poorly defined. From this Raman spectrum, it can be concluded the inner layer is pseudo-boehmite (a nanocrystalline boehmite phase). This hydroxide is often found on surface of aluminium alloys during aqueous corrosion tests at all temperature [15].

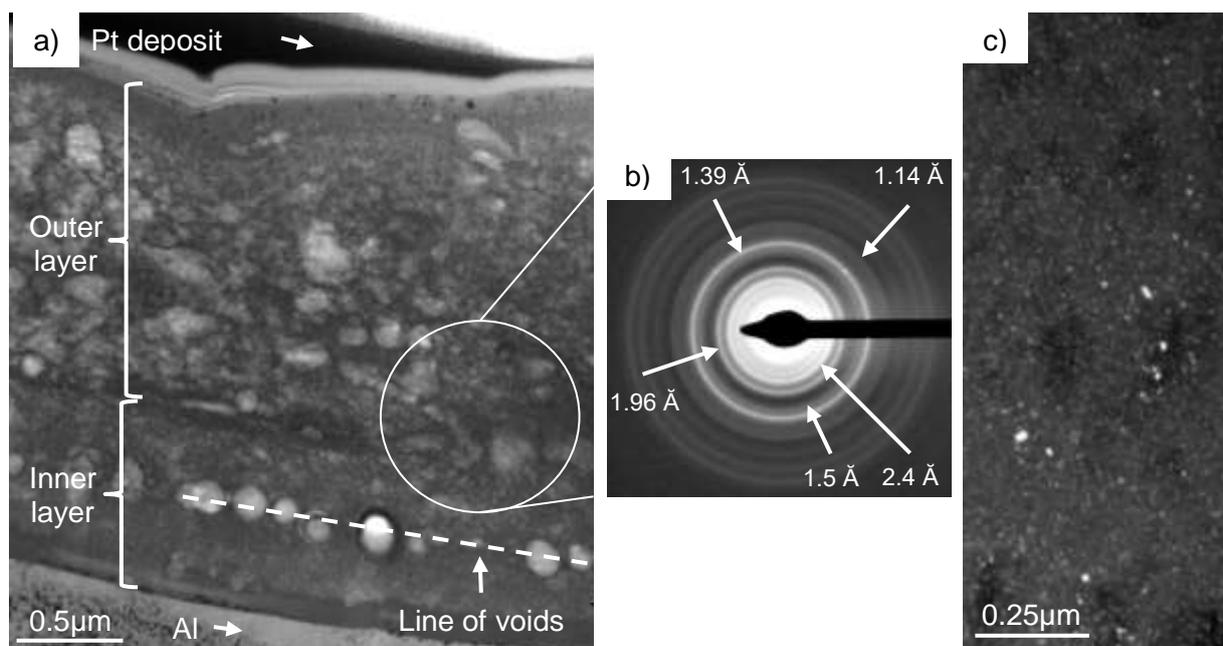
Fig 2. (a) Cross section of irradiated oxide (TEM), (b) electron diffraction pattern obtained from the irradiated oxide, attributed to  $\eta$ -Al<sub>2</sub>O<sub>3</sub>, and (c) Dark Field of the crystallites (in white) in the oxide (in black) that have diffracted to form the ring at 1.39Å.

The Fig. 2.a presents a cross section of the irradiated oxide observed by TEM. The irradiated oxide is between the Pt deposit and the aluminium matrix. After ion irradiation, the distinction between the two former layers (inner and outer layers) is difficult as seen in Fig. 2.a. The outer layer is amorphized: the former micro-crystals of bayerite could not be observed. In addition, voids are present in the irradiated oxide, in the two layers. A line of voids is observed in the middle of the former inner layer. This line corresponds to the peak of damage made by the Al ions in the inner layer (i.e. at 4.5 dpa).

Additionally, an electron diffraction observation is performed on the irradiated oxide (Fig. 2.b). The rings obtained from this electron diffraction indicate the presence of nano-crystallites. A dark field performed on the ring of 1.39 Å is presented in Fig 2.c: the nano-crystallites that have diffracted to form this ring are in white in the oxide matrix in black.

The electron diffraction pattern on Fig 2.b can be attributed to a nanometric  $\eta$ -Al<sub>2</sub>O<sub>3</sub> phase: the d-spacing measured at 1.14Å, 1.39Å, 1.50Å, 1.96Å and 2.40Å are very close to those measured by Tilley for the nanometric  $\eta$ -Al<sub>2</sub>O<sub>3</sub> phase in bauxite [16].

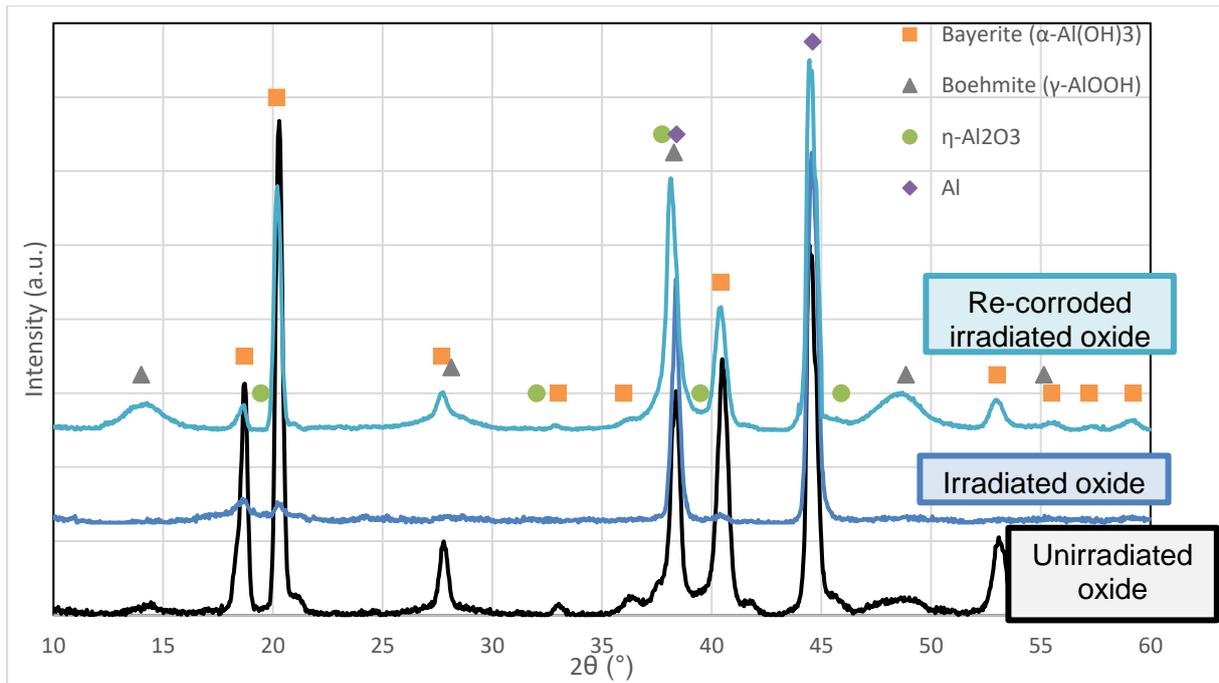
Fig 3. X-rays diffraction spectra of the aluminium hydroxide in different conditions (before and after irradiation and after re-corrosion of the irradiated oxide)

A low incidence X-ray diffraction on the corrosion products confirms the results of  $\mu$ -Raman analyses (Fig. 3): bayerite is the main crystalline phase formed during the corrosion experiments; traces of boehmite are also present. This composition of the hydroxide is common at 70°C, the temperature of the corrosion test, according to the literature [1], [15].

Additionally, the  $\eta$ -Al<sub>2</sub>O<sub>3</sub> phase could not be observed in the X-ray diffraction diagram of the irradiated hydroxide (Fig 3): it can be due to the small size of the crystallites (>10nm, Fig 2.c) and the insufficient resolution of the diffractometer. In addition, the main peaks of  $\eta$ -Al<sub>2</sub>O<sub>3</sub> at 37.80° [16] is very close to the peaks of aluminium at 38.4° [18], a distinction between the two phases is impossible. However, the peaks of bayerite are still present in this spectrum but a decrease in intensity of the peaks is observed. This result can be attributed to an important amorphization of the bayerite.

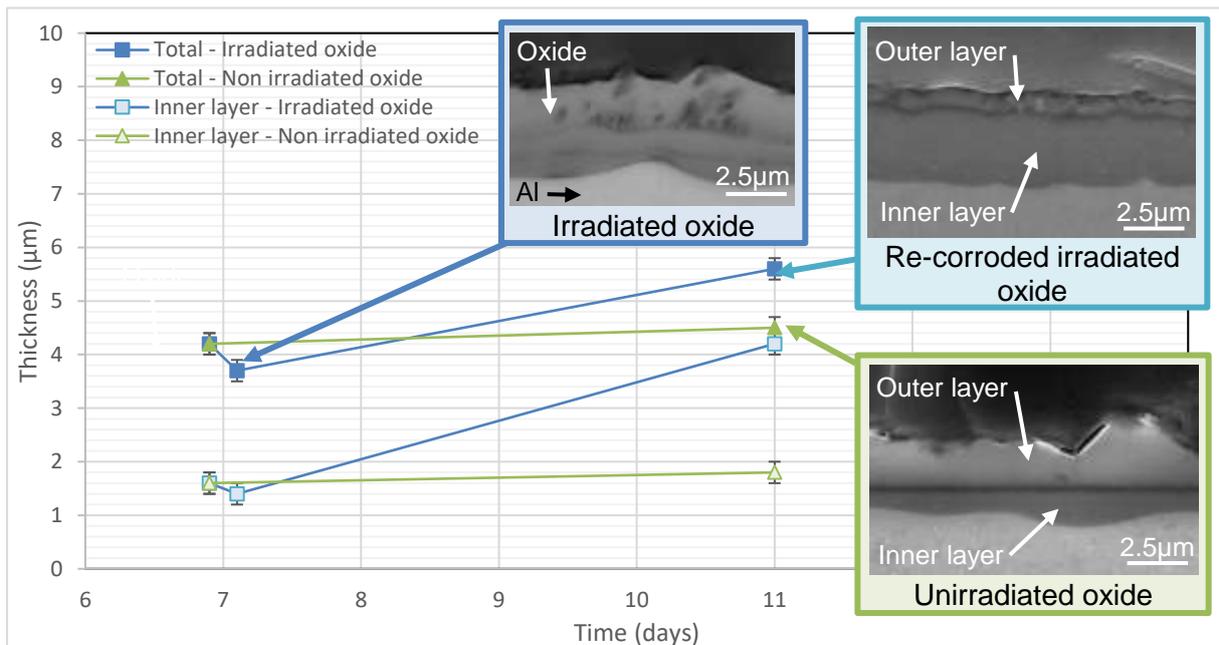
Fig 4. Evolution of the thickness of irradiated and unirradiated hydroxides and micrographs (SEM, secondary electron mode) of the aluminium hydroxide in different conditions: irradiated (in the middle), re-corroded irradiated (on the top right) and unirradiated (on the bottom right)

After the re-corrosion of the irradiated oxide, two layers of aluminium hydroxide are present at the samples surface as seen on the picture of re-corroded irradiated oxide in Fig. 4. The inner layer, near the aluminium matrix, is pseudo-boehmite and the outer layer is bayerite ( $\mu$ -Raman analyses, confirmed by XRD analysis on Fig 3). The thickness of these two layers is measured on a cross section of the hydroxide embedded in resin and observed with SEM (Fig 4).

As illustrated by Fig. 4, after re-corrosion, at 11 days, the hydroxide thickness is larger for irradiated samples than for the unirradiated ones. The increase of the inner layer thickness in particular is very important after ion irradiation and re-corrosion. This inner layer seems to contain the former layers of bayerite and pseudo-boehmite of the hydroxide before the irradiation.

In addition, the ion irradiation seems to increase the kinetics oxidation of aluminium matrix (Fig 4): the ion irradiation degrades the hydroxide film by creating voids, by dehydrating and by amorphizing it. The irradiated film does not protect the matrix. As a result, the oxidation of the aluminium matrix is more important after irradiation compared to the unirradiated samples and it causes the observed increase of hydroxide thickness for 11 days of corrosion in Fig. 4.
