Effect of ion irradiation on aluminium hydroxide in an Al-Mg-Si alloy

EFFECT OF ION IRRADIATION ON ALUMINIUM HYDROXIDE IN AN AL-MG-SI ALLOY

*DEN-Service d'Etude des Matériaux Irradiés, CEA, Université Paris-Sud
F-91191, Gif-sur-Yvette - France*

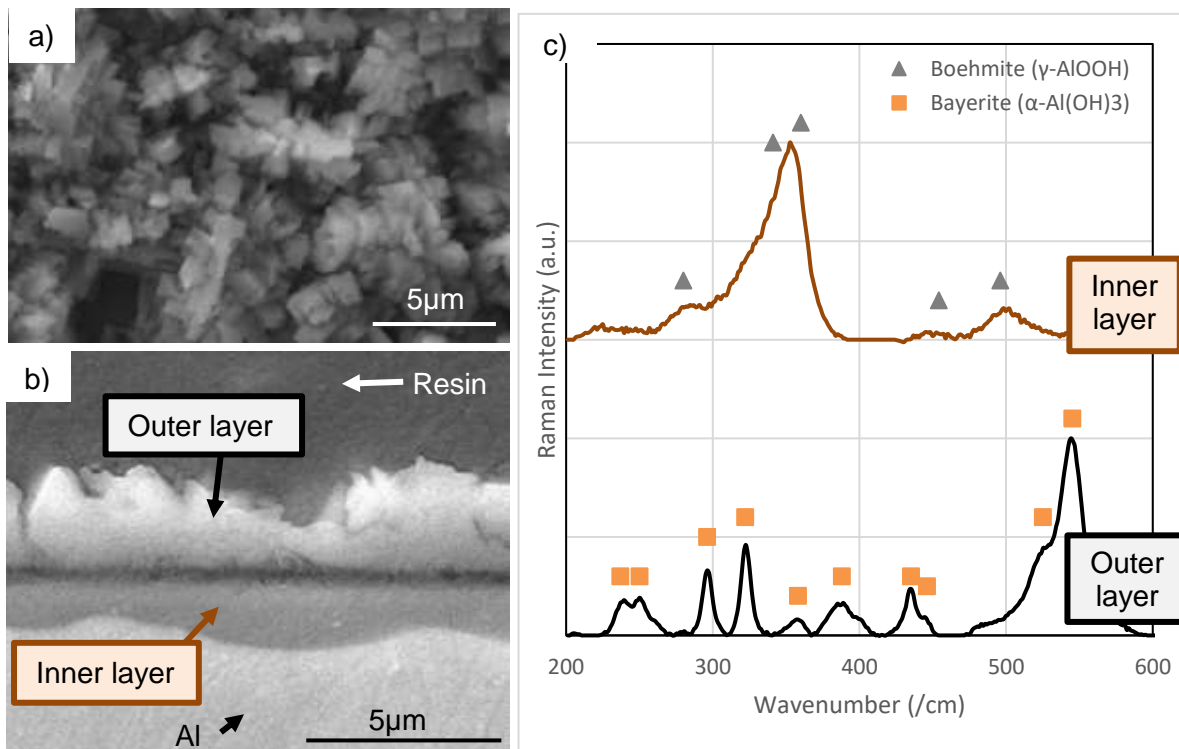
Before ion irradiation, the aluminium hydroxide film is composed of two layers: an inner and an outer layer, as seen in Fig 1.b. The outer layer, in contact with the aqueous media, is a crystalline hydroxide: micro-crystals of aluminium hydroxide are observed on the samples surface as seen in Fig 1.a. The μ -Raman spectrum of this outer layer indicates it is composed of bayerite (α -Al(OH)₃, Fig 1.c, Raman peaks of bayerite : [13]).

Between the bayerite layer and the aluminium matrix, the inner layer is composed of a non-fully crystallised phase. The peaks of the μ -Raman signal obtained on this inner layer can be

attributed to boehmite ($\gamma\text{-AlOOH}$, Fig 1.c, Raman peaks of boehmite : [13], [14]); however, the peaks are poorly defined. From this Raman spectrum, it can be concluded the inner layer is pseudo-boehmite (a nanocrystalline boehmite phase). This hydroxide is often found on surface of aluminium alloys during aqueous corrosion tests at all temperature [15].

Fig 1. (a) Aluminium hydroxide crystals of the outer layer at the surface of the samples (top view, SEM, secondary electron mode), (b) cross section of the aluminium hydroxide found on the samples (SEM, secondary electron mode); (c) μ -Raman spectra obtained on the inner and outer layers.

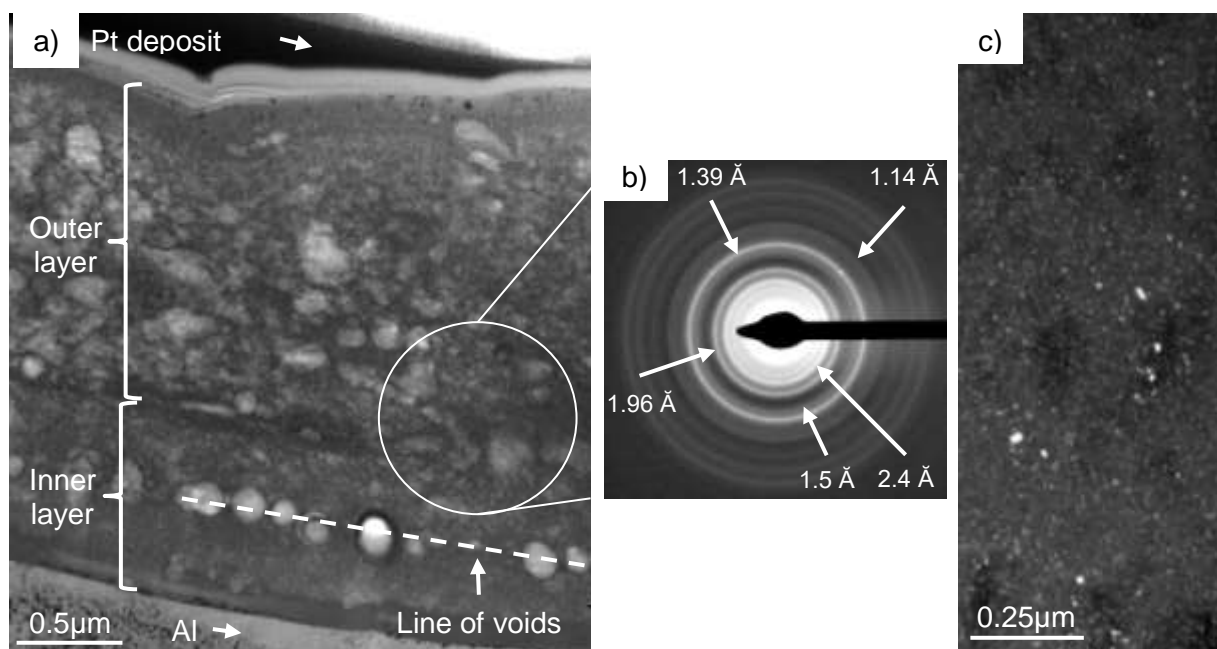
The Fig. 2.a presents a cross section of the irradiated oxide observed by TEM. The irradiated oxide is between the Pt deposit and the aluminium matrix. After ion irradiation, the distinction between the two former layers (inner and outer layers) is difficult as seen in Fig. 2.a. The outer layer is amorphized: the former micro-crystals of bayerite could not be observed. In addition, voids are present in the irradiated oxide, in the two layers. A line of voids is observed in the middle of the former inner layer. This line corresponds to the peak of damage made by the Al ions in the inner layer (i.e. at 4.5 dpa).

Additionally, an electron diffraction observation is performed on the irradiated oxide (Fig. 2.b). The rings obtained from this electron diffraction indicate the presence of nano-crystallites. A dark field performed on the ring of 1.39 Å is presented in Fig 2.c: the nano-crystallites that have diffracted to form this ring are in white in the oxide matrix in black.

Fig 2. (a) Cross section of irradiated oxide (TEM), (b) electron diffraction pattern obtained from the irradiated oxide, attributed to η - Al_2O_3 , and (c) Dark Field of the crystallites (in white) in the oxide (in black) that have diffracted to form the ring at 1.39Å.

The electron diffraction pattern on Fig 2.b can be attributed to a nanometric η - Al_2O_3 phase: the d-spacing measured at 1.14Å, 1.39Å, 1.50Å, 1.96Å and 2.40Å are very close to those measured by Tilley for the nanometric η - Al_2O_3 phase in bauxite [16].

Additionally, the η - Al_2O_3 phase could not be observed in the X-ray diffraction diagram of the irradiated hydroxide (Fig 3): it can be due to the small size of the crystallites (>10nm, Fig 2.c) and the insufficient resolution of the diffractometer. In addition, the main peaks of η - Al_2O_3 at 37.80° [16] is very close to the peaks of aluminium at 38.4° [18], a distinction between the two phases is impossible. However, the peaks of bayerite are still present in this spectrum but a decrease in intensity of the peaks is observed. This result can be attributed to an important amorphization of the bayerite.

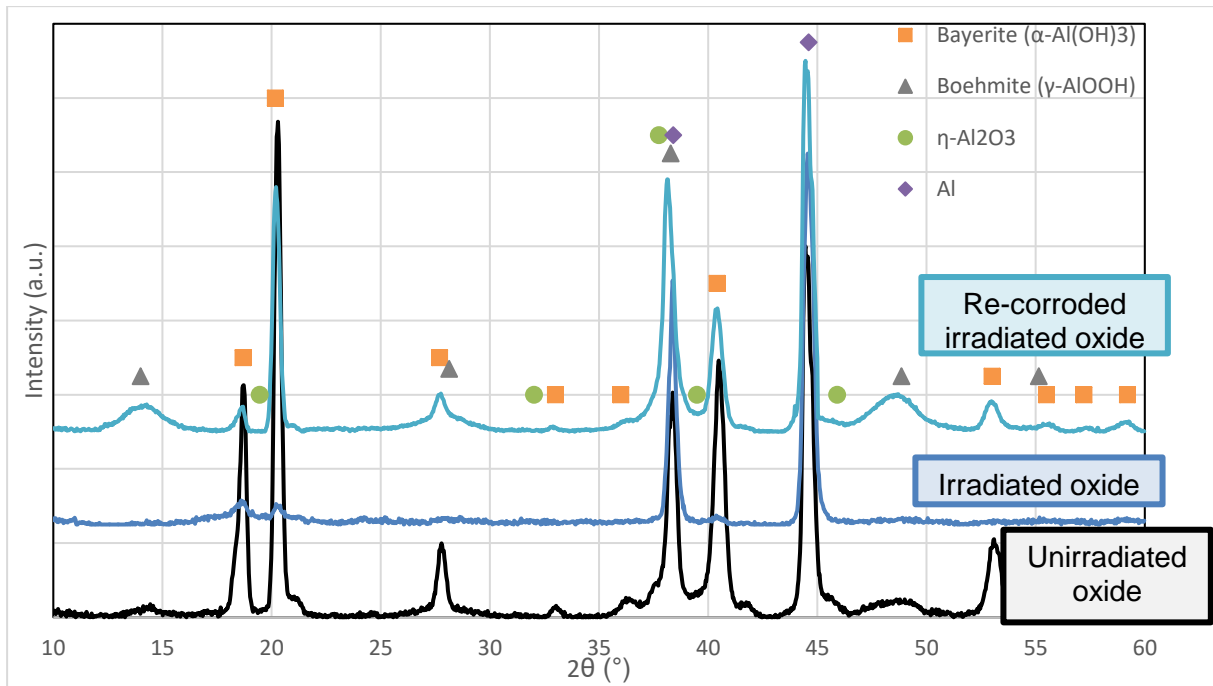
Fig 3. X-rays diffraction spectra of the aluminium hydroxide in different conditions (before and after irradiation and after re-corrosion of the irradiated oxide)

A low incidence X-ray diffraction on the corrosion products confirms the results of μ -Raman analyses (Fig. 3): bayerite is the main crystalline phase formed during the corrosion experiments; traces of boehmite are also present. This composition of the hydroxide is common at 70°C, the temperature of the corrosion test, according to the literature [1], [15].
