Reliability improvement of the evacuation route of fuel elements of Phénix

F. DOMINJON, H. DUPORT, F. LAURENT

INTRODUCTION

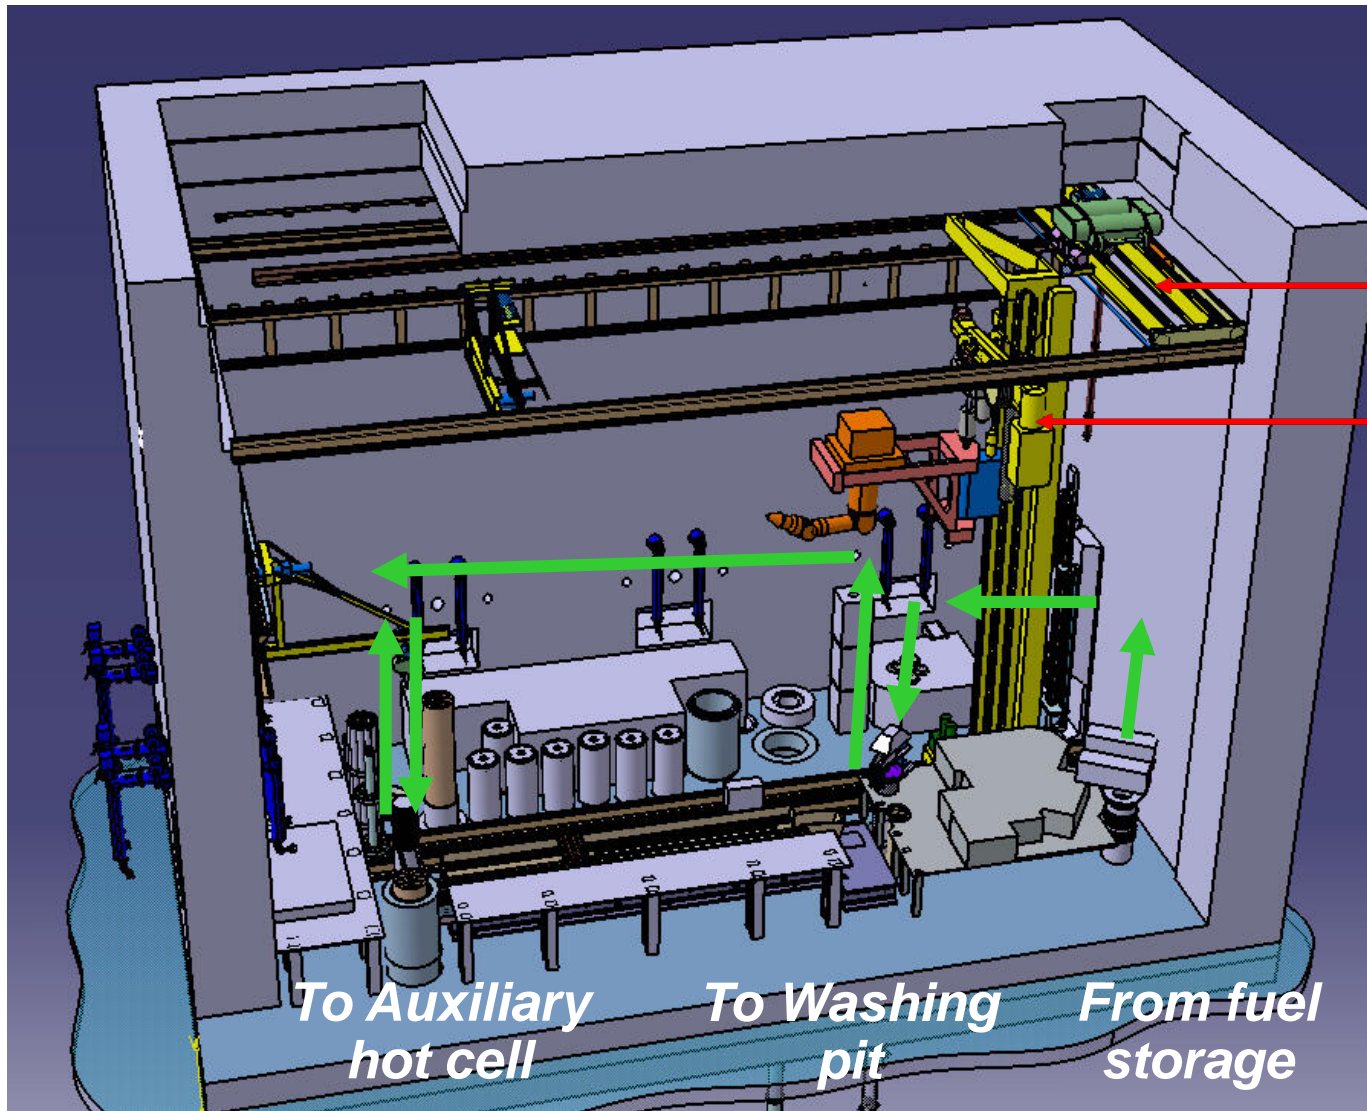
Irradiated fuel elements hot cell

Replaced in 2012

Main Lifting Unit
HOTLAB 2013

Heavy Manipulator
HOTLAB 2014

To Auxiliary
hot cell

To Washing
pit

From fuel
storage

- In 2009, the main crane of the hot cell of the handling route broke down (presented in HOTLAB 2013); in 2010 the heavy manipulator in the cell failed too (presented in HOTLAB 2014), other equipments may face problems. Crane and heavy manipulator failure and replacement stopped the evacuation during around 3 years.
- The reliability of the handling route is estimated at 50% of availability (80% needed).

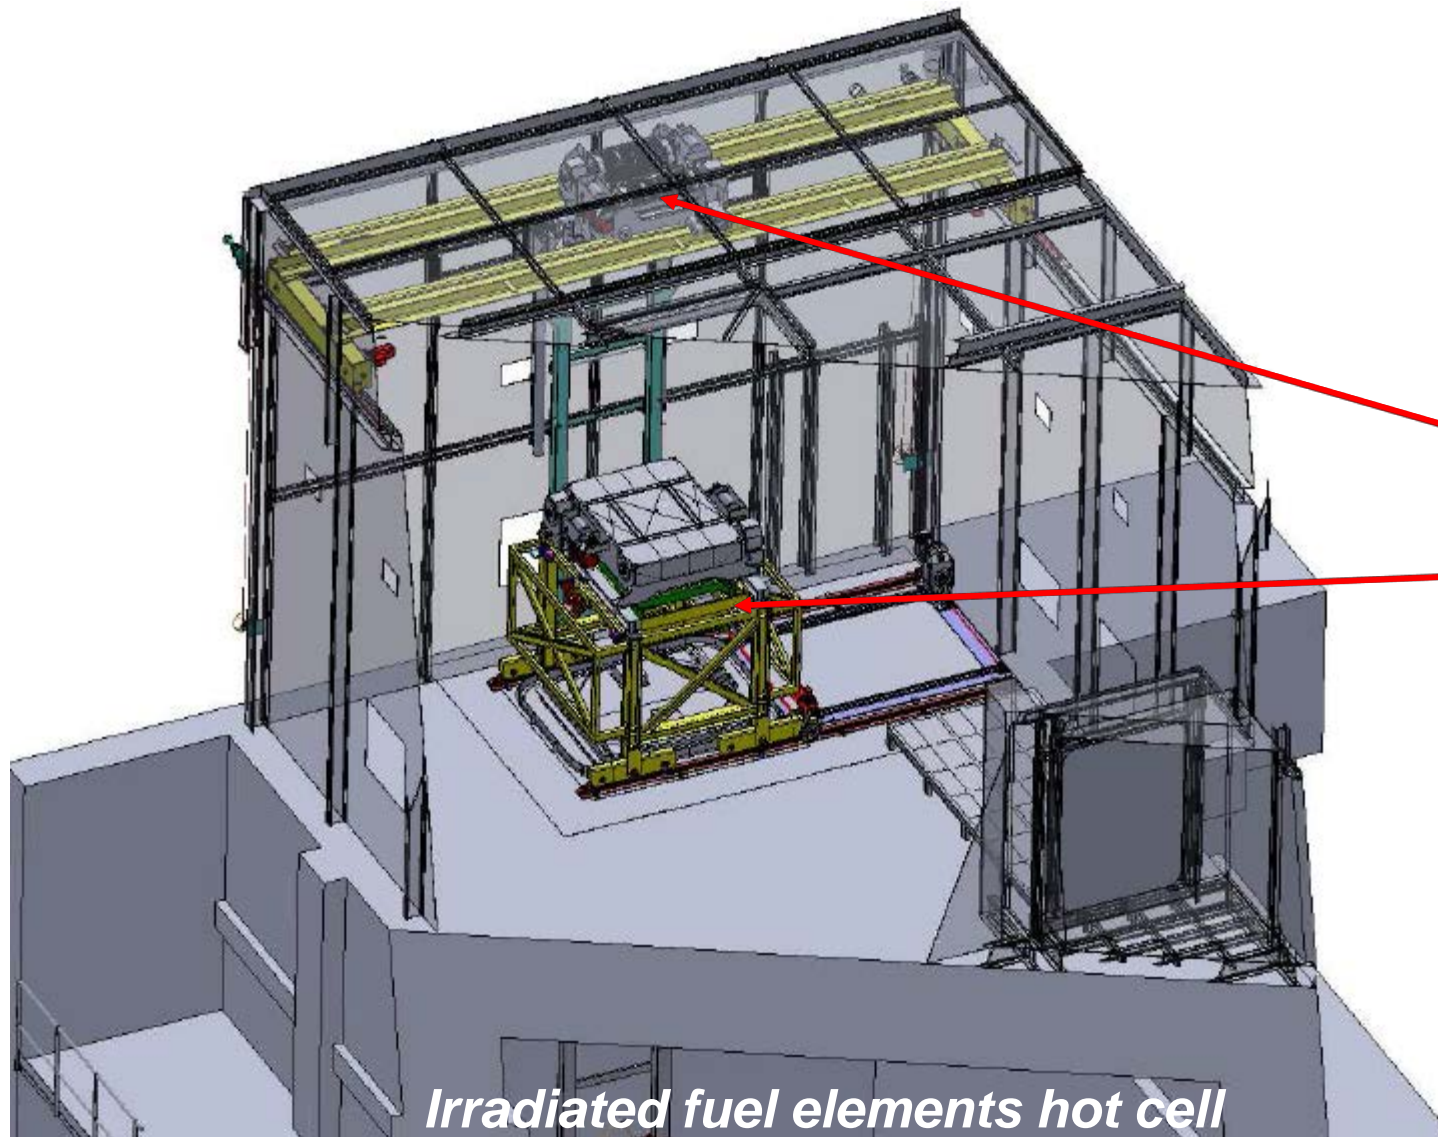
Top maintenance hot cell

Replacement planned in 2016

Main Lifting Unit
Partial replacement

Plug Lifting Trolley
Important refurbishing

Irradiated fuel elements hot cell

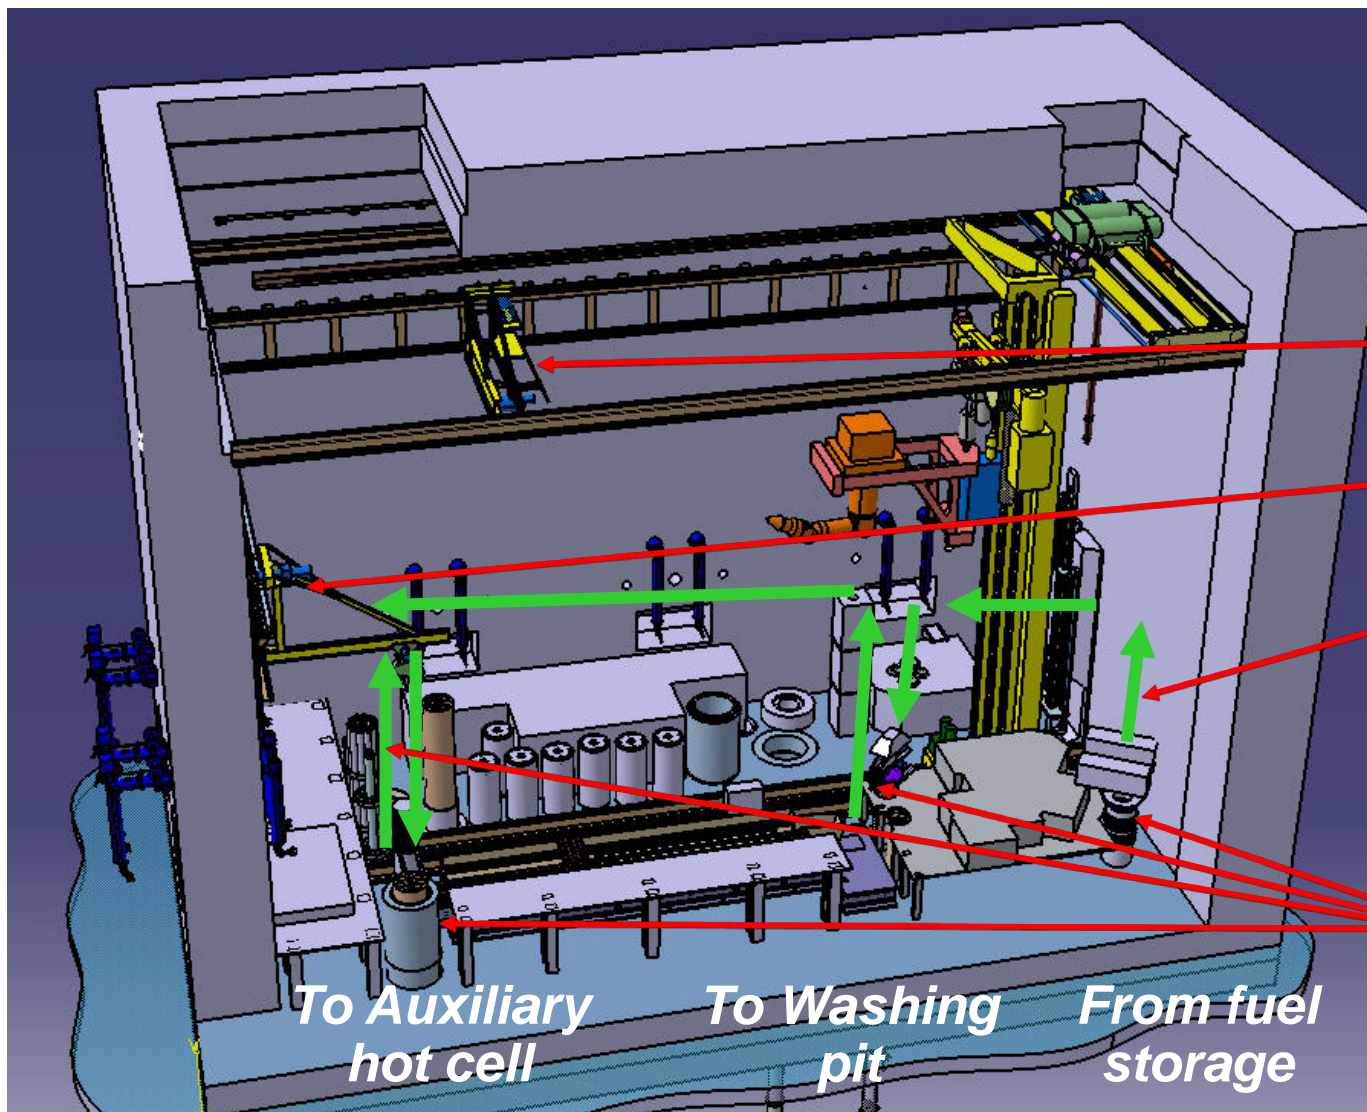
Irradiated fuel elements hot cell

Replacement planned in 2017

West Lifting Unit
Total replacement

South Lifting Unit
Total replacement

Transfer Lifting Unit
Total replacement

Replacement planned in 2016

Link between cells
Refurbishing

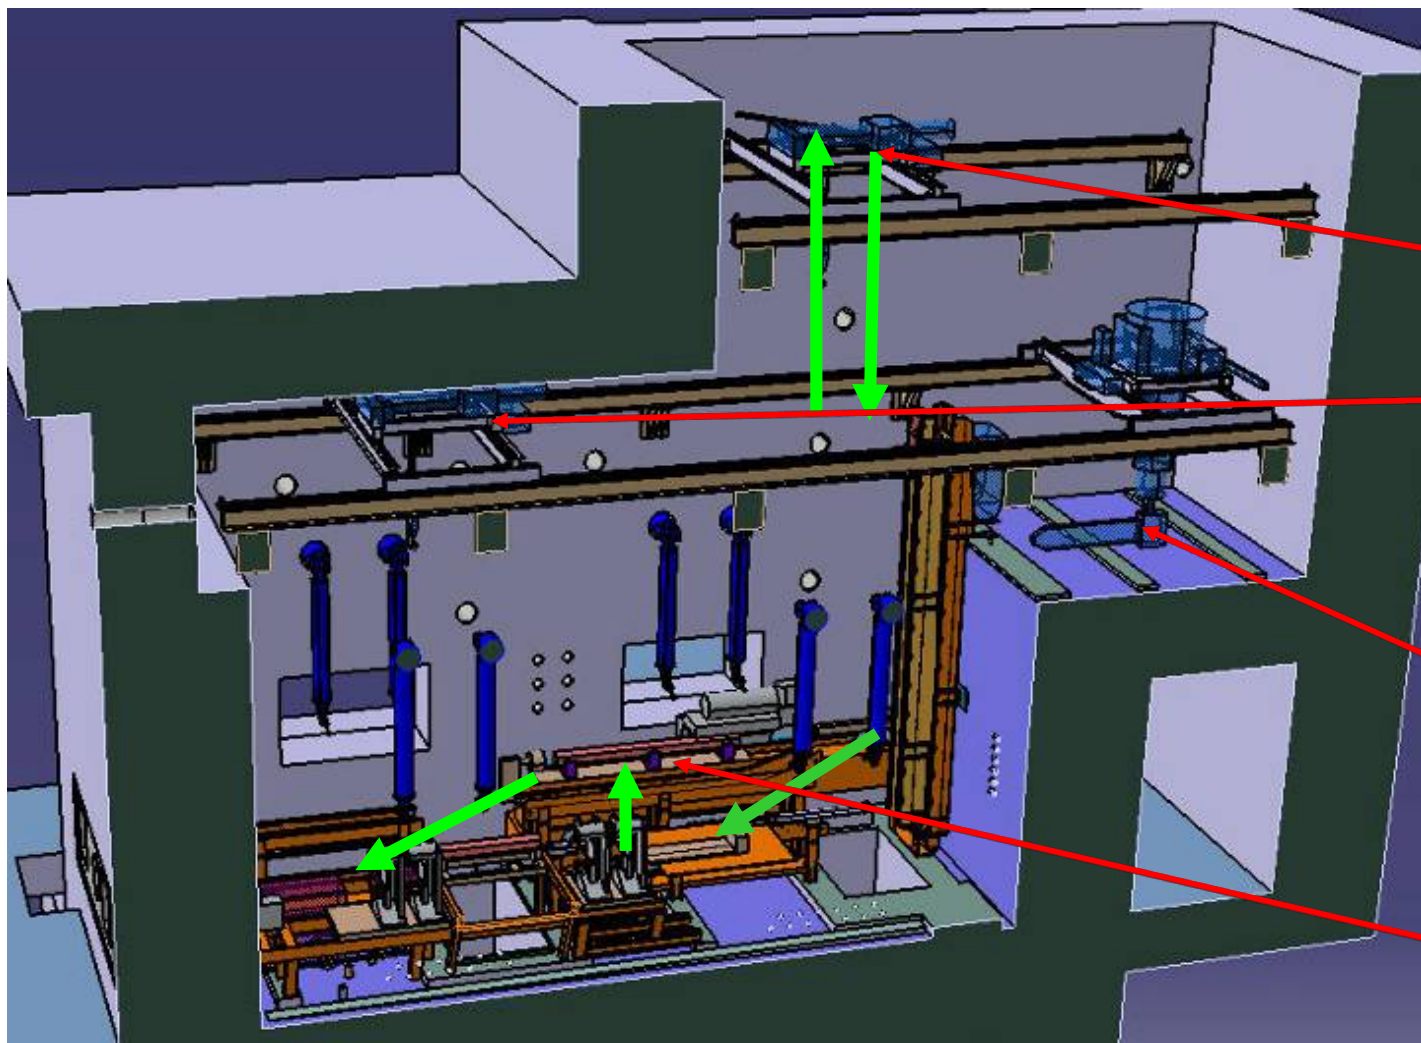
Auxiliary hot cell

To Irradiated fuel elements hot cell

Replacement planned in 2017

Top Lifting Unit
Partial replacement

Below Lifting Unit
Partial replacement

Replacement planned in 2018

Heavy Manipulator
Total replacement

Replacement planned in 2016

Milling bench
Important refurbishing
