Evaluation of Total Ionizing Dose Effects on Commercial FRAM

Mariem Slimani¹, Jean Marc Armani¹ and Rémi Gaillard²

¹ CEA, LIST, Laboratoire de Fiabilisation et d'Intégration des Capteurs, Nano-Innov, Bat 862-PC172

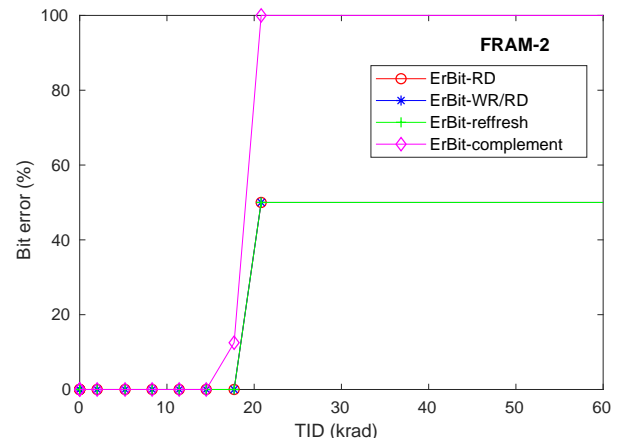
Fig. 3: Bit error versus deposited dose for FRAM-2.

Total ionizing dose testing has shown very different results between FRAM references. Fig. 2 and Fig. 3 show the percentage of bit errors in the memory chips as a function of the deposited dose for FRAM-1 and FRAM-2, respectively. The reference FRAM-1 has maintained the complete functionality up to 200 krad, while radiation hardness level of FRAM-2 is 17 krad. This huge difference can be explained either by the use of different CMOS technology process for the implementation of the peripheral CMOS circuitries (sense amplifier, decoders...) and the nMOS transistors of the memory cell [13] or by the use of different bit cells architectures (1T/1C vs 2T/2C) .

The results of FRAM-2 show a sudden functional failure where all read data are stuck-at zero. This failure is most probably due to a problem at the peripheral CMOS circuitries shared by all memory bit cells, such as control or I/O circuitries.
