Dislocation analysis of a complex sub-grain boundary in UO_2 ceramic using accurate electron channelling contrast imaging in a scanning electron microscope

H. Mansour^{a,*,1}, M.A. Crimp^b, N. Gey^{a,c}, X. Iltis^d, N. Maloufi^{a,c,**}

ABSTRACT

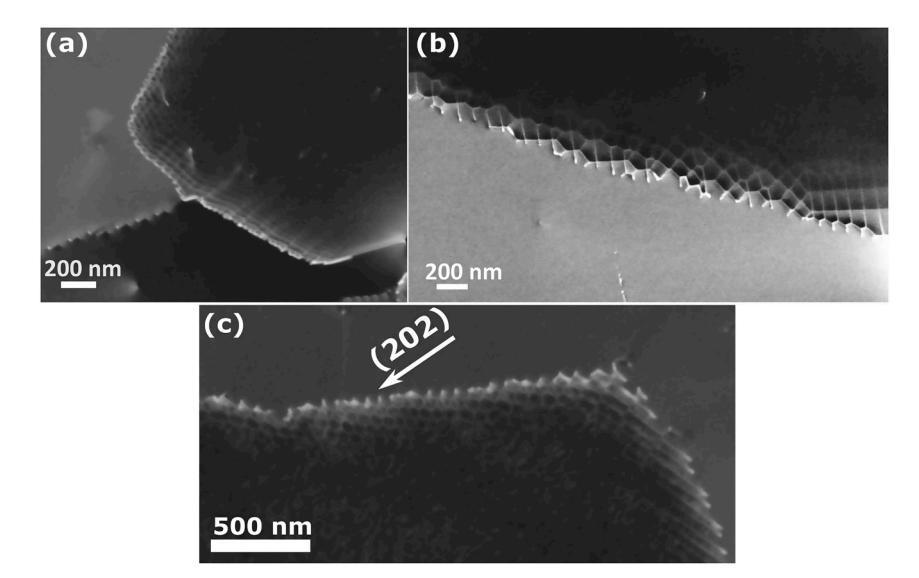
Fig. 1. A-ECC images of several sub-grain boundaries observed in a UO_2 crept bulk sample. The g = (202) diffraction condition is indicated for the sub-grain to which the study related.

Fig. 1(a), (b) and (c) show A-ECC images of several configurations of dislocations (bright lines contrast against a dark background) in UO_2 crept bulk samples highlighting the complexity and diversity of these networks. In this study we focus on the low angle sub-grain boundary of Fig. 1(c), observed by A-ECCI at g = (202). As the boundary orientation varies, it is evident that the corresponding dislocation structure changes, with two significantly different regions. The first, labeled region 1 in Fig. 1(c), is oriented roughly horizontal in the image, extending from the left side past the center of the image. The second region, labeled region 2, extends downward along the right side of the image. Region 1 is made up of a roughly hexagonal dislocations.

Region 1 of the sub-grain boundary is shown under three different channeling conditions in Figs. 1(c), 3(a) and 3(b). The dislocation line traces are plotted with different colors (d_1 in red, d_2 in green, and d_3 in blue) on the stereographic projection in Fig. 3(e). Dislocations d_1 are visible at g = (202) (Fig. 1(c)) and g = (2-20) (Fig. 3(b)), but disappear with $\mathbf{g} = (020)$ in Fig. 3(a), satisfying $\mathbf{g} \cdot \mathbf{b} = 0$ (note that \mathbf{g} is perpendicular to the dislocation line in Fig. 3(a)), consistent with the Burgers vector being $\mathbf{b}_1 = \frac{1}{2}[-10-1]$. The trace analysis in Fig. 3(e) shows that the d_1 dislocation line lies in the (-121) plane, consistent with the line direction being [-10-1] and indicating the dislocations are screw in character. Dislocations d_2 are visible with g = (202) and g= (020), but disappear with \mathbf{g} = (2–20), which is perpendicular to the dislocation line, so the d₂ dislocations have the $\frac{1}{2}$ [110] Burgers vector (\mathbf{b}_2) . The d₂ dislocations line trace lies approximately in the (1–11) plane, consistent with the line direction being close to [110], as illustrated in Fig. 3(e), again suggesting the dislocations are screw in character.

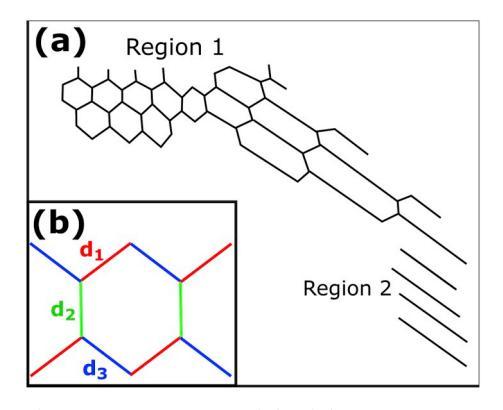
Fig. 2. (a) Schematic representation of the dislocation structures within the sub-grain boundary. (b) Schematic representation of the three dislocations types (d_1, d_2, d_3) forming the hexagonal network in Region 1 of the sub-grain boundary.

A schematic representation of the dislocation structures along the entire boundary is illustrated in Fig. 2(a), while Fig. 2(b) schematically shows details of the hexagonal dislocation arrangement in region 1 of the boundary, with three dislocation types (identified later), labeled as d_1 (red), d_2 (green), and d_3 (blue). There is a smooth transition in the

dislocation structure between the two regions, as the hexagonal network becomes elongated and eventually one of the network dislocation types, d_3 , becomes a significant fraction of the long, straight dislocations in region 2.

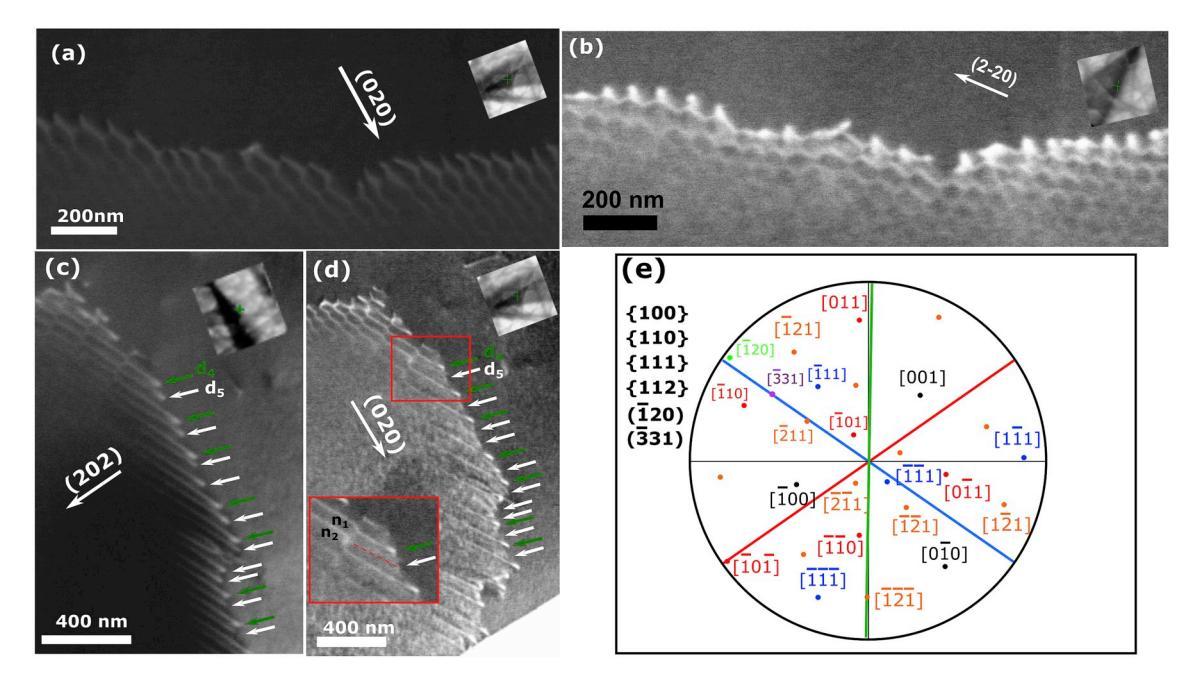
Fig. 3. A-ECC image of region 1 of the sub-grain boundary at (a) $\mathbf{g} = (020)$ and (b) (2–20), and of region 2 at (c) $\mathbf{g} = (202)$ and (d) $\mathbf{g} = (020)$. (e) Stereographic projection showing {100}, {111}, {112}, (-120), (-331) poles. The straight lines correspond to the traces of the dislocations: d₁ (red); d₂ (green); d₃, and d₄ and d₅ (blue). (For interpretation of the references to color in this figure legend, the reader is referred to the Web version of this article.)

Dislocations d_3 cannot be pure screw dislocations because the [0–11] direction does not lie on the trace of the dislocation line, as shown in the stereographic projection (blue line in Fig. 3(e). If these dislocations exhibit pure edge character, their line direction would be [–211] and the only **g**-vector satisfying the $\mathbf{g} \cdot \mathbf{b} = 0$ and $\mathbf{g} \cdot \mathbf{b} \mathbf{x} \mathbf{u} = 0$ edge dislocation invisibility criteria would be $\mathbf{g} = (-422)$. Unfortunately, given the stage limitations, it was not possible to reach this **g**-vector (more than 50° of tilt). Other possible line directions for the d_3 dislocations would result in mixed character and include [–120] or [–331] (see Fig. 3(e)). Regardless, the lack of complete invisibility for these dislocations in the available imaging conditions is consistent with dislocations d_3 being mixed or edge in character.

Region 2 of the sub-grain boundary was likewise characterized under a variety of different channelling conditions. This A-ECC analysis reveals that region 2 of the sub-grain boundary is made of two different types of dislocations (d₄ and d₅) that remain parallel under all of the tilt conditions, indicating they share the same dislocation line direction. Fig. 3 (c) shows an A-ECC image of the boundary using $\mathbf{g} = (202)$, with dislocations d₄ and d₅ labeled by green and white arrows, respectively. These two dislocation types appear to also have the same dislocation line direction as d₃, with their trace also labeled in blue in the stereographic projection (see Fig. 3 (e)). Dislocations d₄ reveal the same

visibility under different imaging conditions **g** as dislocation d₃. Following the dislocation network node rules between regions 1 and 2, reinforces that dislocations d₄ must have the same Burgers vector as dislocations d₃ (**b**₄ = **b**₃). Dislocations d₅ became invisible at **g** = (020) in Fig. 3 (d), consistent with a **b**₅ = $\pm \frac{1}{2}$ [101], possibly the same as **b**₁. This **g**-vector is neither perpendicular nor parallel to the line direction, indicating that dislocations d₅ are mixed dislocations. Like dislocations d₄, dislocations d₅ appear to connect back to the network connecting regions 1 and 2. However, the manner in which dislocations d₅ connect is not readily apparent, with Fig. 3 (d) showing both broken and strong contrast at the node where the uppermost d₅ dislocation comes in to the network. Thus, unfortunately, the spatial resolution of the SEM and ECCI technique in this case is not fine enough to unambiguously image the node, and it is not possible to fully characterize the nature of dislocation d₅.

It is important to note that the distribution of dislocations d_4 and d_5 is irregular, with varying spacing and order of these dislocations along the boundary, as indicated by the green and white lines in Fig. 3(c) and (d). Furthermore, it can be seen that with each d_4 dislocation, there is a step or facet on the sub-grain boundary. This indicates the boundary is asymmetric and made up of two different sets of dislocations. Additionally, as at least one of the dislocation types that makes up the boundary in Region 2 is mixed in character, the boundary most likely has mixed twist and tilt characteristics.

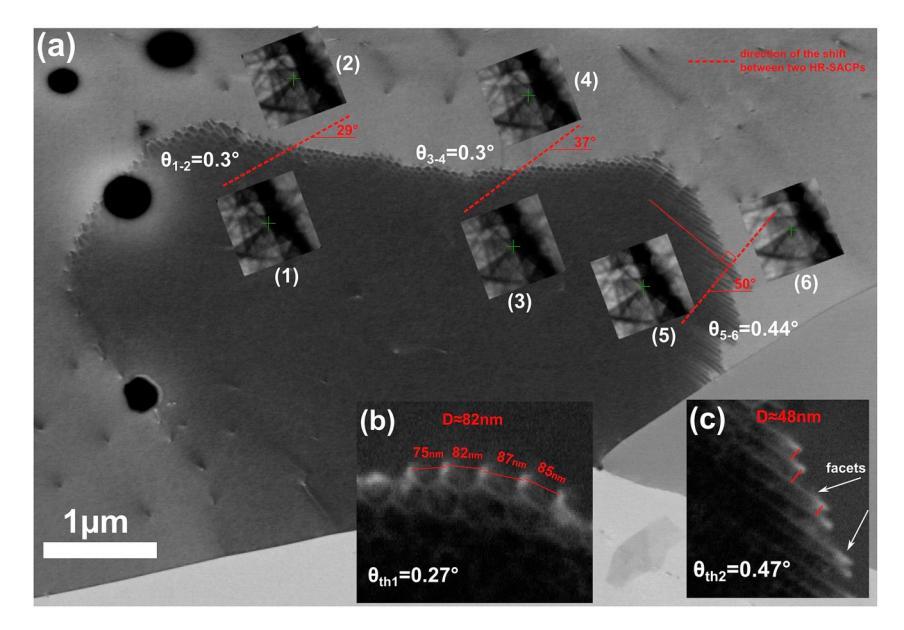
Fig. 4. (a) A-ECC image of the sub-grain boundary. Misorientation across the boundary is indicated by the many HR-SACP (1–6) collected on either side of the boundary. The shift direction between HR-SACPs is labeled in red dotted lines. The misorientation across the boundary was calculated based on the distance between dislocations, as shown for side 1 of the sub-grain boundary in (b) and side 2 of the boundary in (c). (For interpretation of the references to color in this figure legend, the reader is referred to the Web version of this article.)

Fig. 4 shows a relatively low magnification A-ECC image of the region containing the sub-grain boundary of interest. Differences in BSE intensity between the outer primary grain region, in higher intensity, and the region enclosed by the sub-grain boundary, in lower intensity, indicate a significant misorientation across the boundary. Closer examination reveals that the misorientation between the inner (lower) sub-grain and outer grain varies, with large differences in BSE intensity across the right and upper portions of the boundary, and smaller variations in intensity across the left hand portion of the boundary. Of particular note, the intensity of the enclosed sub-grain is seen to vary significantly from right to left, suggesting that the orientation of the sub-grain varies. This orientation variation may result from elastic strains in the sub-grain and/or may be related to the small residual dislocation content that can be observed in the sub-grain (note that similar residual dislocations are observed in the primary grain and there may also be orientation variations in the primary grain, but these are not as evident in the channelling contrast).

To quantify the misorientation variations across the sub-grain boundary, HR-SACP was used to measure the orientations of both the primary grain and the sub-grain. Six of these HR-SACPs, labeled 1-6, are superimposed on Fig. 4. Misorientations between the different regions were determined by superposing pairs of the HR-SACPs using the image analysis software "ImageJ" and allowing the number of pixels and direction of the shift between two patterns to be determined. Crosscorrelation of the patterns shows a misorientation of $\theta_{1-2} = \theta_{3-4} = 0.3^{\circ}$ in region 1 of the boundary. The direction of the shift between two HR-SACPs is indicated by red dotted lines in Fig. 4, with the angle of the red dotted relative to the horizon of the image also indicated in red. Because of the small angular range of HR-SACP pattern, small rotation axes are hard to measure, especially for the rotations perpendicular to the pattern. In contrast, rotational components about axes lying in the plane of the pattern can be measured with high accuracy. Therefore, the measured shift can be considered a qualitative estimate of the crystal rotations across the boundary. While the misorientation angle between positions 1 and 2 is very similar to the angle between positions 3 and 4, $\sim 0.3^{\circ}$ the direction of the shift varies slightly, from 29 to 37°, indicating that the misorientation axis varies also slightly.

When the misorientation is measured between HR-SACPs 5 and 6, a significantly larger misorientation angle of ~0.44° is revealed, consistent with the larger change in channelling intensity across the right hand side of the sub-grain boundary. The misorientation axis also continues to rotate at this point to approximately 50° from the

horizontal. Note that at this point, the misorientation axis nearly lies in the plane of the sub-grain boundary, with the axis nearly parallel with the line direction of the dislocations that make up the boundary, consistent with the boundary being mostly tilt in character in this region.

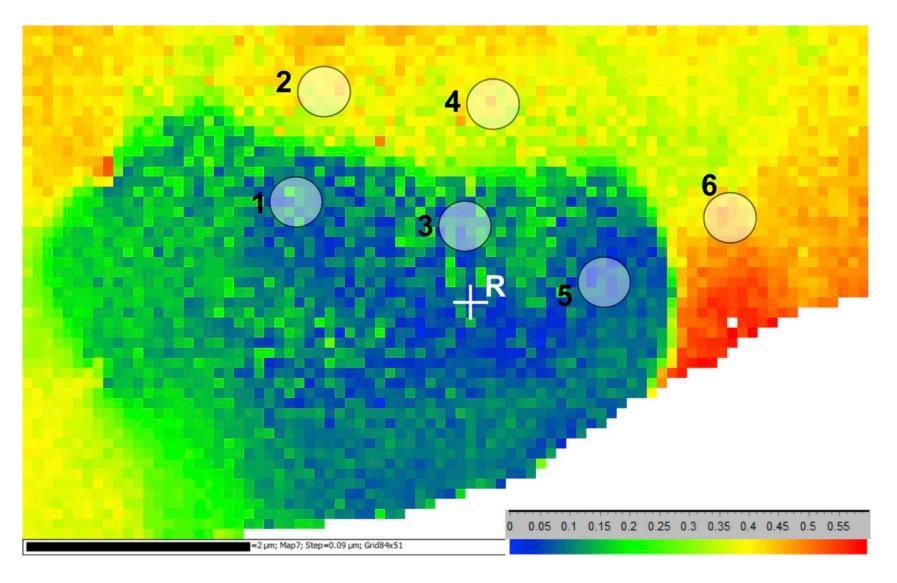
Fig. 5. High precision EBSD map of the grain containing the sub-grain boundary, measured with a step size of 90 nm. The misorientation relative to a reference point "R" is plotted using a scale from 0° to 0.6° . The misorientations across 1–2, 3–4 and 5–6 were measured by averaging the orientations of 20 pixels around those areas (1–6) (labeled as circles).

An EBSD map (Fig. 5) with a step size of 90 nm was acquired around the sub-grain boundary using a "NordlysNano" Oxford instruments EBSD system. The patterns were indexed using "Refined Accuracy" in the EBSD acquisition software AZtec. After primary band detection was performed using an optimized variant of the classical Hough transform approach, each pattern was indexed, which leads to a first estimation of the crystal orientation with a precision in the range of 0.2–0.5°. Then an additional step ("Refined Accuracy") was performed to refine the solution: here the initial proposed solution was used to model the expected positions of the Kikuchi band edges using Bragg's theory, taking into account their hyperbolic nature. Detailed image analysis along the band edges in the original diffraction pattern was then used to refine the original solution, optimizing the fit between the solution and the original pattern (see US patent No 9,671,354 B2 (2017)). The angular precision of the EBSD analysis can thus routinely be improved down to

Nevertheless, the sub-grain boundary is not detectable in the high precision EBSD map using the usual boundary detection algorithms, because of its small misorientation (< 0.5°). Therefore to reveal the existence of the sub-grain, the angular misorientation relative to a reference point, labeled R in the middle of the sub-grain, is plotted in Fig. 5. The misorientation map was scaled from 0 to 0.6°. Areas identical to the ones measured by HR-SACP around the sub-grain boundary were labeled as circles from 1 to 6. The misorientation between these areas were measured (the orientations were determined by averaging over 20 pixels in each area): $\theta_{EBSD1-2} = 0.39^\circ$, $\theta_{EBSD3-4} = 0.37^\circ$ and $\theta_{EBSD5-6} = 0.46^\circ$.

The misorientation values measured by high accuracy EBSD are very consistent with those measured by HR-SACP and those calculated based on the ECCI characterization of the dislocations in the boundary.
