Influence of ageing heat treatment on A-286 microstructure and stress corrosion cracking behaviour in PWR primary water

Influence of ageing heat treatment on alloy A-286 microstructure and stress corrosion cracking behaviour in PWR primary water

M. Savoie ^{a,b}, C. Esnouf ^c, L. Fournier ^a, D. Delafosse ^{b,*}

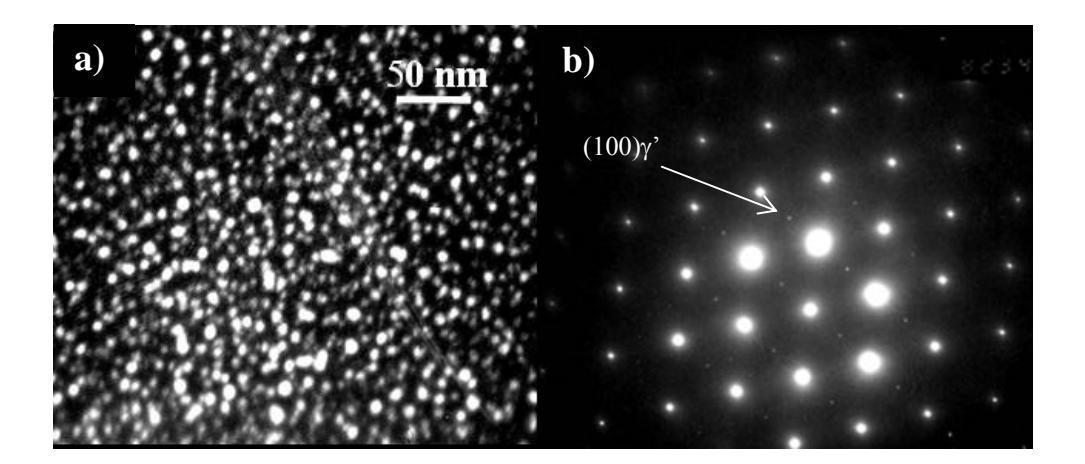
Figure 1

Fig. 1. a) Dark-field TEM micrograph showing γ' precipitates in the specimen aged 16h at 720°C. The associated diffraction pattern is shown in b). The precipitates were imaged using $(100)_{\gamma'}$ superlattice reflexion (indicated by an arrow) in zone axis <110>.

The γ' mean diameter, volume fraction and density measured after ageing for 50 and 100h at 670°C, and 5, 16, 24 and 100h at 720°C are summarized in Table 2. Between 192 and 1066 precipitates in 3 to 5 different areas of a single TEM foil were analysed for each ageing condition. Thin foils thickness ranged between 30 and 110 nm. A dark-field TEM micrograph of γ' precipitation for the 16h at 720°C ageing heat treatment is displayed in Figure 1. Size distribution histograms for γ' precipitates are displayed in Figure 2 for all ageing heat treatment investigated. It should be mentioned here that γ' were too small to be imaged by TEM for ageing at 670°C for 24h. The evolution of the γ' density and mean diameter as a function of ageing time are shown in Figure 3 and 4, respectively.

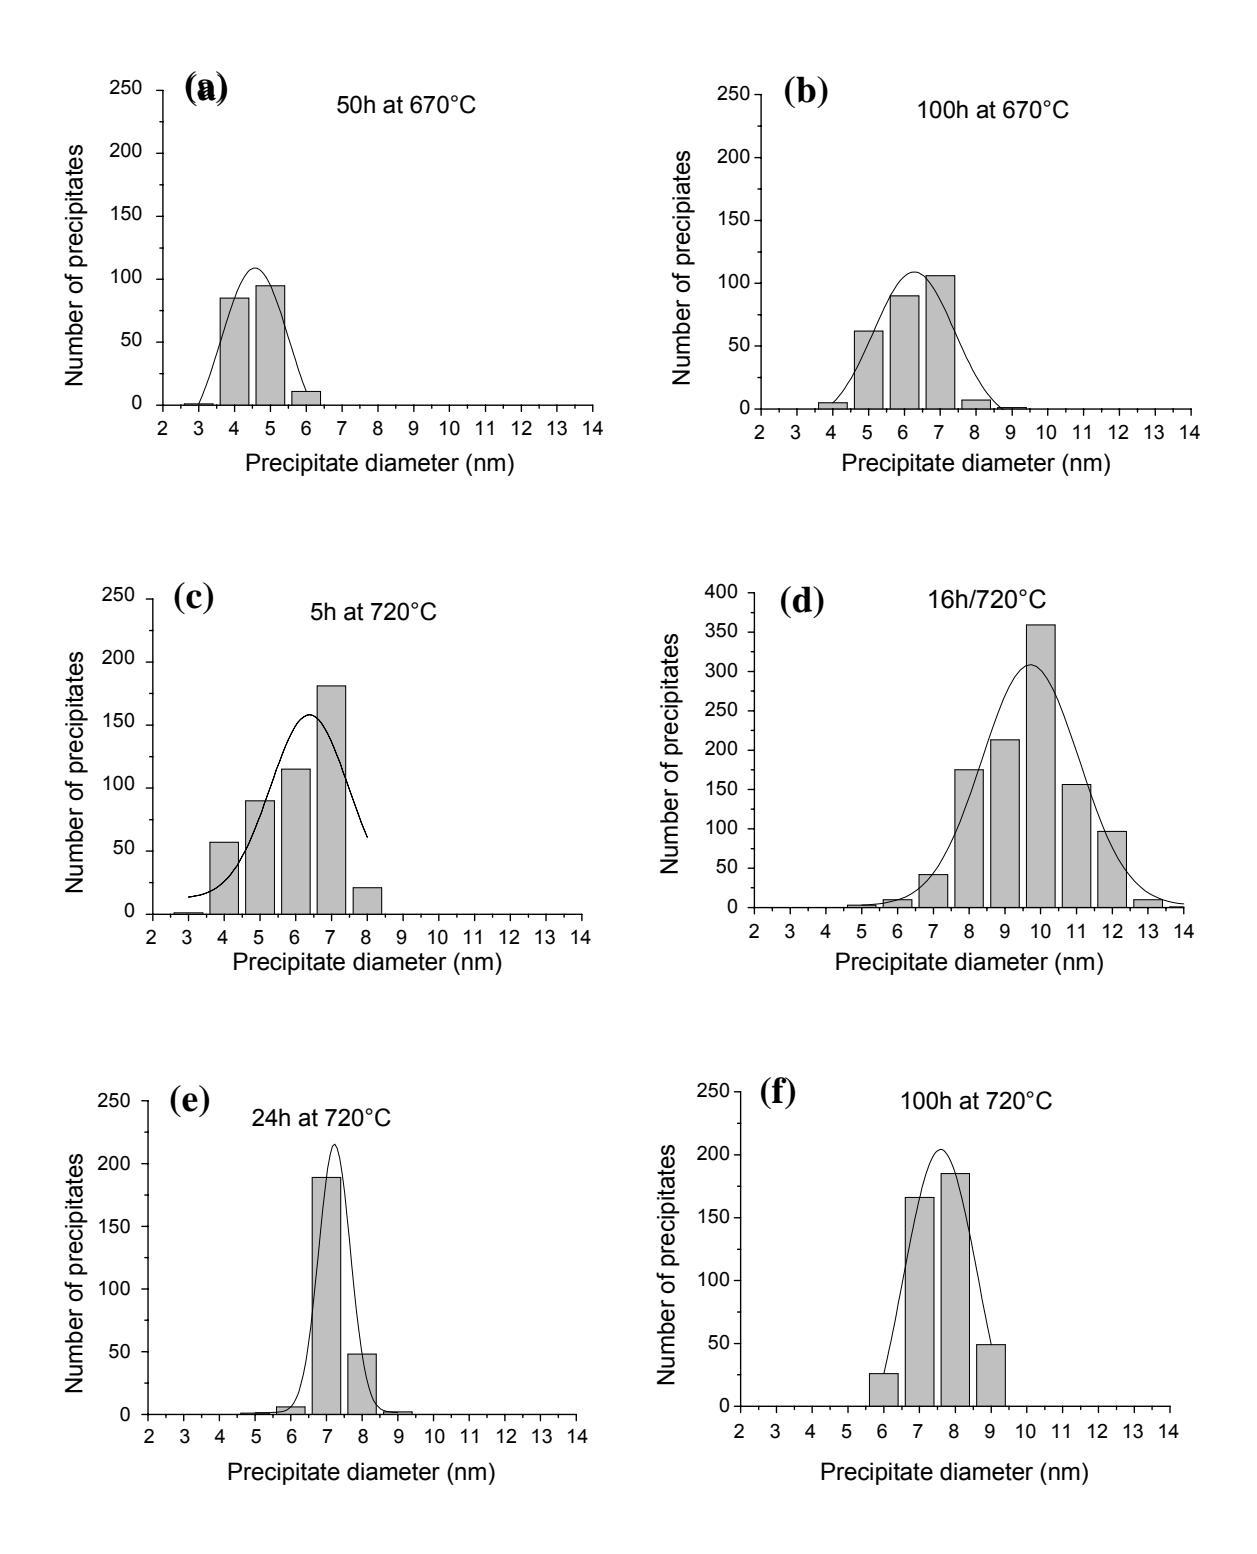
Figure 2

Fig. 2. γ ' precipitate size distribution in alloy A-286 aged for (a) 50h and (b) 100h at 670°C and for (c) 5h, (d) 16h, (e) 24h and (f) 100h at 720°C.

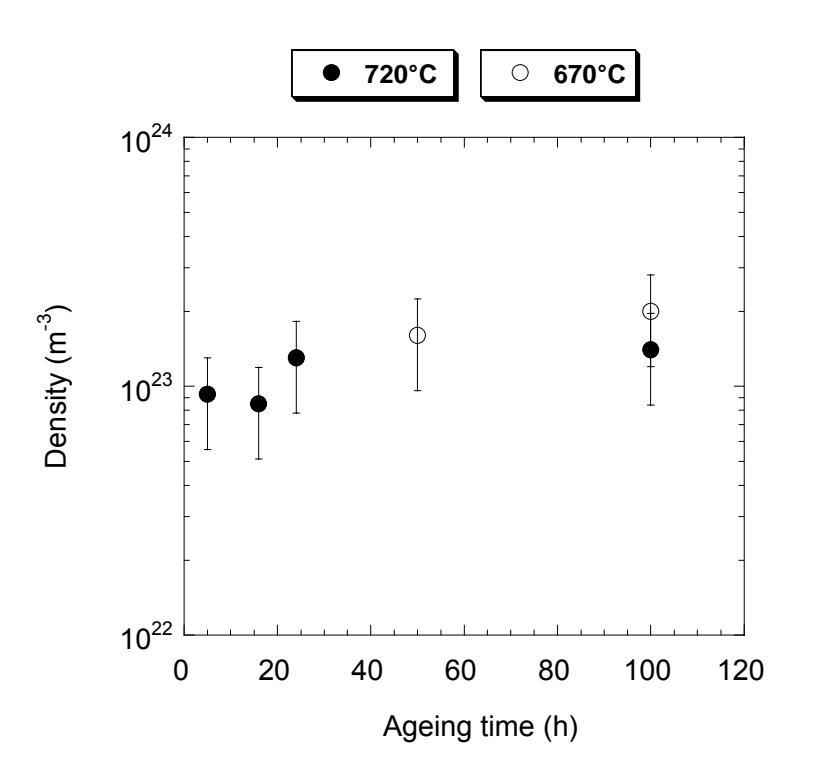
Figure 3

Fig. 3. γ ' density evolution as a function of ageing time at 670°C and 720°C.

Densities are ranging from 8.5×10^{22} m⁻³ to 2×10^{23} m⁻³. Density seems to saturate around 10^{23} m⁻³ to 2×10^{23} m⁻³ for ageing time at both 670°C and 720°C.

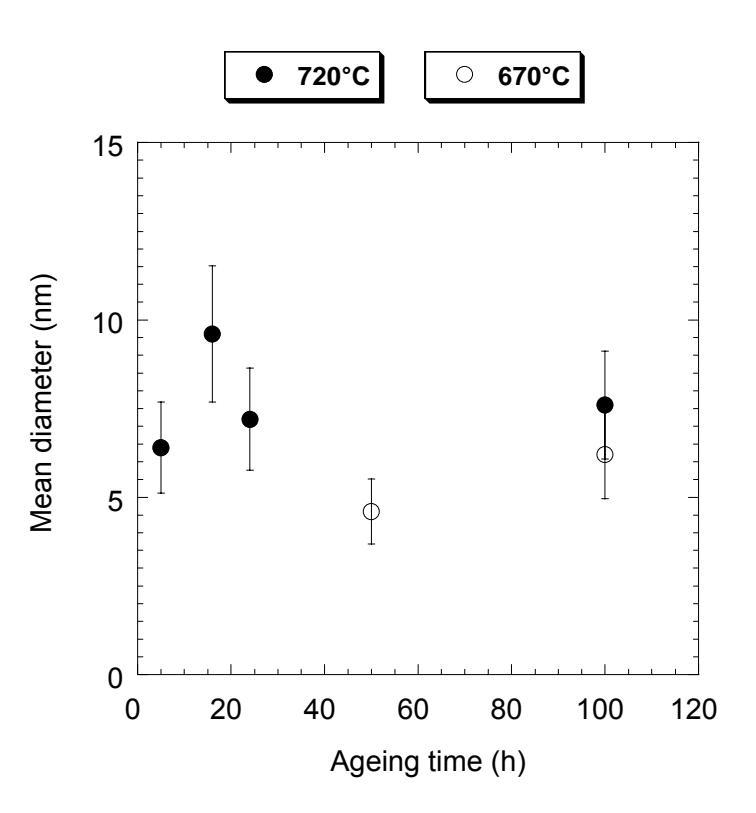
Figure 4

Fig. 4. γ ' mean diameter evolution as a function of ageing time at 670°C and 720°C.

Mean diameters are ranging from 4.6 to 9.6 nm. The mean diameter is increasing with short ageing time at 720°C, reaches a maximum at 16h, then decrease for 24h and seems to saturate for ageing time up to 100h. In contrast, mean diameter is still increasing with ageing time up to 100h at 670°C. The mean diameter measured in this study after ageing at 720°C for 5h is consistent with the value reported by Thompson [6] for a slightly higher ageing duration at the same temperature. The mean diameter measured in this study after ageing at 720°C for 16h is also in excellent agreement with the values reported by Thompson [6] and De Cicco [7] for the same ageing conditions.

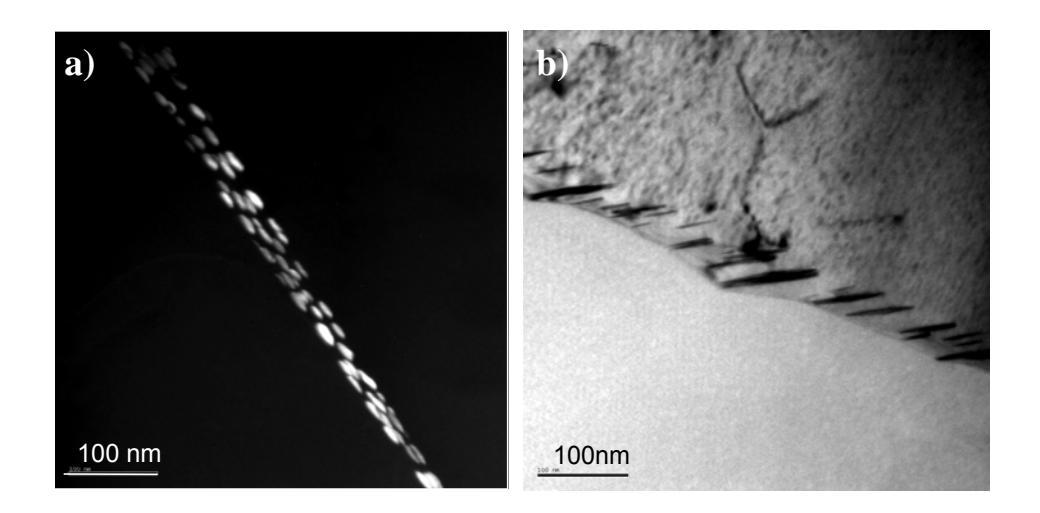
Figure 5

Fig. 5. TEM a) dark field micrograph of grain boundary discs η phase in A-286 alloy aged 5h at 720°C and b) bright field micrograph of grain boundary η phase platelets in A-286 aged 16h at 720°C.

The results of η phase TEM observations after ageing for 24, 50 and 100h at 670°C, and 5, 16, 24 and 100h at 720°C are summarized in Table 3. About 100 grain boundaries in 2 different TEM foils were observed for each ageing condition. As illustrated in Figure 5, η

phase in the form of discs or platelets were found to decorate grain boundaries. The fraction of grain boundaries decorated by η phase is displayed in Table 3 making a distinction between grain boundaries with disc η phase and grain boundaries with platelets η phase. In good agreement with results from Brooks et al. [8], grain boundary η phase precipitates were systematically observed for ageing heat treatment at 720°C even for short ageing period. In contrast, no grain boundary η phase precipitates were observed for ageing heat treatment at 670°C except after 100h ageing.

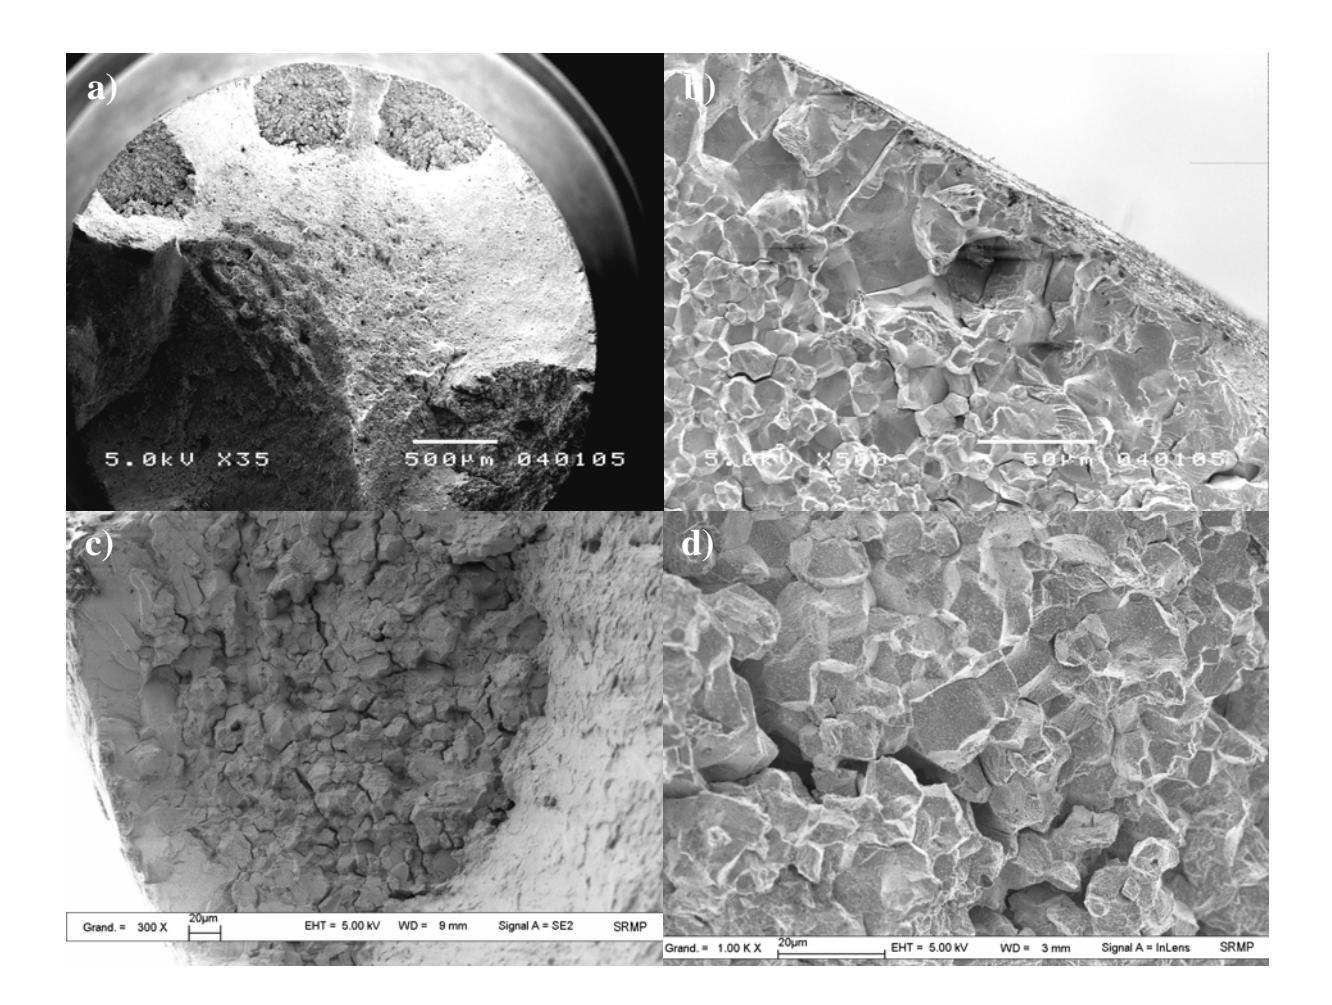
Figure 6

Fig. 6. SEM micrographs of the fracture surfaces of specimens aged a)-b) 50h at 670°C and SCC tested at 360°C, (c) 100h at 720°C and SCC tested at 360°C and (d) 50h at 670°C and SCC tested at 320°C showing TG initiation and IG propagation.

percentage of "brittle" cracking on fracture surface, total crack length, and the ratio of total crack length to failure strain are tabulated for each specimen. SEM micrographs of the fracture surfaces of specimens aged 50h at 670°C and 100h at 720°C and strained in PWR primary water at 320°C and 360°C are displayed in Figure 6.

The specimen aged at 670°C for 24h and strained at 320°C in simulated PWR primary water exhibited a fully ductile failure mode. It exhibited the largest strain to failure (26%) and did not display any cracks on its side-surface. All the other tested specimens were susceptible to SCC. In all cases, cracks initiated and propagated for a few tens of µm in a transgranular (TG) mode, and then propagated in an intergranular (IG) mode. The possible influence of the cold worked layer resulting from mechanical surface polishing on the TG initiation mode was investigated by means of a specific CERT test in the same conditions on a specimen aged at 720°C for 16h but that was electropolished before testing. Initiation and first few tens of µm of propagation remained transgranular suggesting that cold worked layer resulting from mechanical surface polishing is not responsible for TG initiation.

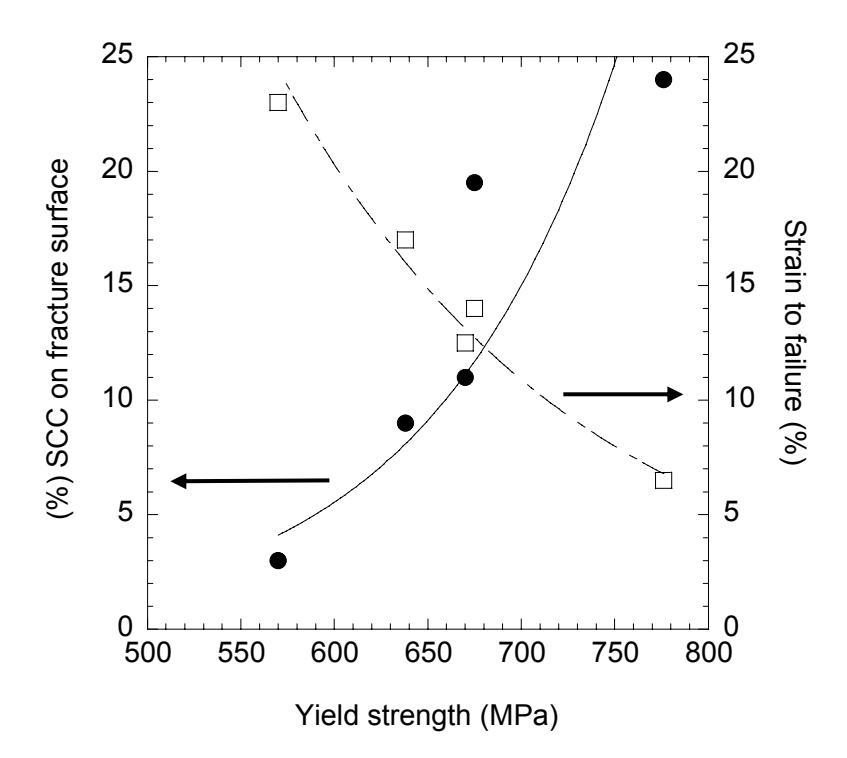
Figure 7

Fig. 7. Evolution of the percentage of brittle cracking on fracture surface and strain to failure as a function of yield strength in alloy A-286 strained at 1.5×10^{-7} s⁻¹ in PWR primary water at 360°C.

Ageing conditions were also found to have a strong impact, via the yield stress, on A-286 SCC susceptibility in simulated PWR primary water. This effect of the yield strength on SCC is illustrated in Figures 7 and 8. Clearly, an increase in the yield strength results in a significant increase in the susceptibility of the material to SCC. In contrast, grain boundary η phase was not found to play a significant role on A-286 SCC.

The evolution of the percentage of brittle cracking on the fracture surface is plotted together the evolution of strain to failure as a function of yield strength in Figure 7. Increasing the yield strength leads to a significant increase in the percentage of brittle cracking on the fracture surface and a concomitant decrease in the strain to failure. The evolution of the ratio of the total crack length over the strain to failure as a function of yield strength is plotted in Figure 8. Again, increasing the yield strength leads to a significant increase in the ratio of the total crack length over the strain to failure. These results clearly demonstrate the important role of the yield strength in the SCC behaviour of A-286 in simulated PWR primary water. This result is in good agreement with the strong influence of yield strength on crack growth rate of stainless steels reported by Andresen et al. [19] in high purity water with 95 and 1580 ppb of hydrogen at stress intensity factor around 30 MPa \sqrt{m} .

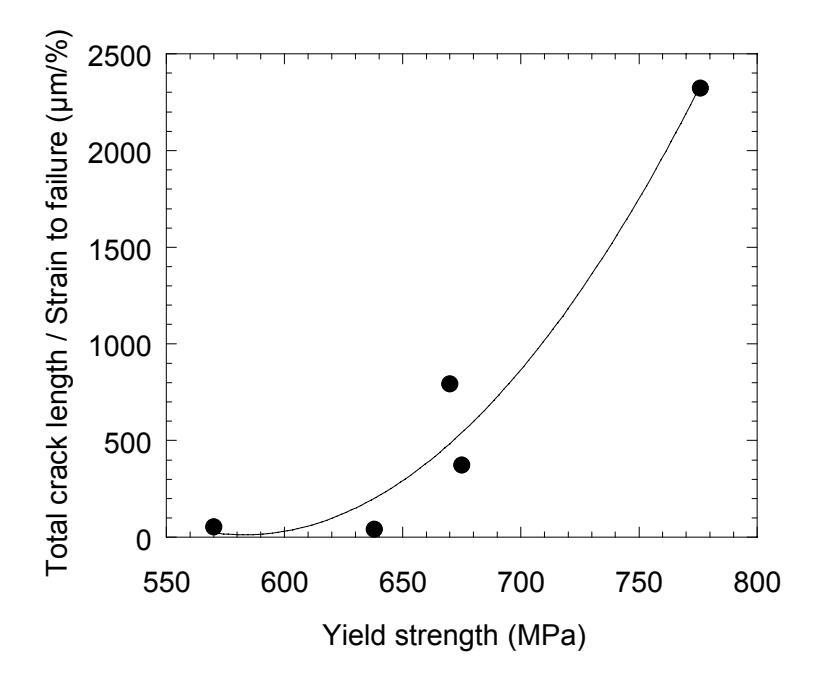
Figure 8

Fig. 8. Evolution of the ratio of total crack length on side surface over strain to failure as a function of yield strength in alloy A-286 strained at 1.5×10^{-7} s⁻¹ in PWR primary water at 360°C.
