Evidence of damage in carbon fibre composite tiles joined to a metallic heat sink under high heat flux fatigue

R Mitteau, P Chappuis, L Moncel, J Schlosser. Evidence of damage in carbon fibre composite tiles joined to a metallic heat sink under high heat flux fatigue. Journal of Nuclear Materials, 1998, 258-263, pp.972 - 977. 10.1016/s0022-3115(98)00314-6. cea-03134221

R. Mitteau, P. Chappuis, L. Moncel and J. Schlosser Association Euratom - CEA sur la Fusion Contrôlée. Centre d'Etude de Cadarache F-13108 Saint Paul Lez Durance CEDEX

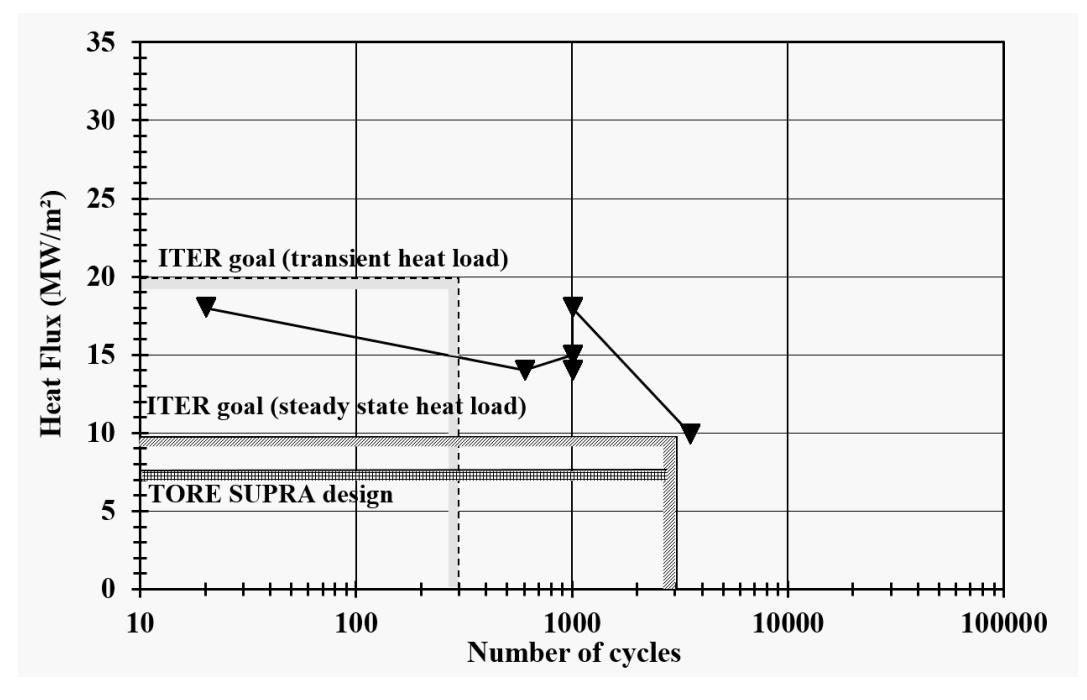
Figure 1 : results of high heat flux tests of CFC armour to Cu heat sink joints.

With NS31 from SEP and Dunlop concept 2, SMS 2B and 3B were cycled during 1000 cycles at 18 MW/m², showing an evolution of the surface temperature, and intense erosion but no tile detachment. Those tests compare well with the literature (figure 1, see also [10]).

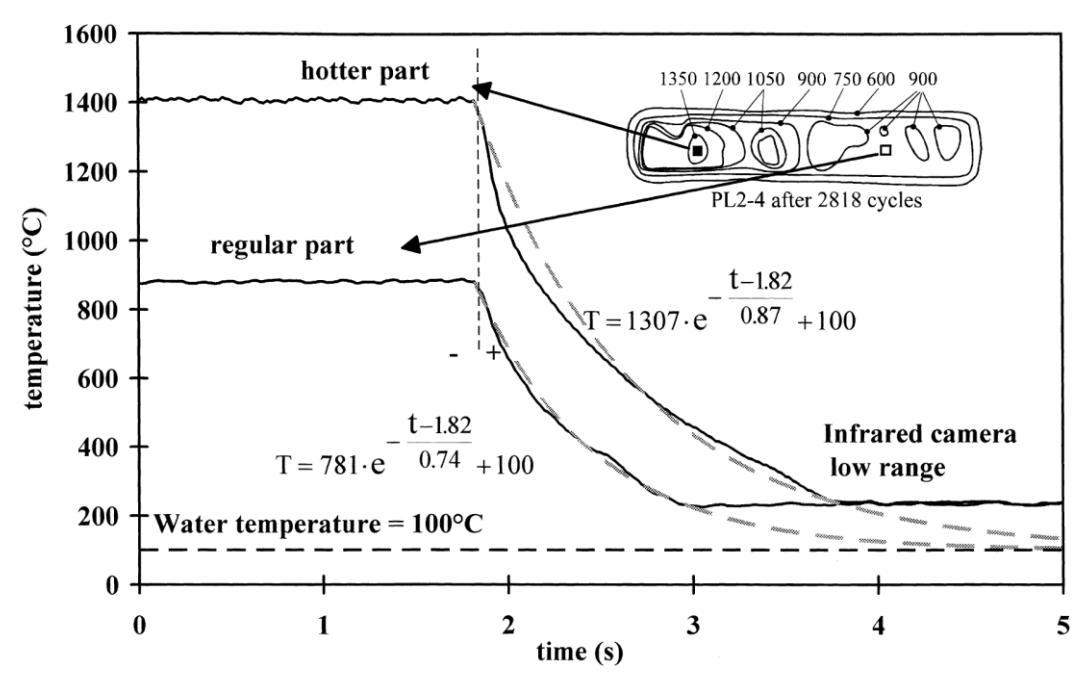
Figure 2 : time evolution of the surface temperature after stopping the incident power after 2818 cycles on PL2-4.

The infrared view shows regular and hotter parts (figure 2). The hotter parts can be attributed to numerous effects such as deteriorated bonds, lower tile conductivity, local differences in the surface emissivity and non evenness of the beam. After the cycling, surface temperature of both parts versus time are extracted by averaging on 10*10 pixels zones (figure 2).

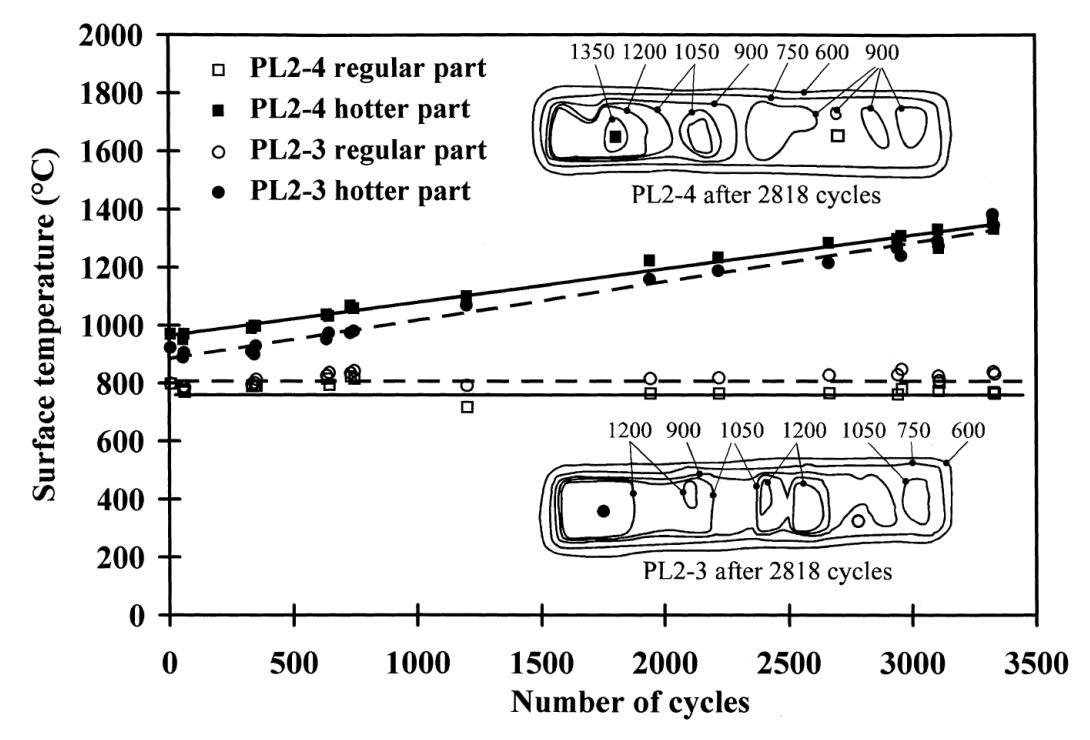
Figure 3 : Evolution of the surface temperature versus number of cycles for TPL prototype elements.

The temperatures of the regular tiles of both fingers are almost constant, around 800°C. Hotter parts on both fingers show a steady increase of the temperature with the cycling, from 950°C to 1350°C. The temperature rise of the hot tiles cannot be attributed to lower tile conductivity or beam profile, which are constant during the test. For this reason, this temperature rise is linked to progressive damage at the interface, either as the progression of a crack or to progressive micro-cracking.

The temperature variation on neighbouring points gives the uncertainty of the method. For 0, 500, 1000 and 3000 cycles where at least two temperatures for close number of cycles are known, the fluctuations can be evaluated to 30 °C. Therefore, the temperature rise of ~ 400°C of the hotter parts of PL2-3 and PL2-4 is significant.

The surface temperature is calculated on the plateau and the time constant during the cooling of the structure. The emissivity of the surface was set to 0.85. Calibration shots before and after the tests showed that the correction coefficient (transmission of the windows, tile emissivity, etc...) didn't noticeably changed during tests. Only the cycles with a heat flux higher than 10 MW/m² (ranging from 10.6 to 11.5 MW/m²) were taken into account in this study. The surface temperatures were normalised to 10 MW/m² according to finite element calculations to allow comparison. The normalised surface temperature of regular and hotter parts of PL2-3 and PL2-4 are given versus the number of cycles (figure 3).

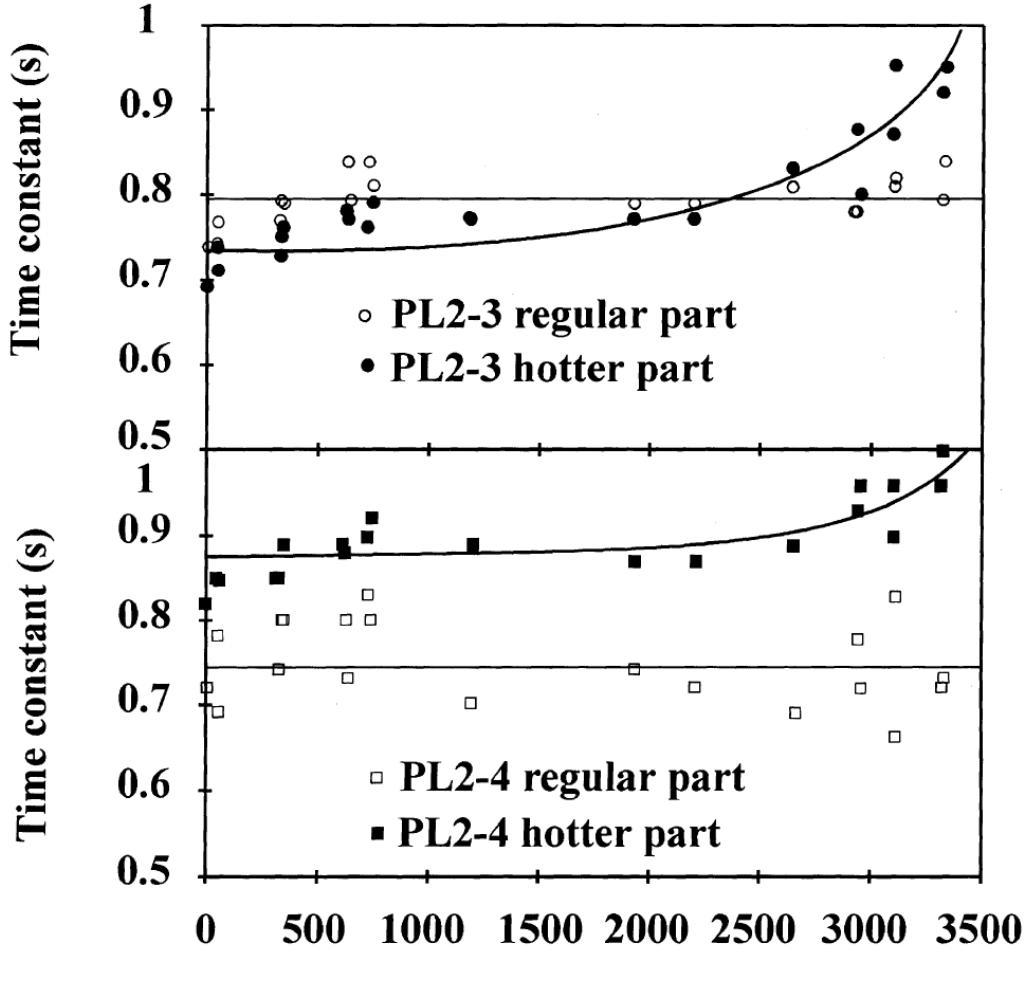
Number of cycles

The interface damage is also characterized by a longer time response of the tiles. The time constants of the tiles are calculated during the transients. They are given figure 4 for hotter and regular parts.

Rather big fluctuations are observed, around 0.07 second while the time constant is around 0.7 second. However, different evolutions between the spots are still significant. The time constants of the regular zones are approximately constant, while those of the hotter parts always increase with the number of cycles. The hotter tiles always finish with longer time constants than the regular tiles. For PL2-3, the increase is around 23 % of the initial value, and for PL2-4 around 12%. The time constants, although less precise than the surface temperature measurements, confirm the degradation of the heat transfer capability of the structure. However,

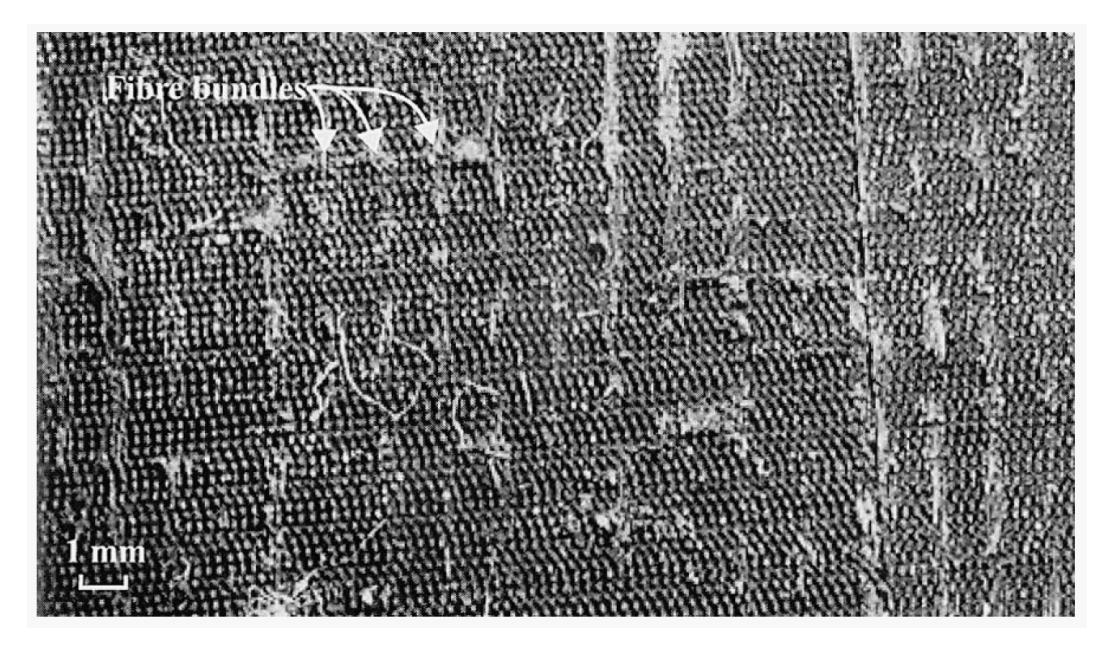
Figure 5 : Macrography of the heat sink after tests at 18 MW/m² (the defective tile was removed in laboratory)

On broken tiles removed from the mock-up after test at 18 MW/m² (figure 5), the copper is mainly black, with many cones visible. The cones are made out of copper that has solidified in the laser - machined holes in the CFCduring the AMC process. Fibre bundles often remain attached to the copper. Very few copper is visible on the fractured area of the tile. These elements indicate that such cracks propagate mainly in the CFC or just beneath. Moreover, some black dust falls from the tile, suggesting a disintegration of the CFC material in the vicinity of the bond.

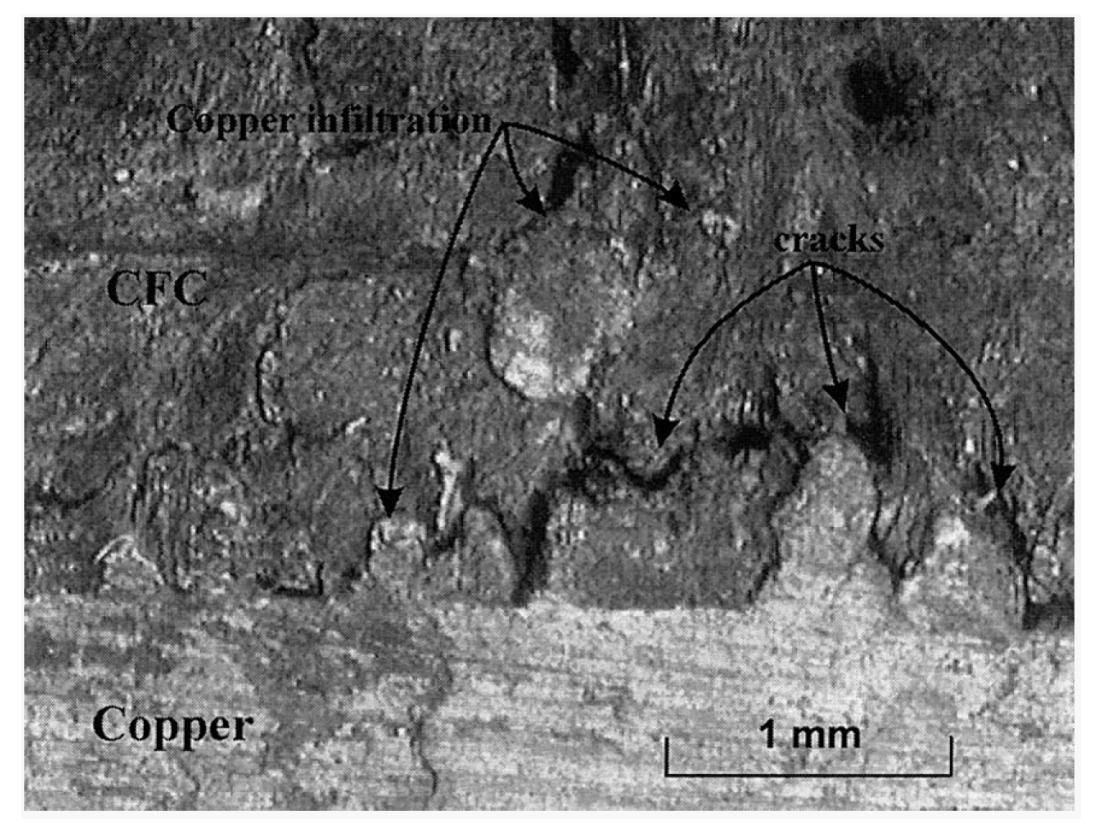
In the CFC (figure 6), cracks are observed above the cones, on top of the cones or between cones. On the edges, cracks start in the CFC in front of the cones. Inside the tiles, the cracks begin at the interface to copper or inside the CFC. Cracks can be observed at the interface between the copper and the CFC. More often such cracks are hybrid, that is they propagate indifferently in the CFC or at the interface of the CFC to copper. In these areas, the cones recede from the CFC, leaving a crack

that follows the cones or sometimes goes through the CFC between two cones. On some very damaged tiles, continuous cracks that go straight through the cone and the CFC could be observed.

Figure 6 : Macrography of cracks in the CFC and at the interface CFC-copper.

Internal voids in the CFC near the interface are sometime filled with copper or carbides. Such inclusions in the CFC are to expand and shrink during thermal cycling. As the CFC has a lower thermal expansion coefficient, it will undergo cyclic compression. This suggests a damage mechanism which could explain the disintegration of the CFC above the bond. In some cases, such inclusions were observed above cracks, showing that the crack was subsequent to the manufacture of the AMC bond.

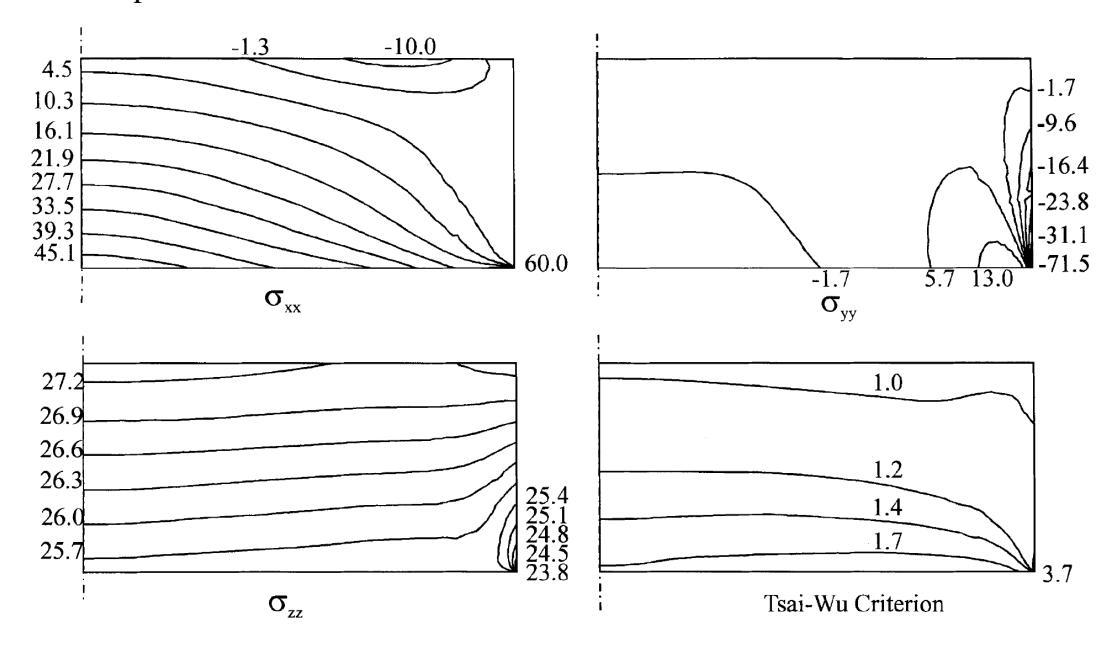
Finite element calculations are done to evaluate the stresses in the structure of a finger. A new non-linear model was specially developed and implemented for the CFC [11]. Stresses in a CFC tile of the LPT for 10 MW/m² and a computation of the Tsai-Wu criterion are shown figure 7.

In most of the tile, the criterion exceeds 1, showing the CFC material should break. Even if the criterion may be overestimated, the level of stress explains the observed cracks. It explains also the kind of disintegration of the CFC observed above the bond. However, the cracks also allow the CFC to accommodate somehow the imposed deformation, which could explain that damaged tiles still hold to the heat sink. These results also point out the limitation of the Tsai-Wu criterion, which isn't suitable for this configuration. A new criterion is currently under development at Tore Supra to characterize the stress level.

Figure 7 : Stresses (MPa) in a CFC tile under 10 MW/m² (2D generalised plain strain calculation)
