Corrosion issues in pressurized water reactors : achievements and challenges

CORROSION ISSUES IN PRESSURIZED WATER REACTORS: ACHIEVEMENTS & CHALLENGES

NUPP 2017

Damien Féron

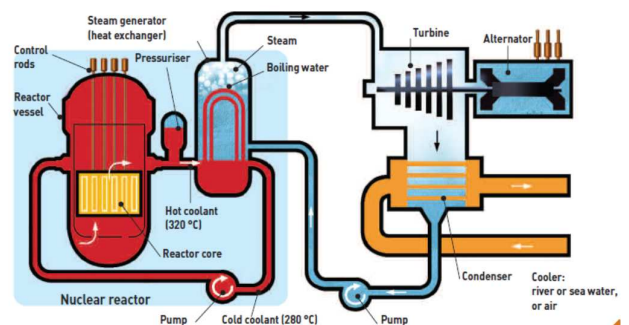
Corrosion issues (Pressurized Water Reactor – PWR)

- (Fuel cladding)
- Primary circuit
- Steam generator tubing
- Secondary circuits

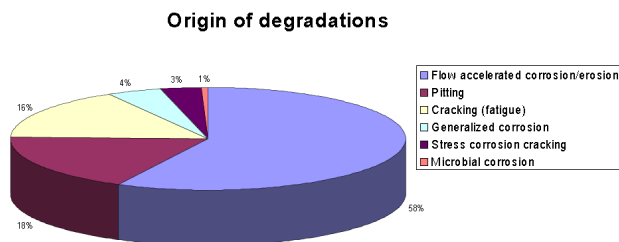
Events of Interest for Safety of French PWRs (IRSN, 2010)

Most degradation is caused by Flow Accelerated Corrosion (FAC). Stress Corrosion Cracking (SCC) is highly generic and has a large impact on safety because it appears in the second containment barrier.

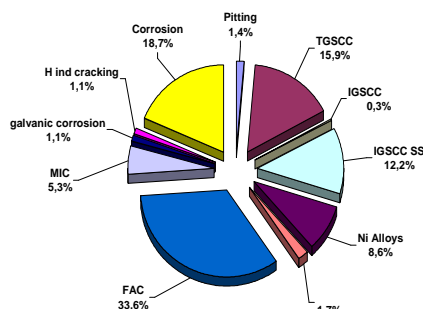
Main Degradation Mechanisms leading to NPPs shutdown (R. Killian, 1995-2005)

- Two main dominant mechanisms:
- Flow accelerated corrosion (FAC) and
 - Stress Corrosion Cracking (SCC)
 - Pipes and internals
 - SG tubes

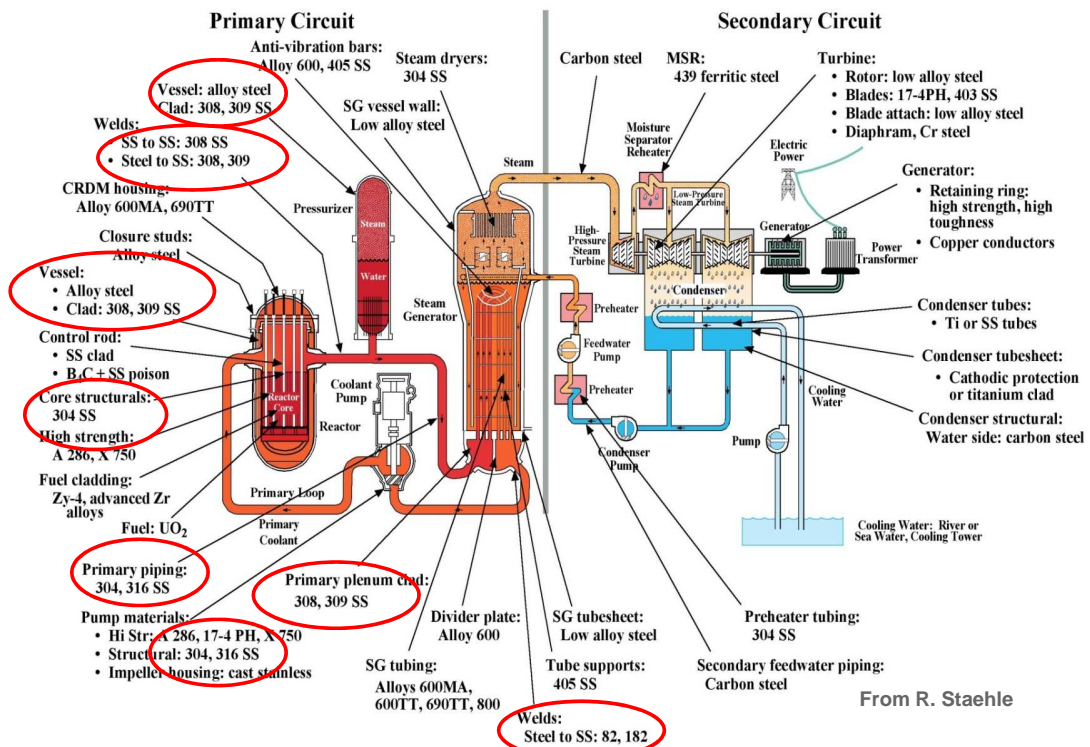
PWR Materials

Stainless steels are widely used in PWR primary circuits

Practical experience shows that de-oxygenated, hydrogenated PWR primary water does not cause SCC. The reason is clearly related to the dissolved hydrogen in PWR primary circuits, which ensures that any radiolytic decomposition products of water are efficiently scavenged (unlike in BWRs on Normal Water Chemistry).

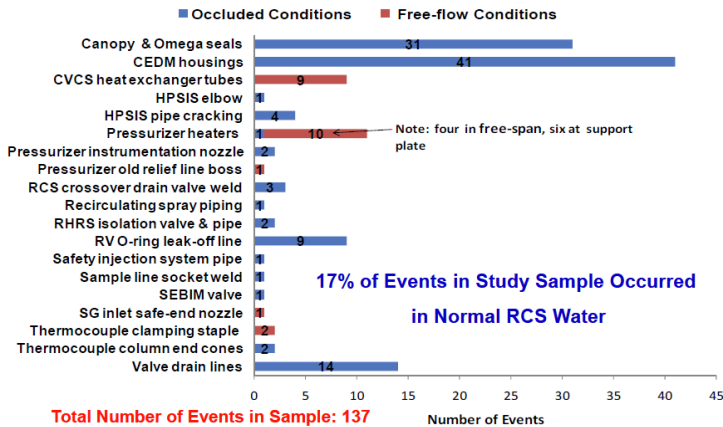
Stress corrosion cracking has been experienced on unirradiated stainless steels :

- Low number of events
- 83% of the events occurred in low flow or stagnant ("occluded") zones.
- 17% occurred in nominally free-flow conditions and have been associated with cold work and excessive hardness (>300 HV)

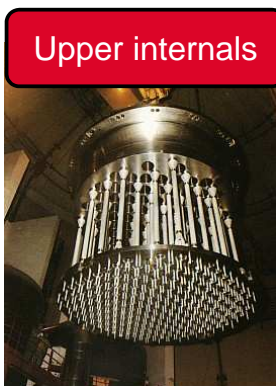
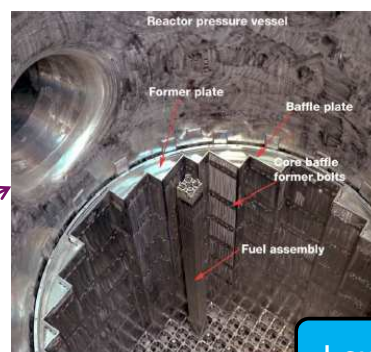
Lower internals

Objectives: to understand, to anticipate and to predict the degradation of PWR internals.

- Preventive maintenance for the replaceable components
- Extension of the operation time of the current PWRs (up to 60 years)
- Understanding the degradation phenomena
- Improvement for new PWRs (materials & design)

➤ **Irradiated Assisted Stress Corrosion Cracking**

- ❑ Cracking linked to the evolutions of the environment (radiolysis) and the materials (damages) due to irradiation
- ❑ Major influence of the dose rate

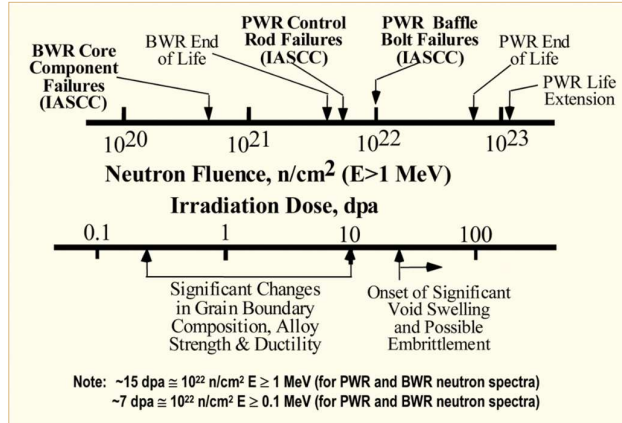
PWR primary water: 155 bar, 300-340°C, 30ccH₂/kgH₂O, 2 ppm Li, 1000ppm B

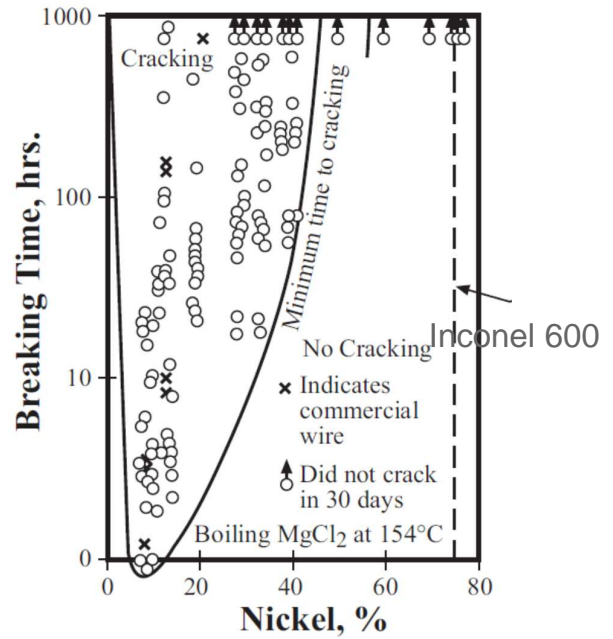
Time to failure of laboratory alloys (1963)

By 1957, H. Copson at INCO had demonstrated that the Stress corrosion cracking of Fe-Cr-Ni alloys, when exposed to boiling $MgCl_2$, would stop above about 40% Ni.

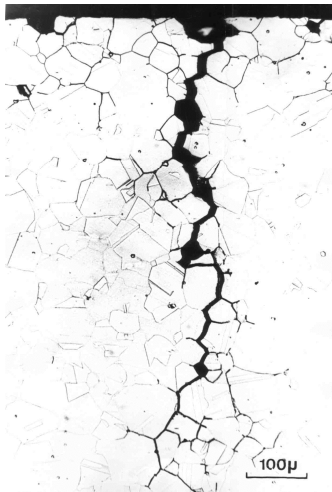
Intergranular SCC of Alloy 600 (350°C, pure deoxygenated water) – 3 months

Intergranular oxidation on Alloy 600 (350°C, pure deoxygenated water, 3 months)

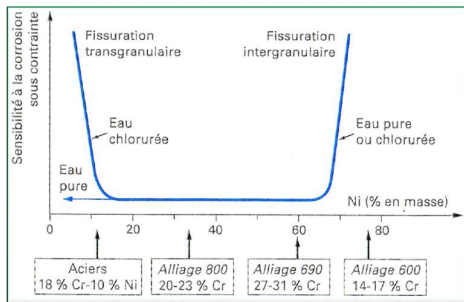
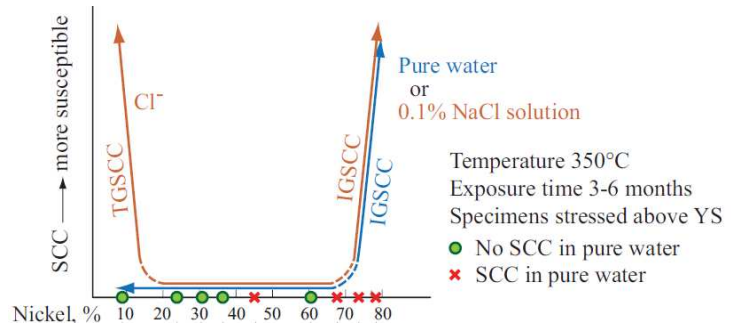
SCC susceptibility as function of the nickel content (Coriou's work – summary 1967)

Work done with a series of laboratory alloys Fe-18%Cr-Ni with various Ni content
Pure water and solution with 0.1% NaCl / 350°C / 6 months / 1.2 and 1.7 $E_{0.2}$

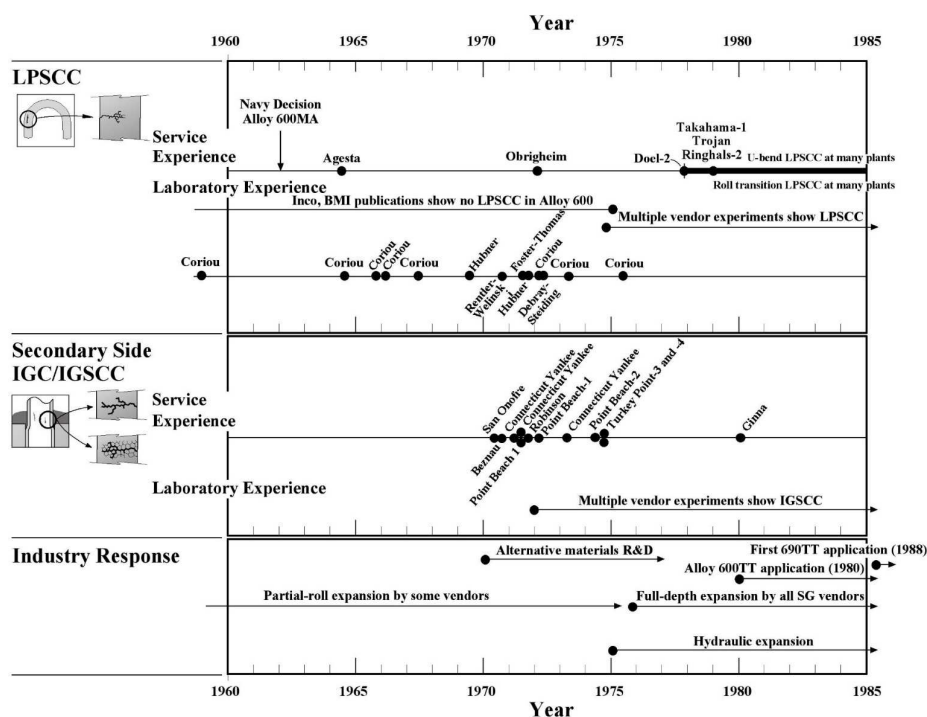
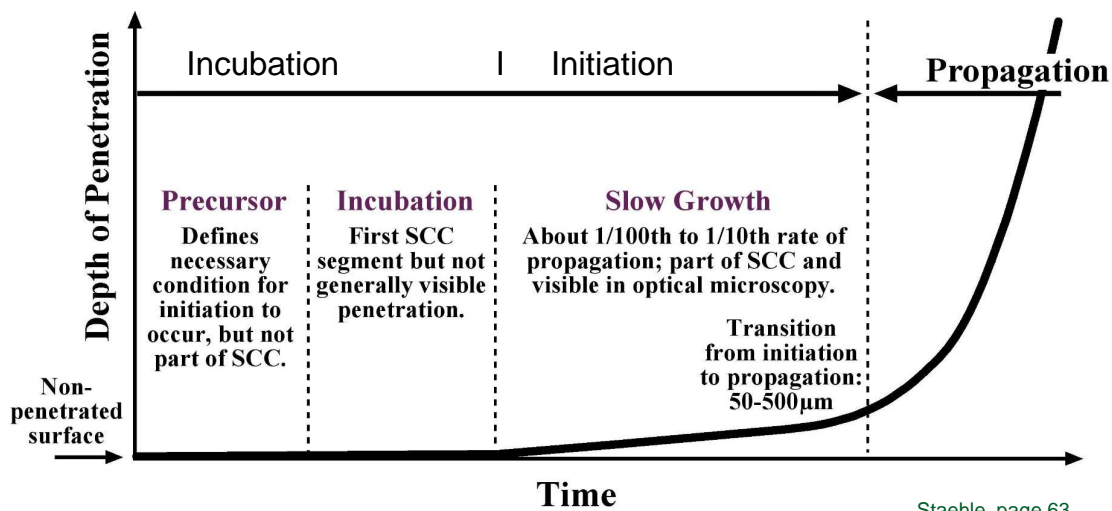
Incubation: Passive film formation and evolution

Initiation: Film rupture & Intergranular oxidation

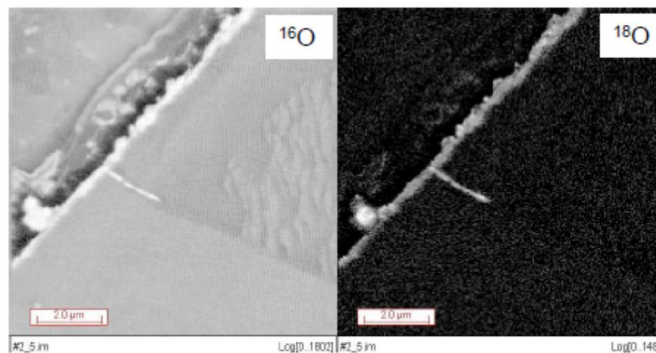
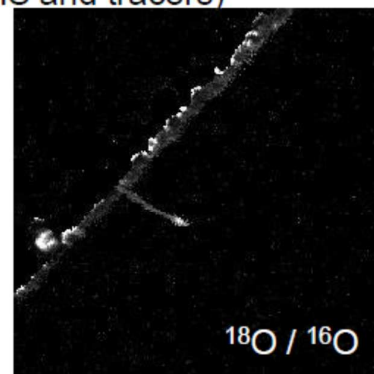
Oxygen transport in the crack tip (nano-SIMS and tracers)

Solution-annealed material (no intergranular carbide)

1340 hr in nominal primary water + primary water containing tracers (deuterium and ^{18}O) for 67 hr

-> ^{18}O is located at the tip of the IG penetration and in the outer part of the surface oxide layer, where the oxide growth occurs.

-> ^{18}O diffusion occurs during the second stage of the test in 67 hr

-> estimate of the oxygen transport coefficient : $> 10^{-13} \text{ cm}^2 \cdot \text{s}^{-1}$

Oxygen transport up to the crack tip is not a rate limiting step.

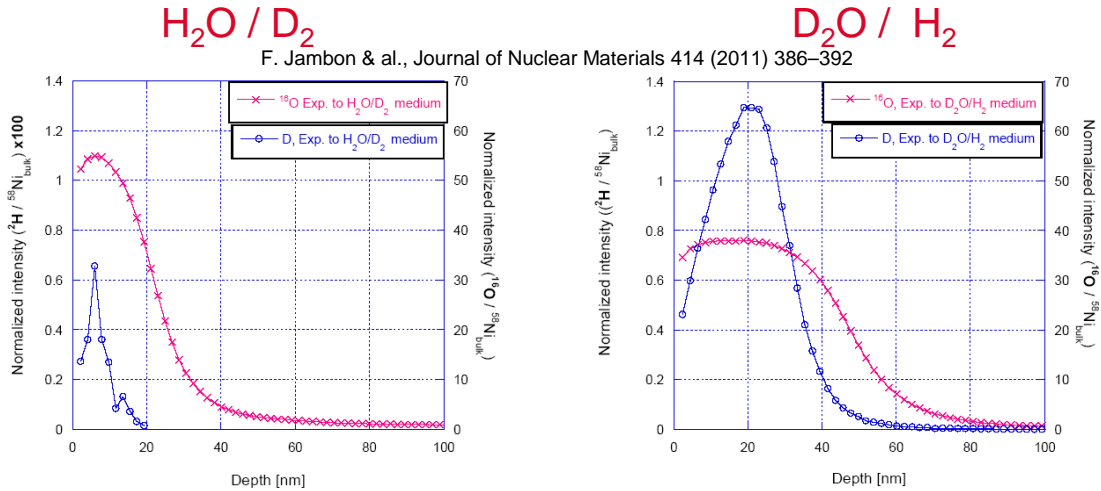
- Two series of experiments were done, in which the specimens are exposed to:
- a PWR primary medium in which the water is replaced by deuterated water D₂O (D content 97.90%) , pressurized by classical hydrogen gas (H₂)
 - a classical primary medium (with H₂O), pressurized by deuterium gas (D₂) (D content 99.05%).

Hydrogen absorption is associated with the cathodic reaction
 $(\text{H}_2\text{O} + \text{e}^- \rightarrow 1/2\text{H}_2 + \text{OH}^-)$

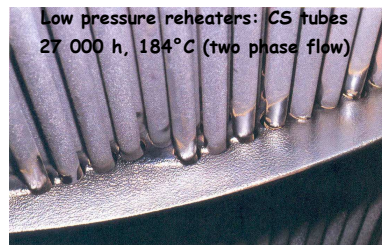
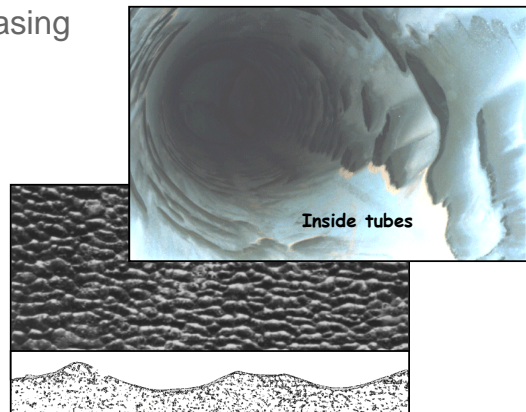
Electrochemical based phenomena accelerated by flow rate
(and not mechanically – erosion / abrasion)

- Metallic materials in contact with liquid water at high flow rates
- Carbon steels (CS) or low Alloyed Steels (LAS) covered with a protective layer magnetite / hematite (passive layer)
- Stationary conditions: $V_{\text{film formation}} = V_{\text{oxide dissolution}}$
- High flow rate
 - Oxide dissolution is faster
 - Oxide film thickness is decreasing
 - Corrosion rate is increasing

The flow accelerated corrosion rate decreases when pH increases (iron solubility decreases when pH increases)
Importance of the chemical agent (linked to the formation of complexes)

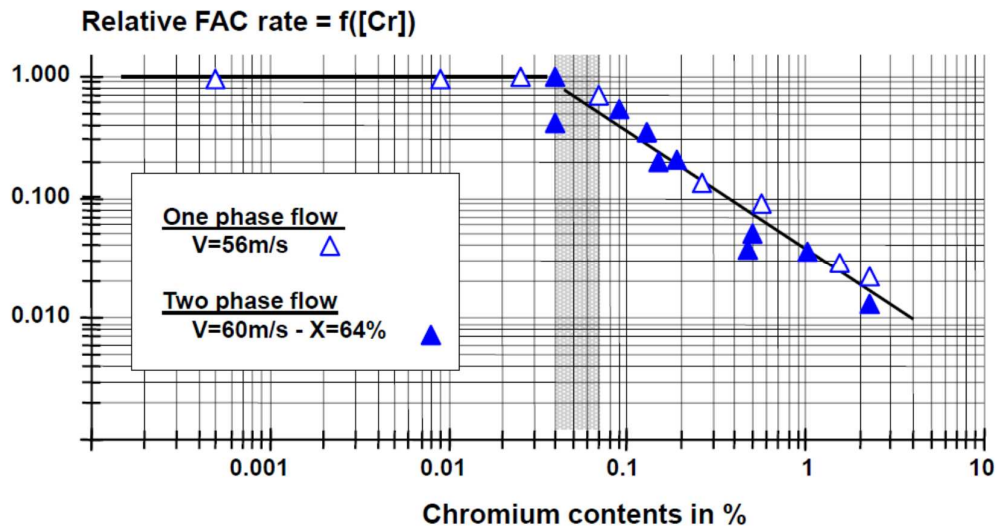
With only 0,5% of chromium in the steel, the FAC rates are decreased by a factor of 10 at least

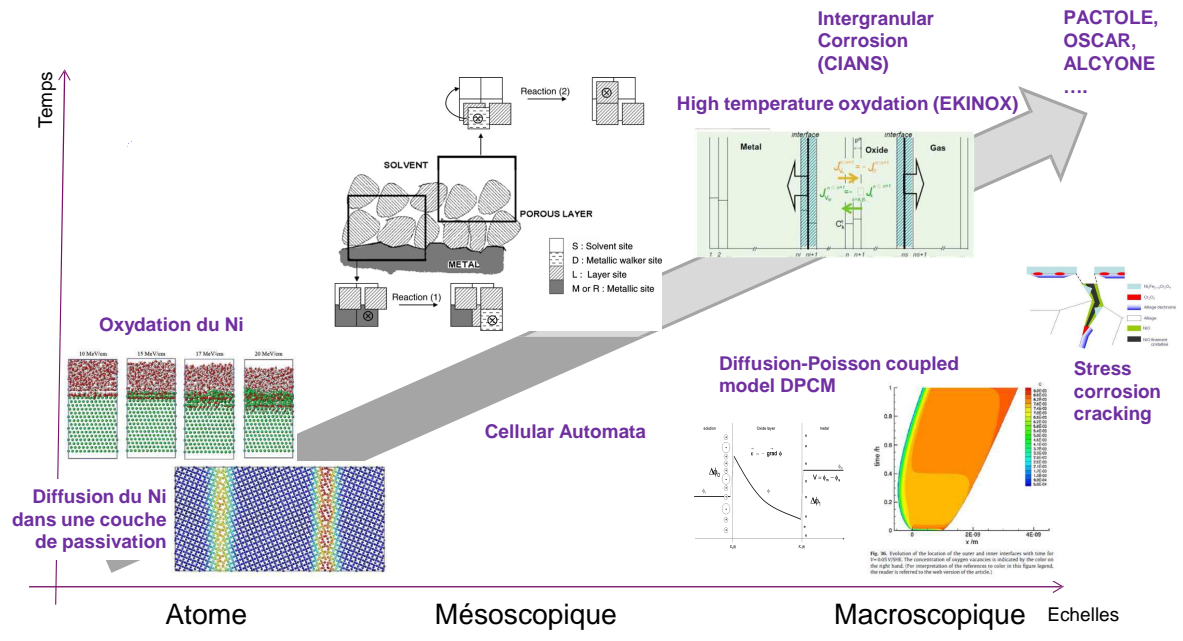
MULTISCALE MODELING

- ⇒ Needs to replace semi-empirical models by more phenomenological models
- ⇒ Multiscale modeling is then needed
- ⇒ Strategy for homogenization & harmonization

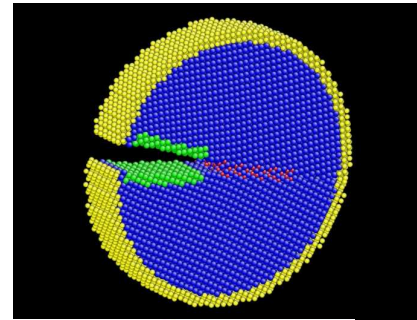
Brittle crack without dislocation nor amorphization

Dislocation

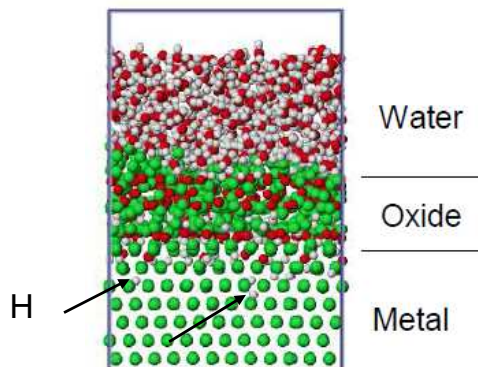
Molecular simulation of the oxidation by water of Ni (hydrogen in the metal from the cathodic reaction)

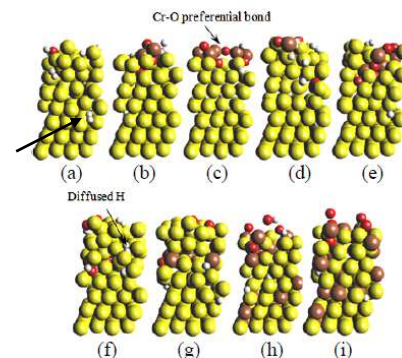
Same results on Cr
N.K. Das & T. Shoji, SNA-MC, Paris, November 2013

Atomistic simulation of oxidation & experimental observations in agreement
