Passive guided wave tomography for corrosion monitoring under varying environmental conditions

Guided Wave Tomography for Corrosion Monitoring under Varying Environmental Conditions

Tom DRUET¹, Axel THOMAS¹, Arnaud RECOQUILLAY¹, Yann GELEBART², Etienne MARTIN³ and Bastien CHAPUIS¹

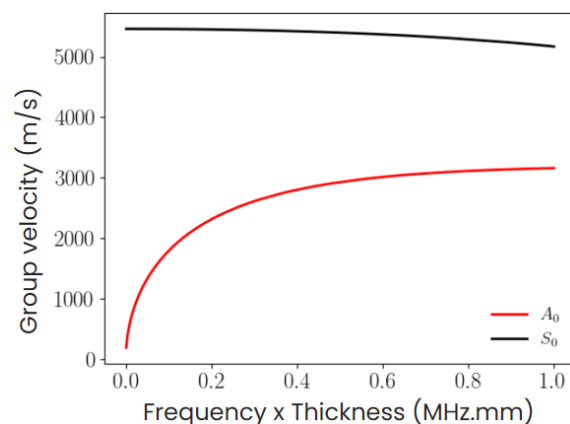
A 3mm thick aluminium plate is instrumented with 48 piezoelectric transducers that are glued on the plate (see Figure 2) using epoxy. The circle of transducers has a diameter of 30cm. For the emission, a Hann burst of 5 cycles at 50 kHz is used. For that specific frequency, the wavelength is about 23.1mm for A_0 mode which is used to perform guided wave tomography images presented later in this paper. The dispersion curves for the group velocity are also presented in Figure 2 for a temperature of 20°C. Note indeed that the dispersion curves of the guided modes will depend on the EOCs, especially the temperature, hence the sensitivity of guided wave methods.

Figure 2: Instrumented aluminium plate and dispersion curves of A_0 and S_0 modes.

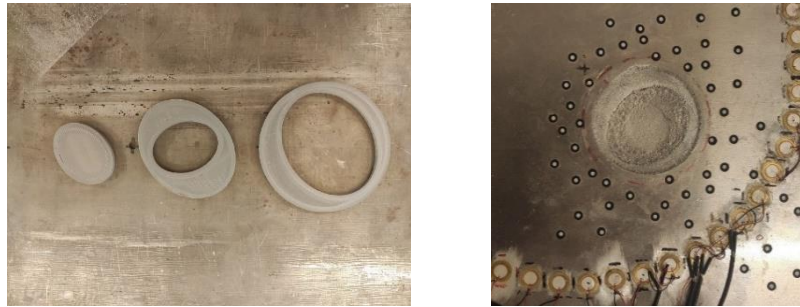
Regarding the defects, electrolysis is used to create erosion defects in the aluminium plate. Three different defects are created thanks to elliptic masks that allow to obtain more complex geometries than simply circles. These masks and the third defect are presented in Figure 3.

Figure 3: Elliptic masks and third defect created by electrolysis.

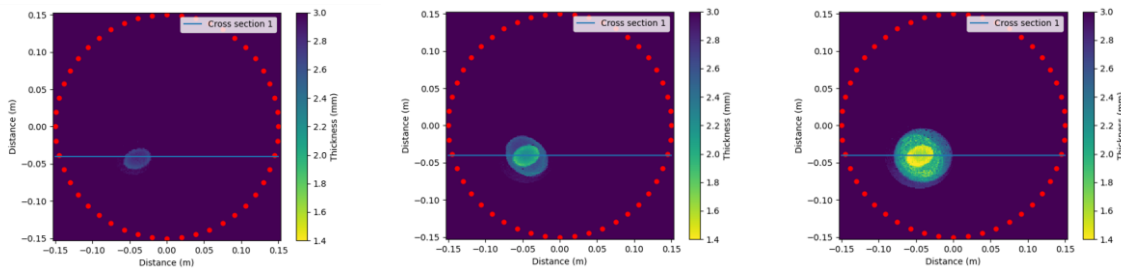
In order to get a reference of these three defects, a structured light 3D scanner (Go Scan system) is used. This allows to assess the quality of guided wave tomography images later in this paper. The three references corresponding to the three defects are presented in Figure 4.

Figure 4: The 3 reference maps measured by 3D scanner.

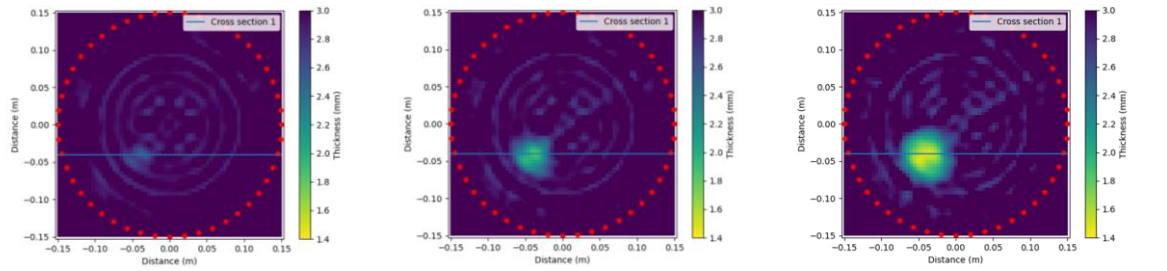
We first start with absolute tomography at ambient temperature, i.e. 20°C. This first study gives an idea of the behaviour of the algorithm when the temperature is the same for the acquired signals and the computation of the dispersion curves. The results are presented in Figure 5. The tomography images contain a constant background noise of about 0.2mm no matter how deep the defect is. By comparing these results to the Figure 4, the global size of the defects are well retrieved and the remaining thickness is well estimated for the three cases. In the next studies of this paper, cross sections are plotted to allow a better visual comparison. This cross section corresponds to the blue line of Figure 5.

Figure 5: The 3 absolute tomography results for the nominal temperature 20°C.

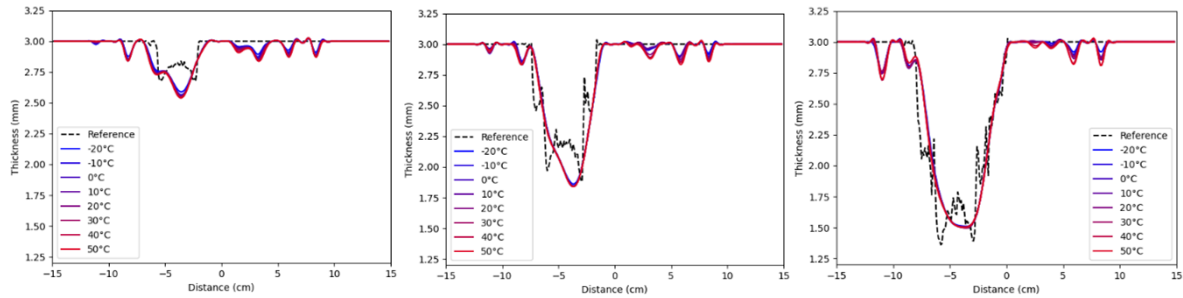
Now that we have checked that absolute tomography gives good results on the three defects, we present absolute tomography cross sections for all temperature levels, i.e. starting from -20°C and ending at 50°C with 10°C steps. Those results are presented in Figure 6. Once again we retrieve that the global shape and the minimal remaining thickness are well estimated. More interesting is that whatever the temperature, the defect reconstruction is of good quality. Absolute tomography seems to compensate intrinsically a part of the effects of temperature thanks to the use of the autocalibration method [10].

Figure 6: The 3 absolute tomography cross sections for all the temperature levels.

The same cross sections and the same temperature levels that for absolute tomography are studied. The baseline used to calibrate the relative tomography corresponds to the data measured at -20°C . The results are presented in Figure 8. By comparing the cross sections with the ones of Figure 6, we find that in relative tomography a bias in the reconstruction occurs when the baseline is measured at a different temperature from the current state. Thus, absolute tomography appears to be a very attractive method compared to relative tomography to assess the real remaining thickness of the structure in case of varying environmental conditions.
