Solar cell UV-induced degradation or module discoloration: between the devil and the deep-yellow sea

Nicolas Pinochet^{1,2}, Romain Couderc¹, Sandrine Therias²

¹University of Grenoble Alpes, CEA, LITEN, DTS, LSA, INES, F-38000, France

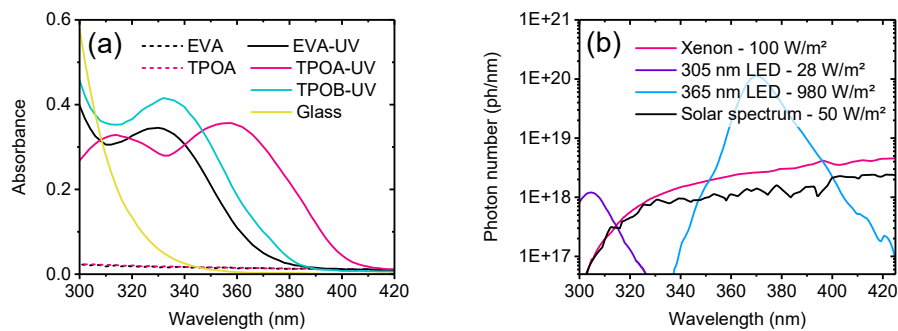
Ten modules have been aged in an Atlas Ci5000 weatherometer with an AM1.5G emission spectrum [19] for 4200 hours. Two modules with TPOB-UV were exposed under UV LEDs to study the impact of UV light alone over discoloration phenomena. One was aged under UVB LEDs (305 nm) for up to 1300 h and the other was tested under UVA LEDs (365 nm) for 1000 h. The selection of ageing temperature (83 °C) as well as xenon lamp UV irradiance was made according to IEC 62788-7-2 standard draft to provide a high acceleration of degradation kinetics [20]. Ageing tests parameters (UV chamber, lamp type, UV irradiance, sample temperature, atmosphere) corresponding to each module are presented in Table 1. Figure 1b shows the emission spectra of the different lamps that are used during the tests.

Figure 1: UV absorption spectra of the encapsulant materials (a) and UV emission spectra of the aging lamps (b)

A slight fluorescence can be noticed on both aged modules after 1000 and 1300 hours of accelerated aging test, respectively. Because of the lower intensity of fluorescence emission, the integration time we chose for imaging was five-fold higher than that of the previous study. It explains the brightness of the unaged sample that may be caused by the fluorescence emission of pristine additives. A sole UVA (*i.e.* 320 to 400 nm) exposure seems to be enough to cause fluorescence. Because of their massive UV absorption (Figure 1a), UV absorbers

Long irradiation time (1000 hours) under UVA LEDs (365 nm) seem to induce more fluorescence emission than 1300 hours of UVB LEDs (305 nm) irradiation while Figure 1 shows that UVA photons are less susceptible to be absorbed than their UVB counterparts. Furthermore, fluorescence is even higher after the aforementioned 4200 hours long ageing under a solar-like light. The UV photon dosage under UVB LEDs, UVA LEDs and xenon-arc lamp are 2.3×10^{22} , 1.8×10^{24} and 1.2×10^{23} ph.h.m⁻², respectively. While UVB irradiation may be more likely to degrade UV absorbers, the fact that UVA photons dosage is 2 decades higher may explain why fluorescence emission is brighter on Figure 8b compared to Figure 8c. According to Figure 1, the front glass strongly absorbs in the UVB range, which further reduce the amount of UVB photons that reach the encapsulant. The presence of UVB radiations in the xenon-arc lamp combined to a closer photon dosage may account for the more intense fluorescent emission of modules that were aged in Ci5000 test chamber. Failure of the reciprocity law (*i.e.* proportionality between degradation rate and UV light dosage) in that irradiance range could also lead to a higher fluorophore formation in the 4300 hours of ageing test under xenon-arc lamp.

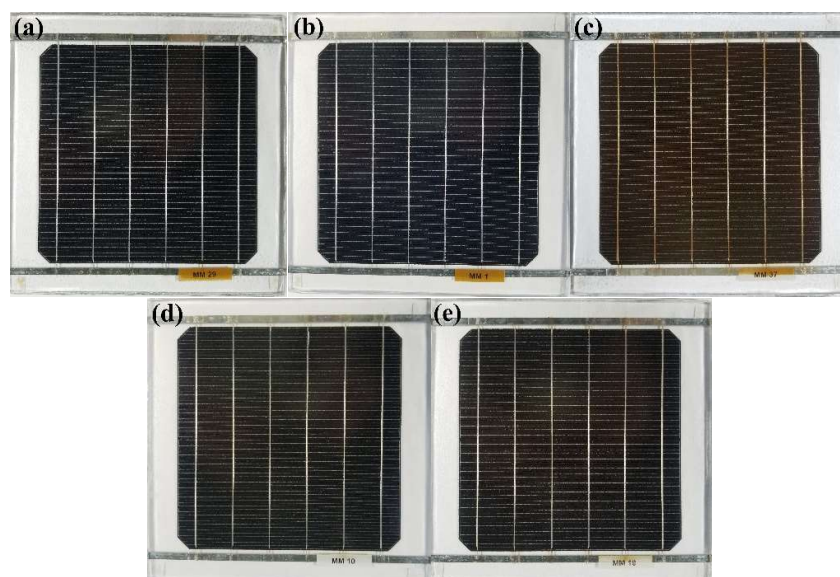
After 4200 hours of accelerated UV aging under a xenon arc lamp, some monocrystalline modules show yellowing with varying intensity as shown in Figure 2. In absence of polymeric backsheet, this phenomenon is attributed to encapsulant degradation. This is confirmed by a thorough visual inspection that enables a first yellowing mapping. The most affected is EVA-UV, which tends to a brown colouring (Figure 2c). TPOB-UV also exhibits minor discoloration (Figure 2e), followed by TPOA-UV of which yellowing is almost imperceptible to the naked eye (Figure 2d).

Figure 2: Comparison of monocrystalline modules with EVA (a), TPOA (b), EVA-UV (c), TPOA-UV (d) or TPOB-UV (e) encapsulant after 4200 hours long accelerated UV aging

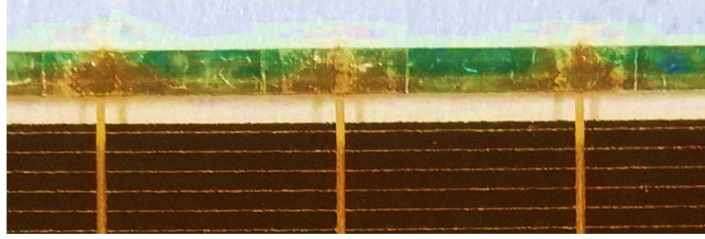
More precisely, we detected discoloration in the front encapsulant parts that cover the cell and a part of output ribbons (Figure 3), with the notable exceptions of cell edges and gaps between ribbons and cell.

Figure 3: Output ribbon of an aged EVA-UV module. The colours are oversaturated to highlight the discoloration. A part of the output ribbon is partially yellowed, especially near the tab ribbons soldering points.

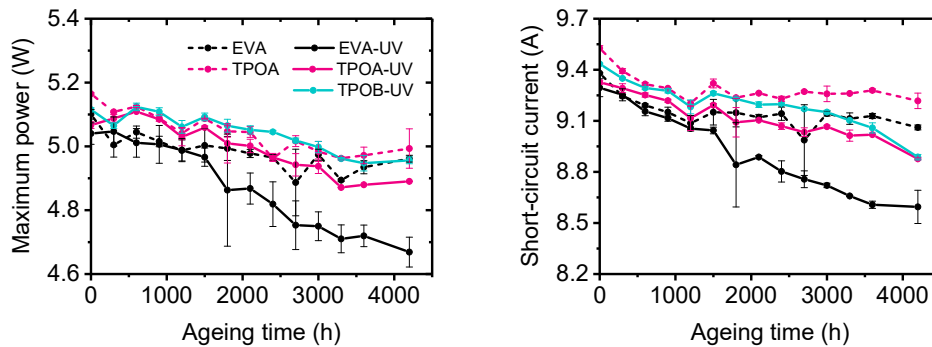
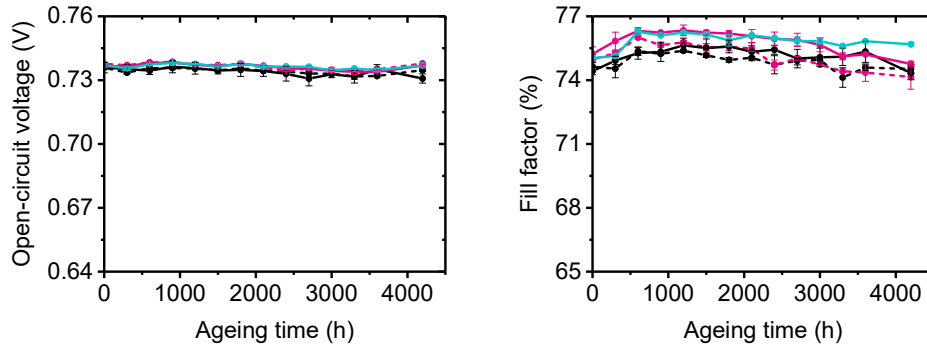
Figure 4 presents the evolution of the I-V parameters measured in figures of merit for all nHJT modules during UV aging.

Figure 4: Evolution of the monocell modules performances during accelerated UV aging

The initial discrepancy between modules with and without UV absorbers rapidly shrinks and P_{\max} of the modules with the same encapsulant matrix are similar after only 300 h. After this initial stabilization, the maximum power of all modules are going down at the same rate until 1500 h of aging. After 1500 h, EVA-UV modules power drops at a much faster rate than that of the others. Moreover, if we compare the same matrix with and without UV absorbers, P_{\max} losses of TPOA-UV modules are slightly more important compared to those with TPOA. Such difference is even higher for EVA-UV and EVA modules, and P_{\max} of TPOB-UV modules follows a similar trend as EVA-UV modules' after its initial stabilization.

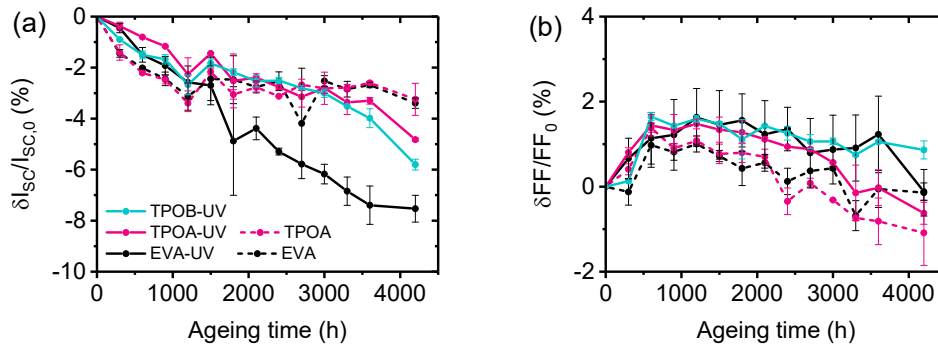
Figure 5: Evolution of the relative loss of modules short-circuit current (a) and fill factor (b) during the test

According to Figure 5a, the short-circuit current (I_{sc}) decreases for all modules. On one hand, after 1500 h, the modules without UV absorbers (EVA, TPOA) maintain their current with a I_{sc} loss of 3.3%. On the other hand, modules with UV-cut encapsulants (EVA-UV, TPOA-UV, TPOB-UV) show a continuous decline of their I_{sc} that reaches up to 7.5% in the case of EVA-UV. The initial I_{sc} decrease could be attributed to the opacification of the cell transparent conductive oxide (TCO) layer under high UV irradiance [25]. The long-term loss could be linked to the yellowing occurrence on modules with UV-cut encapsulants as such discoloration implies a reduced transmission of blue light that impairs the current generation of the cell. By comparing I_{sc} of modules with EVA-UV to that of modules with EVA, the net loss due to discoloration after 4200 h is at least 4.2%. If UV absorbers effectively slow the degradation

that seems to affect the TCO, the associated I_{sc} loss is reduced for UV-cut encapsulants. In that case, the I_{sc} loss due to yellowing is higher than the simple difference between short-circuit currents of modules with UV-cut and UV-pass encapsulants. The fact that these additional losses only concern encapsulants with UV absorbers indicate that these additives are involved in the degradation mechanism. Pickett and Moore [26] proposed a brief mechanism that could explain the destruction of the aforementioned UV screeners in polymethyl methacrylate (PMMA) that is exposed in the presence of air to wavelengths below 365 nm. According to their results, these molecules are excited by the UV light and decomposed in benzoic acid and phenol products. According to Jentsch *et al.* [16], these molecules can be responsible for the discoloration.

Figure 5b shows a fill factor (FF) increase after the first 600 hours of illumination. Furthermore, it also decreases in the long run for TPOA and TPOA-UV modules. The I-V curves reveal a notable increase of the series resistance R_{series} , which may explain the FF loss. However, for other modules, the FF variation does not follow the same trend as the decrease of their I_{sc} is more pronounced and consequently compensates for the R_{series} rise in the FF calculation. The early FF gain can be caused by the light soaking of the HJT cells involved by visible and infrared parts of the lamp spectrum [27]. The R_{series} increase could be attributed to the potential TCO photodegradation that would cause the aforementioned early I_{sc} loss.

None of these losses comes from a V_{oc} loss. None of the modules, with or without UV absorbers, shows any V_{oc} loss after 4200 h of ageing. The stability of our nHJT passivation under UV is notable and contrasts with the observations of Sinha *et al* [24]. Such behaviour may be due to the emitter position. In our case, it is located in the rear part of the cell while the cited work touches on HJT cells with front emitter. The V_{oc} invariability means that the P_{\max} losses come from I_{sc} or FF degradations which are displayed in Figure 5.

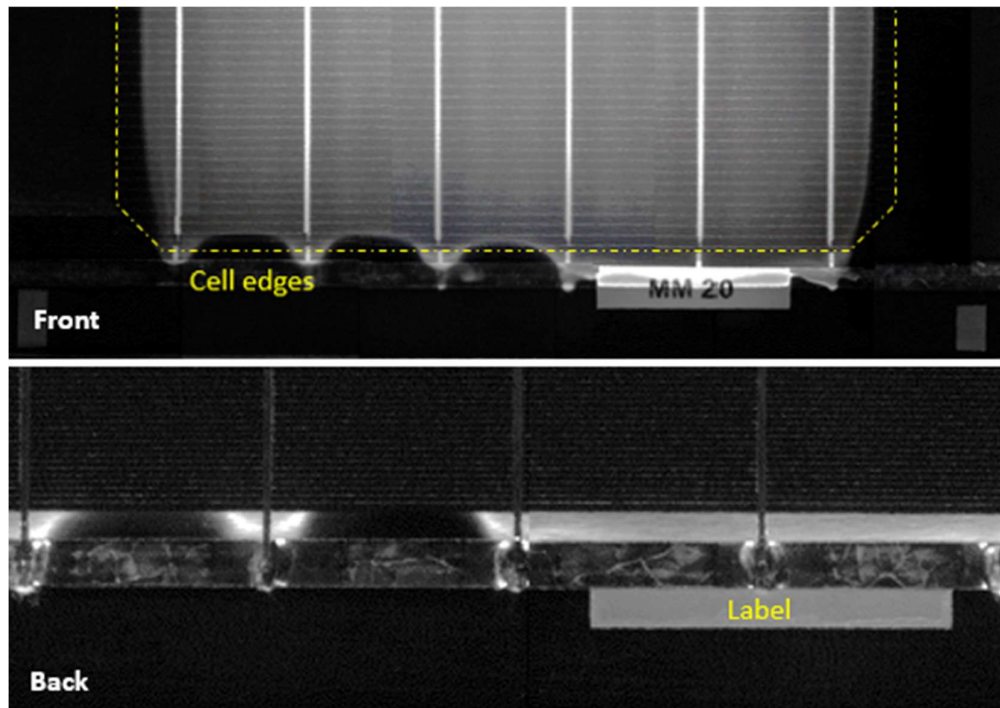
Figure 6 is a partial fluorescence mapping of a module of both front and back sides.

Figure 6: Partial fluorescence mapping of a monocell module with TPOB-UV encapsulant

On the front face, the module displays fluorescence with extended cell coverage while the edges remain dark. Over the cell, the intensity of the fluorescence emission becomes slightly higher toward the centre. The frontier between regions with and without fluorescence is very sharp and forms an arc-shaped front between the tab ribbons. Near the module tag, which is in between the front glass and the front encapsulant, the fluorescence front is smoother and irregular bright spots can be seen above the output ribbon. On its back face, fluorescence can be observed as well but output and tab ribbons obscure it. Then, the fluorescence emission seems to come from the upper part of the front encapsulant. Lyu *et al.* [30] also found that yellowing is mainly occurring near the glass-encapsulant interface. In fact, UV photons will be first absorbed in the encapsulant near the glass-encapsulant interface. It leads to a higher photoreactivity near the glass surface and thus a higher yellowing.

The sharp fluorescence gradient at the cell edges may be the consequence of a reaction-diffusion mechanism that arises from the competition between several chemical reactions. As soon as chromophore products are generated from UV absorbers, they can be destroyed through photobleaching (photooxydation mechanism) [21] that erases the discoloration. Strong photobleaching was expected at the edges of the module where oxygen concentration is kept high because of lateral diffusion. It explains the absence of fluorescence emission in this region. The fluorescent area is limited near the edges of the cell. Photobleaching seems limited because of the presence of obstacles. For example, the module label seems to favour fluorophores formation over photobleaching by acting as a mechanical barrier to oxygen diffusion. The same fluorescence patterns are visible with TPOA-UV and EVA-UV modules as shown in Figure 7.

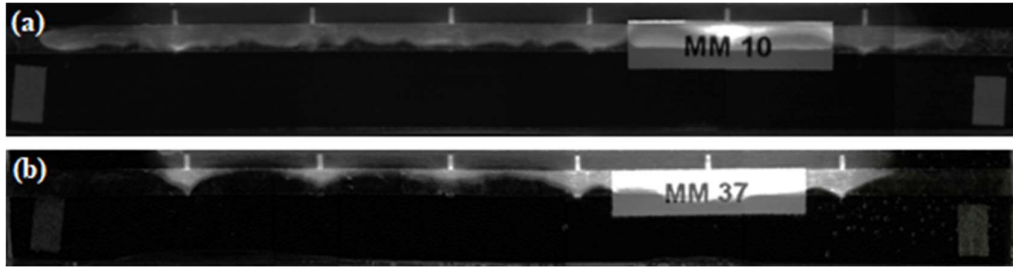
Figure 7: Fluorescence imaging of TPOA-UV (a) and EVA-UV (b) modules output ribbon.

Fluorescence emission can be detected on both modules and parts of respective fluorescence fronts are localized on the output ribbons. Because the fluorescent encapsulant part over the output ribbon is smaller, photobleaching seems more advanced in the case of EVA-UV compared to that of TPOA-UV. UV degradation in a given medium may differ relatively to their chemical nature [31] and the various polymer matrix can influence differently the behaviour and stability of such additives [32]. As such, the differences in UV-cut encapsulants formulation may explain the variability of fluorophores formation and photobleaching balance. Figure 3 and Figure 7b reveal similar patterns and location between yellowing and fluorescence emission, meaning that the visible chromophores and the fluorophores are the same species.

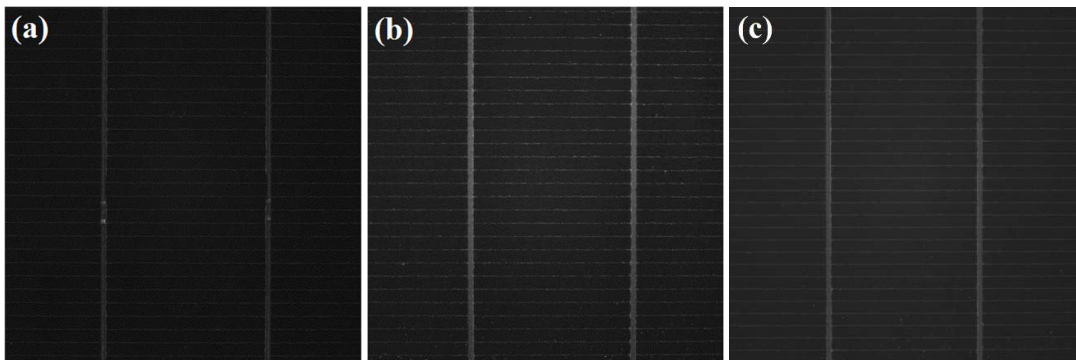
Modules with TPOB-UV encapsulant has also been aged under UV LEDs that emit around either 365 or 305 nm. The emission spectra are much narrow than AM 1.5G or xenon-arc lamp's (Figure 1). As such, the specific role of UV irradiation on yellowing and photobleaching is investigated on an encapsulation polymer for which it has been proven that discoloration can happen under solar-like light during accelerating aging tests. Figure 8 presents the fluorescence shots of the modules with TPOB-UV module aged under 365 nm and 305 LEDs.

Figure 8: Fluorescence shots of unaged module (a), and modules aged under UVA (b) and UVB light (c). The three pictures were shot in the same conditions and covers a $5 \times 5 \text{ cm}^2$ surface.
