New Insights using Avalanche Mode for On-wafer Evaluation of SiC Diodes Technology and Design Ruggedness

Ahmad Abbas^{1,2}, Cyrille Le Royer¹, Romain Lavieville¹, Saliou Gningue¹, Rihab Chouk¹, Jérôme Biscarrat¹, Edwige Bano², and Philippe Godignon¹

¹Univ. Grenoble Alpes, CEA, Leti, F-38000 Grenoble, France

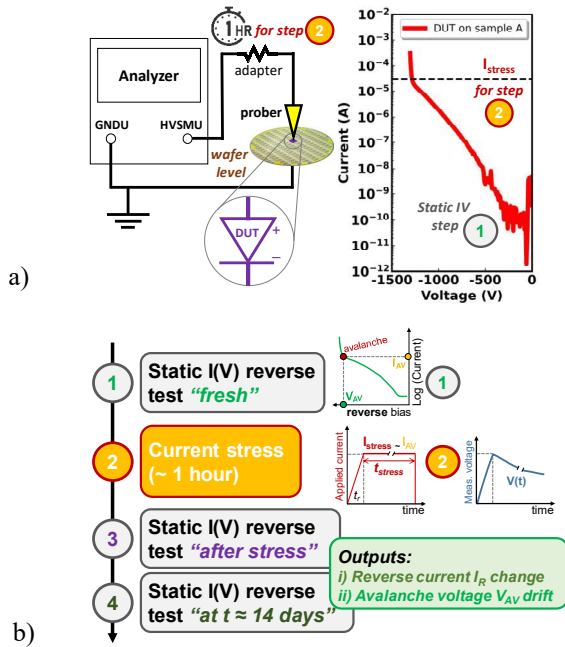
Fig. 1: a) general concept of the proposed test method based on avalanche mode bias starting with on-wafer static I(V) reverse characteristic measurement using high voltage SMU. b) Test sequence for the proposed method. Step 1 is a standard reverse I(V) measurement. Step 2 is a DC current stress using a constant I_{stress} closed to avalanche (Fig. 1a). Additional static I(V) (step 3 and 4) enable to monitor I_R and V_{AV} potential drift and recovery.

- We test the devices on-wafer using solely a wafer prober and a HVSMU (Fig. 1a).
- The method allows to test and compare devices (featuring different architectures, different designs) co-integrated on a single wafer.

This approach can be easily implemented to perform a relatively fast preliminary screening (compared to usual reliability techniques) of new designs or any technological change. The method is composed of three main steps (described in Fig. 1b).

- Step 1 consists in a standard blocking mode I(V) measurements. In the case of the tested SiC diodes, an example of reverse I(V) curve [4] is illustrated in Fig. 1a. It enables to identify the current at which avalanche starts (I_{AV}).
- Step 2: a new measurement of the same device is set to apply a DC current stress slightly above I_{AV} for a given duration (Fig. 1b). We can bias either in voltage or in current, which leads to similar results. For better accuracy, biasing in current is preferred since the current range is larger than the voltage one above avalanche.
- Step 3 (and 4): Standard blocking mode I(V) measurement (similar to step 1) is performed in order to highlight an eventual drift of the electrical behavior. Furthermore the time-dependence recovery of the shifted I(V) can be investigated through additional measurement (step 4).

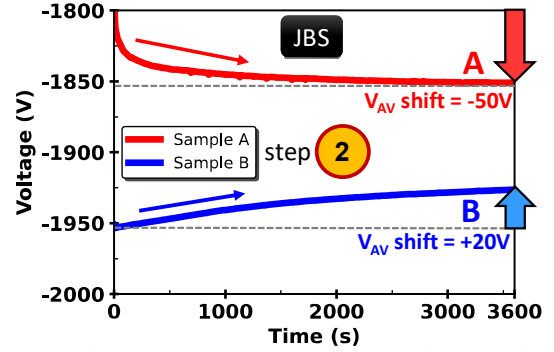
Fig. 2: Example of current stress step (step 2) results obtained with the method for JBS devices from samples A and B. Diode reverse voltage is plotted as a function of time for a 1-hour current stress. The devices are operating in avalanche mode.

In Fig. 2, we show the JBS reverse voltage monitoring at a fixed current stress of 1 hour for both A and B processes (step 2). For both cases, we observe a change of the anode voltage with stress time, but in opposite directions: voltage

increase for A, voltage decrease for B. This discrepancy is attributed to different degradation phenomena, as discussed in next section.

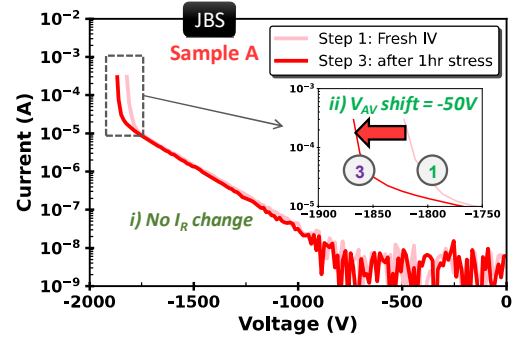
Fig. 3: I(V) curves for step 1 (fresh) and 3 (after 1 hour stress @ 30 μA) for a JBS diode from sample A. Reverse current below avalanche is unchanged, whereas avalanche voltage V_{AV} is shifted (-50 V). Edge termination is a JTE with 4 inner rings + 3 outer rings [8].

In step 3 of I(V) characteristic shown in Fig. 3 (sample A), the increase of the avalanche voltage (V_{AV}) is confirmed while the leakage current below avalanche remains the same. The V_{AV} drift is not permanent and starts to relax back several hours after the stress (step 4, in Fig. 4).

can note that the forward I(V) characteristics of sample A is not modified before and after stress (Fig. 6), indicating that the Schottky contact is in this case stable with a Schottky barrier height fixed at 1.57eV (cf. unchanged leakage current in step 3 and 1, Fig. 3).

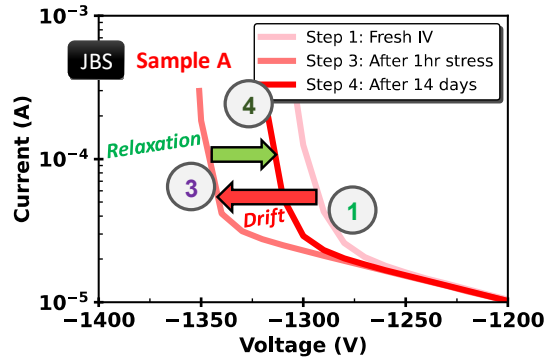
Fig. 4: Example of step 4 results (sample A with 10 μm epi) with partial recovery observed after 14 days. Time constant for recovery is very slow. The drift is not caused by a destructive phenomena, which supports the presence of charge effects in the oxide instead of an oxide structural degradation.

observed I(V) drift (avalanche). For sample A, the avalanche drift recovery (Fig. 4) indicates that the corresponding effect can be attributed to the trapping and de-trapping of hot carriers. This has been confirmed by a stress under electroluminescence, which demonstrated the presence of light emission around the termination region due to the recombination of electron-hole pairs and the release of light energy (photons) by impact ionization. The stress method leads to the generation of hot carriers, specifically electrons, which gain sufficient energies to be subsequently injected and trapped at the field oxide/SiC interface, in accordance with the increase of the avalanche voltage (Fig. 4, step 3), predicted by simulations. These carriers are then de-trapped, leading to the recovery of the initial characteristics (Fig. 4, step 4). However, the relaxation time constants are unusually high for electron de-trapping. Then, hole trapping may also be involved. Besides, the localization of the electroluminescence (Fig. 8) confirm that these occurrences take place within the termination region of the device.

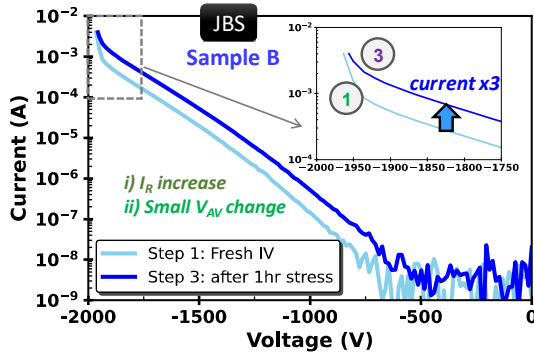
Fig. 5: I(V) curves for step 1 (fresh) and 3 (after 1 hour stress @ 3mA) for a JBS diode from sample B. Reverse current increases here, whereas avalanche voltage is almost not impacted. Edge termination is a JTE with 3 inner rings. P+/Schottky ratio is the same as for JBS of process A.

The behavior of sample B (Fig. 5) is utterly different. The avalanche voltage V_{AV} is not affected by the stress, whereas the reverse leakage current before avalanche is 3 times higher. This leakage current is mainly dependent on the Schottky contact properties. From forward I(V) measurements before and after stress (Fig. 6), we can derive a change in the Schottky barrier height of sample B, where we observe a decrease from 1.098eV before stress to 1.011eV after. The drift in sample B is not recovered when measuring after several days (step 4: not shown here). One

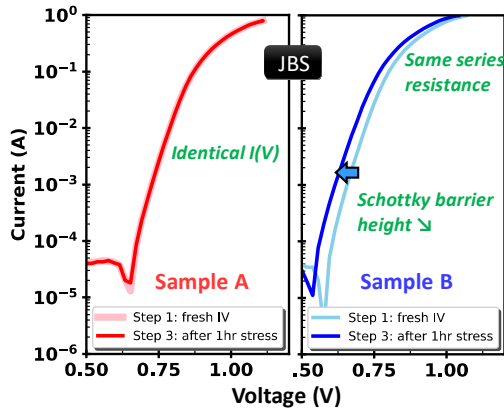
Fig. 6: Forward I(V) measurements to step 1 and 3 for samples A and B highlighting the change (after step 2 stress) in the JBS Schottky barrier height of sample B [6]. Sample A forward characteristics are identical. In both cases, series resistances in the ohmic conduction region are unchanged.

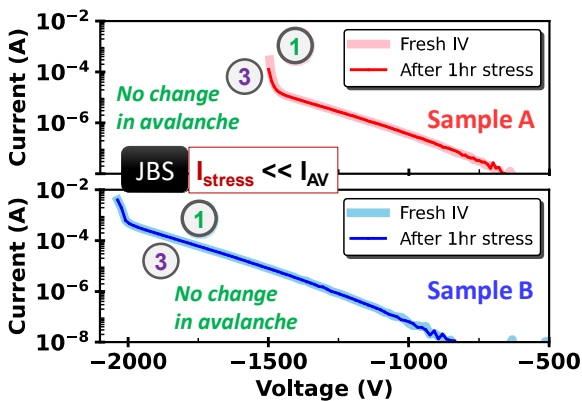
Fig. 7: Reverse I(V) characteristics before and after current stress below avalanche mode. No drift of the curves is observed if current stress ($I_{\mu\text{A}}$ here) is lower than avalanche current level ($I_{\text{AV}} \sim 10\mu\text{A}$ for A, $\sim 500\mu\text{A}$ for B). Sample A characteristics correspond to the 10 μm epilayer wafer. Similar behavior is obtained for the 12.7 μm epilayer wafer of process A.

Beside, when applying a stress current corresponding to a voltage below the avalanche point ($I_{\text{stress}} < I_{\text{AV}}$), no drift is observed (Fig. 7). These results highlight the fact that the method implies a stress current close to I_{AV} (and thus that the avalanche process is responsible for the observed drift).

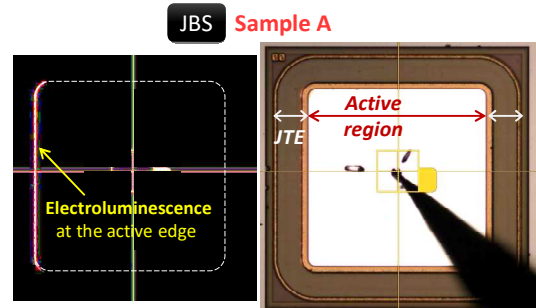
Fig. 8: Top view of a sample A diode under current stress through the probe optical microscope. Electroluminescence generated by electrons-holes recombination is observed on the left side of the active area due to the anisotropy of the impact ionization in the SiC crystal.

We can speculate from the former that the drift may reach a steady level after 5 hours indicating a saturation in the carriers injected in the oxide [7]. From the latter we can presume that the drift widens with high stress current bias to reach the same saturation. TCAD simulations have been performed to better understand the drift mechanism. Simulation results show a strong presence of the electric field around the termination inner rings (Fig. 11). This is in agreement with the localized peaks of impact ionization rates observed in Fig. 12. These hot spots of generated electron-hole pairs are the direct cause of light emission seen by electroluminescence in Fig. 8.

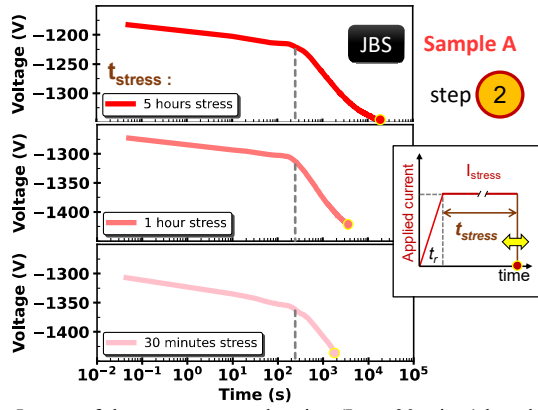
Fig. 9: Impact of the current stress duration (I_{stress} : 30 min, 1 h and 5 h, on three different devices) on the reverse voltage drift during step 2. Log scale for time enables to identify a change in the voltage evolution after 200 s of stress.

To investigate the stress sequence parameters, we tested several stress durations (Fig. 9) and different stress current levels (Fig. 10). Concerning the impact of the stress duration, we observe at least two phases during step 2: for stress duration below 200 s, we see a steady increase of voltage. After 200 s the voltage increase drops. In addition, beyond 5 h, the voltage starts to saturate. Further investigations are needed to clarify the exact reason for these characteristics.

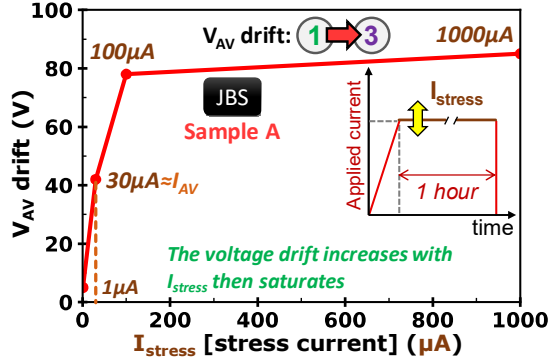
Fig. 10: Impact of the stress current value on the avalanche voltage V_{AV} drift for a 1 hour stress (same design, different devices). Saturation of the V_{AV} drift value is seen above a given current bias (around $100\mu\text{A}$ for the device used in this figure). This value will depend on the device design.

The voltage drift between step 3 and 1 (Fig. 10) clearly depend on the I_{stress} . A minimum I_{stress} value is required (30 μA here) and for stress larger than 100 μA , we observe a saturation in the voltage drift. The cumulative time/current effect can be related to the injected charges, which are responsible for the observed phenomenon, which tends to saturate.

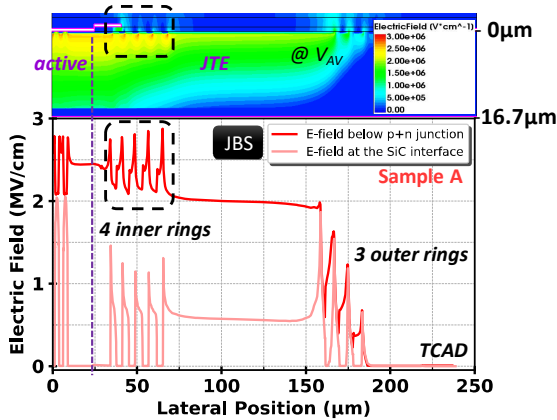
Fig. 11: TCAD simulation showing the electric field distribution: a) 2D mapping, b) corresponding outlines at the surface of the SiC, and below the junctions of the p^+ rings. The e-field peaks beneath the inner rings correspond to the electroluminescence location (Fig. 8).

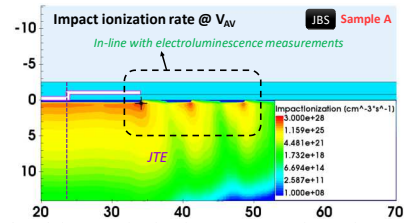
Fig. 12: Simulated impact ionization 2D mapping of sample A JBS (via TCAD Sentaurus). Peaks around the first 3 internal p^+ guard rings at the beginning of the JTE during avalanche mode are observed. Combined with electroluminescence, these peaks endorse the assumption of injected hot carriers into the oxide at the JTE edge (same region of light emission).
